Program Bulletin

CUSTOMER SATISFACTION PROGRAM

SUBJECT: Dealer Installed Rear Seat Entertainment System

MODELS: 2014-2015 Chevrolet Silverado, Suburban, Tahoe
2014-2015 GMC Sierra, Yukon

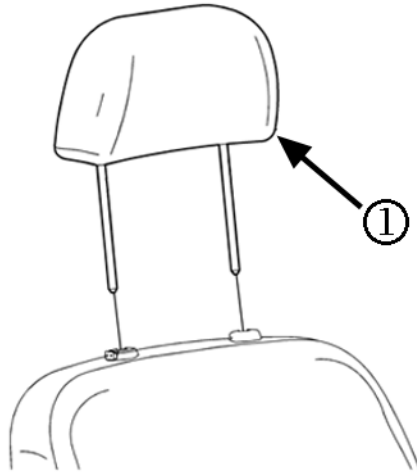
4079902

1. Remove the driver headrest restraint (1) by pushing in on release buttons located on monitor mounting base and pulling up.

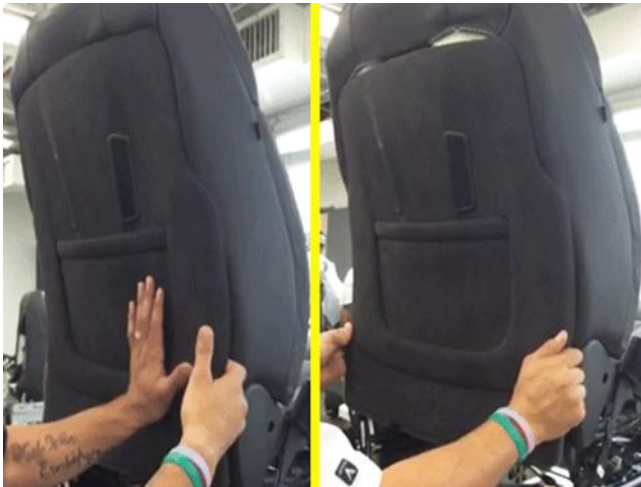
4079906

2. Remove the driver seat back finish panel. Refer to *Front Seat Back Cushion Finish Panel Replacement* in SI.

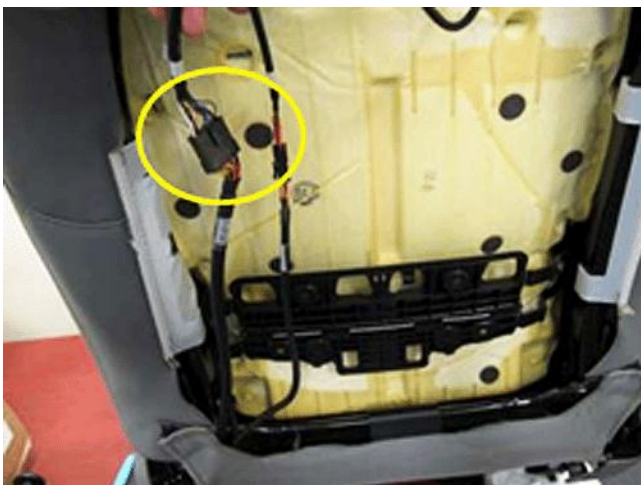
4079909

3. Cut the wire ties securing the monitor harness inside the seat back.

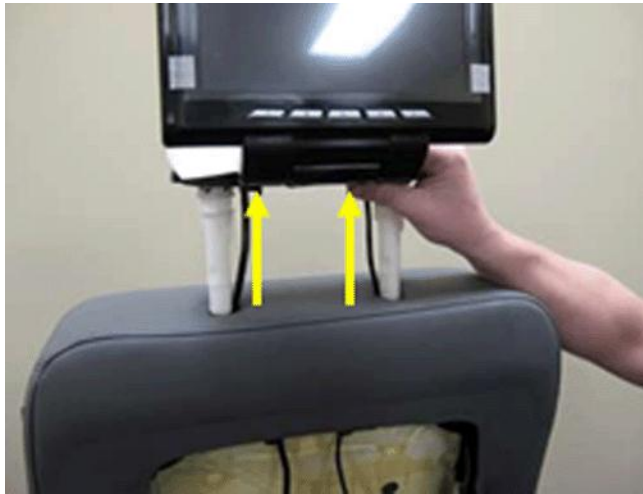
4079914

4. Using a suitable flat-bladed tool, remove the drivers monitor from the seat.
 - Place the tool between the seat material and front edge of the monitor post guide sleeve, locating the release tab.
 - Press in on the tab on each sleeve and the sleeve can be released for removal.

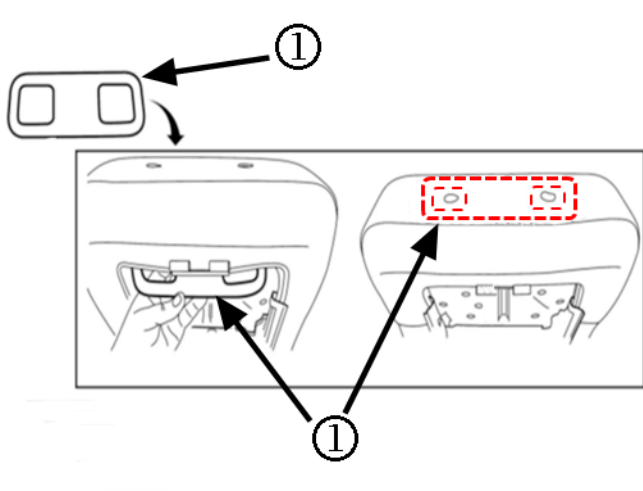
4079954

5. Reaching up under the seat cover material, remove the felt spacer (1) between the seat foam and material. Once removed, the new post guide sleeve can be installed.
6. Repeat steps 1-5 on Passenger side seat.

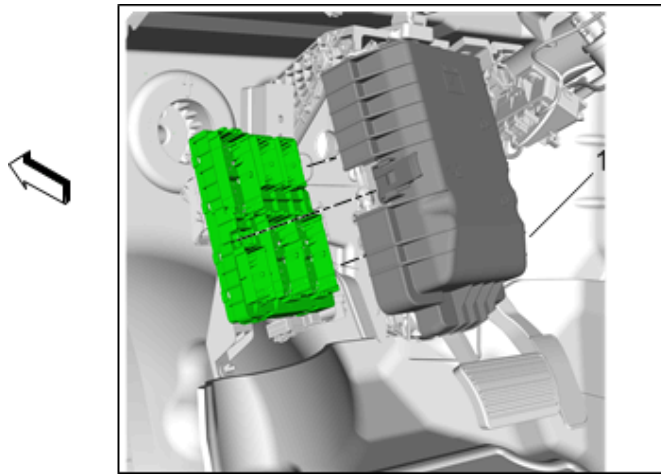
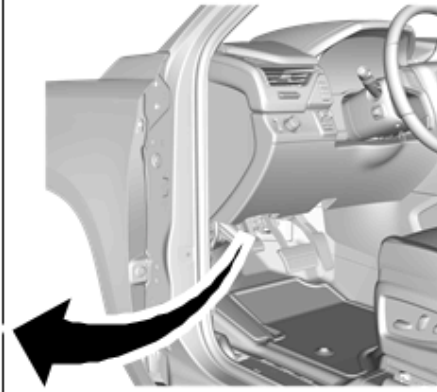
3766475

- 7. Remove the MBEC cover located below instrument panel on driver side right of parking brake. Pull tabs on either side of cover (1) to remove.

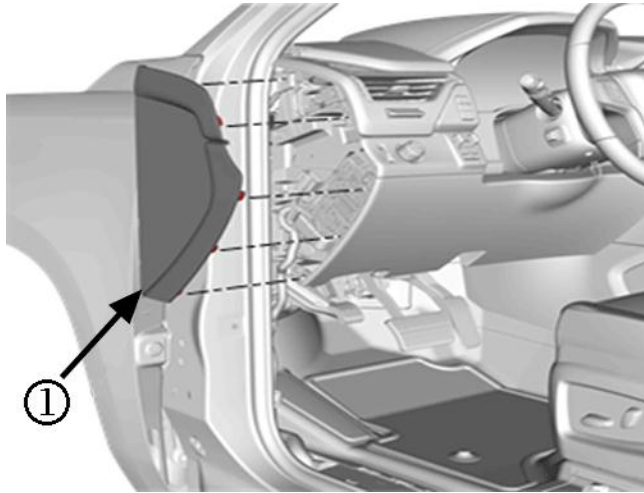
4079922

- 8. Using flat-bladed plastic trim tool, remove the instrument panel fuse block access hole cover (1) from the instrument panel.

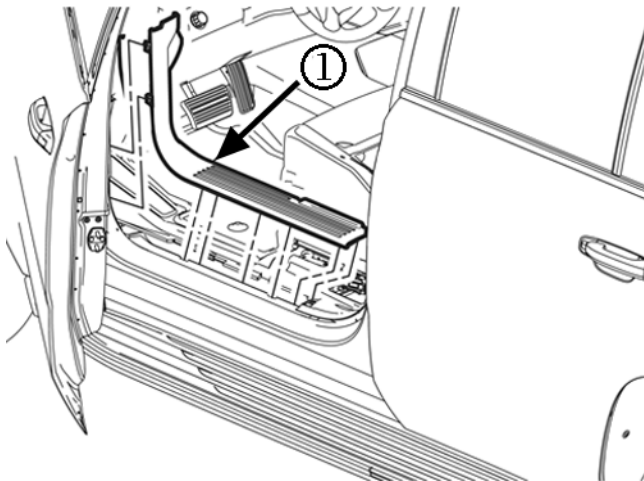
4079926

- 9. Pull the front side door sill garnish molding toward the rear of vehicle to disengage integral clips.
- 10. Reposition the front floor panel carpet as needed and remove front side door sill garnish molding (1).

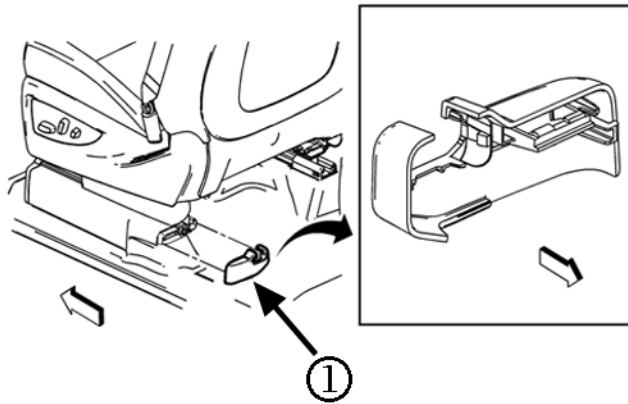
4079931

Caution: Do not twist the cover during removal. Twisting the cover may cause the component to break

- 11. Adjust the seat to the full forward position to gain access to the finish cover (1).
- 12. Firmly grasp the finish cover, pulling rearward to disengage it from the seat track.

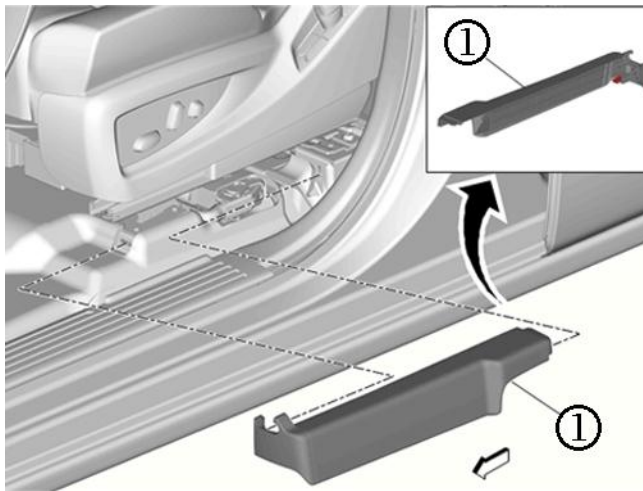
4079936

Caution: Do not twist the cover during removal. Twisting the cover may cause the component to break

- 13. Adjust the seat to the full rearward position to gain access to the finish cover.
- 14. Firmly grasp the adjuster front finish cover and side cover (1), pulling forward to disengage it from the seat track.

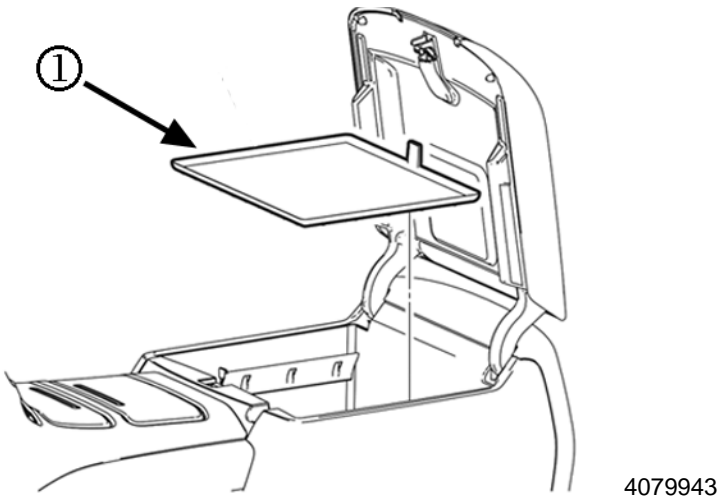
15. Remove the front floor console compartment liner (1) from the front floor console.

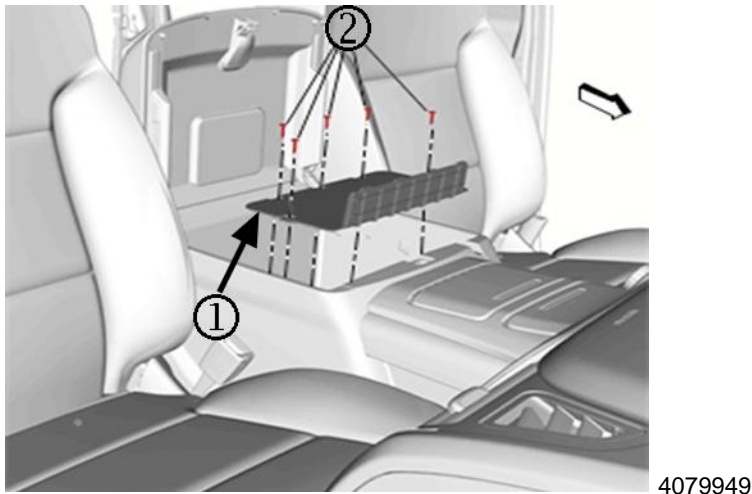
16. Remove the five Philips screws (2) and the compartment trim panel (1) from the front floor console to allow access for wire routing under the panel.

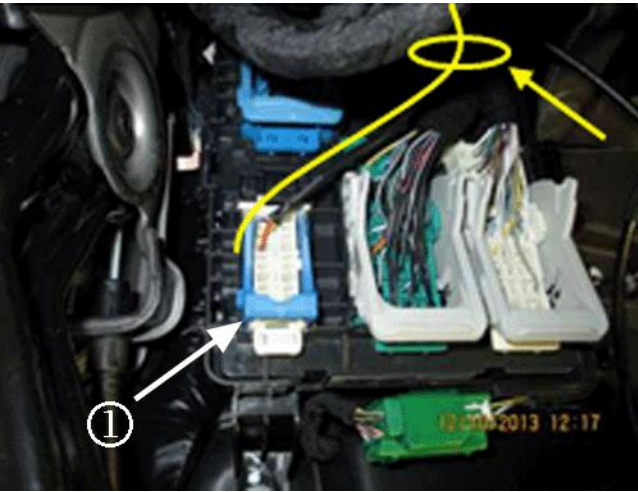
4080526

1. Locate MBEC. Remove 20 pin connector (1) of the power harness cable in the lower left hand corner of the MBEK. Cut the wire ties securing the harness.

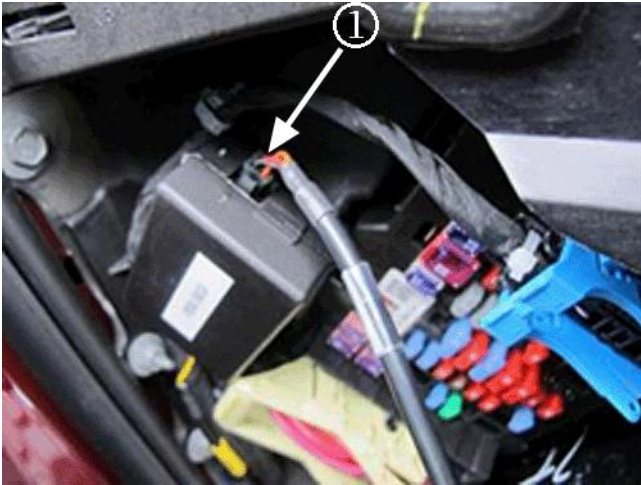
4080530

2. Unplug the power cable (1) from the power filter located above the fuse panel (approximate location shown circled in previous graphic). The filter is held in place by two-way tape; pull tape off dash panel and remove, along with the harness.

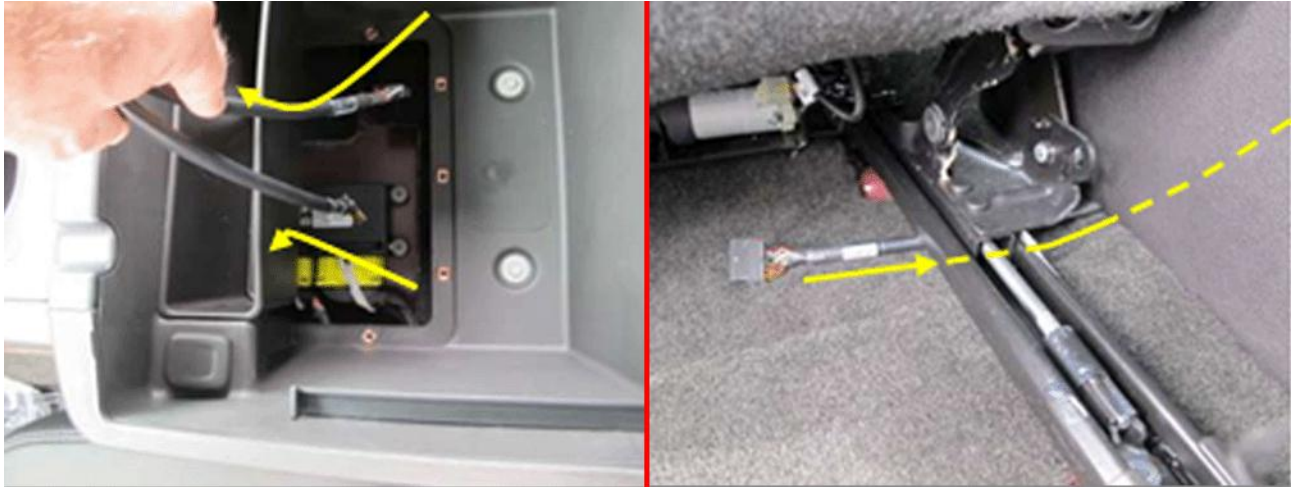
4080533

1. The A-B signal cable routes through the opening of the floor console main compartment, under the sides and under the seat frame rails. From inside the opening in the floor console, pull each end of the cable out from under the seat.
2. Reinstall the floor console opening cover and rubber pad.
3. Repeat step 1 on the passenger side.
