**SIRIUS SATELLITE RADIO - AUDIO CUTS OUT/NO SIGNAL - BUILT ON  
OR BEFORE 7/14/2015**

TSB 15-0136

2015 Edge

2015 MKC

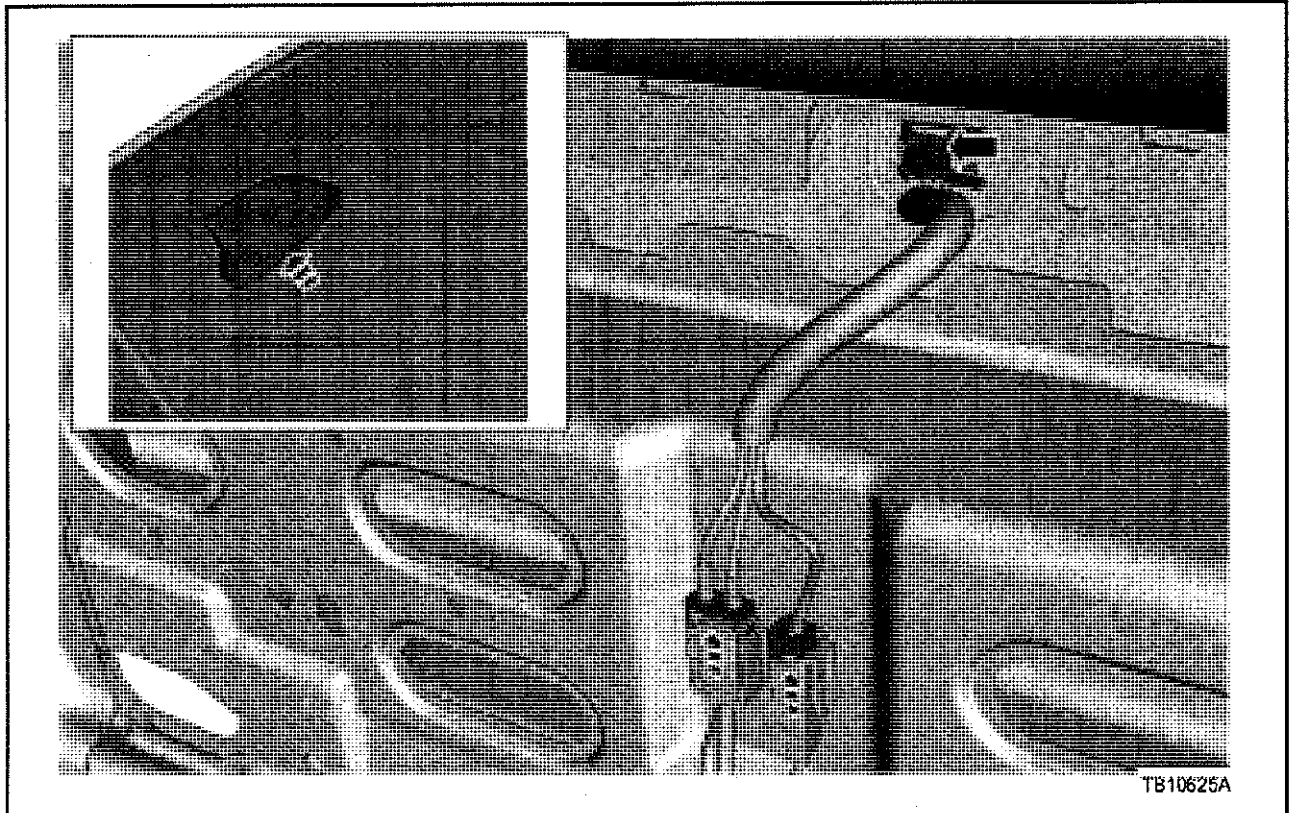
Figure 1 - Article 15-0136

- a. Remove the retainer and audio unit antenna and harness through the roof opening. (Figure 1)

- b. The new audio unit antenna must be painted to the vehicle color before installing.  
 c. Tighten the bolt to 7 Nm (62 lb-in.).  
 7. To install, reverse the removal procedure.
