Bulletin No.: 14773
Date: July 2015

Service Bulletin

SB-10058746-6268

SUBJECT: Special Coverage Adjustment – Coolant Leak / Drip on Automatic Transmission Shifter Grommet

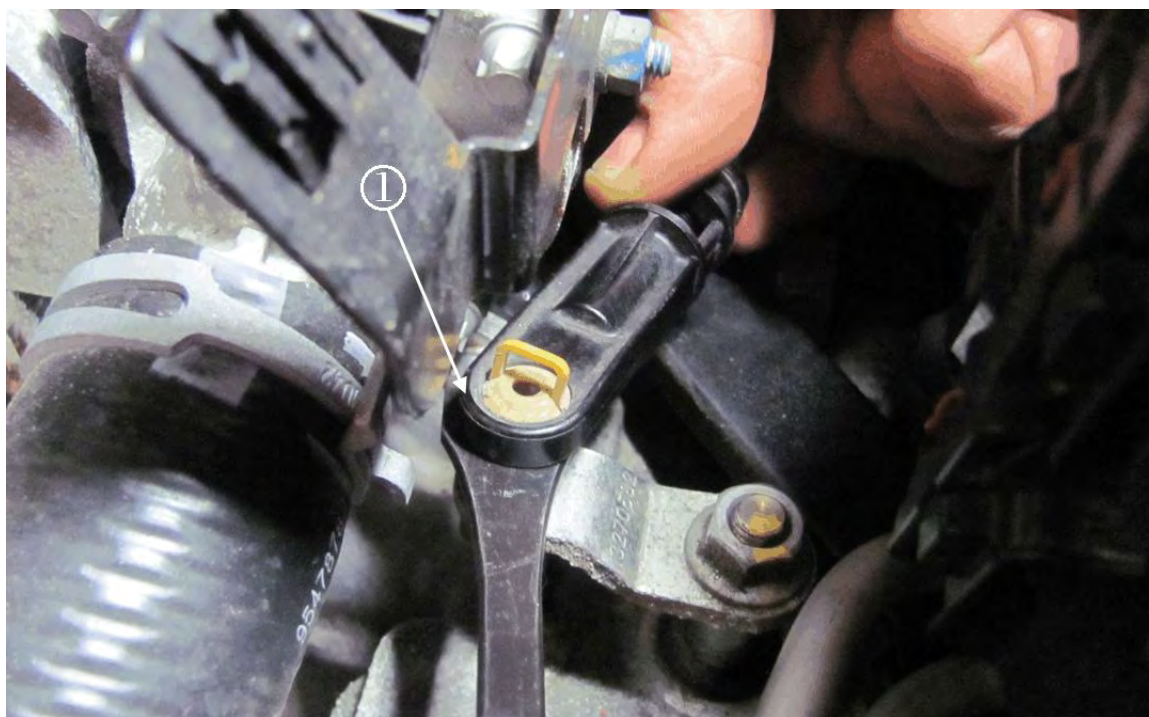
4211004

Caution: Do NOT aggressively pry the adjuster body end off (1) of the transmission lever ball stud (7). The end of the adjuster body (1) should only be raised high enough to clear the transmission lever ball stud to avoid damaging the shift cable.

5. Carefully remove the front portion of the shift cable adjuster body (1) from the transmission lever ball stud.

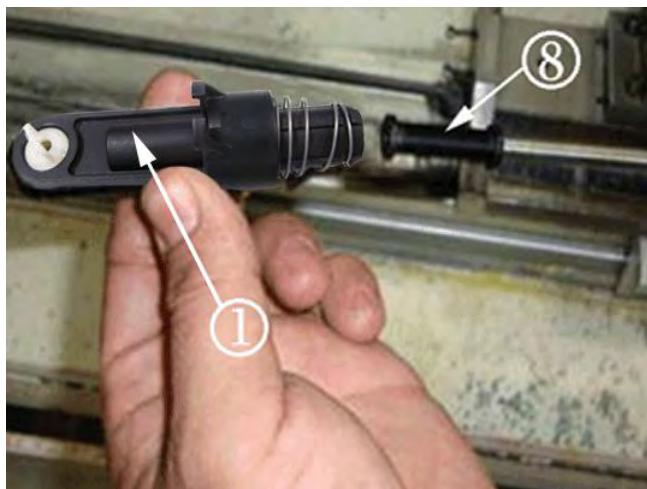
4211026

Note: The new adjuster body (1) has a secondary lock and a spring on the outside of the adjuster body.

8. Install the new adjuster body over the adjuster slider (8).

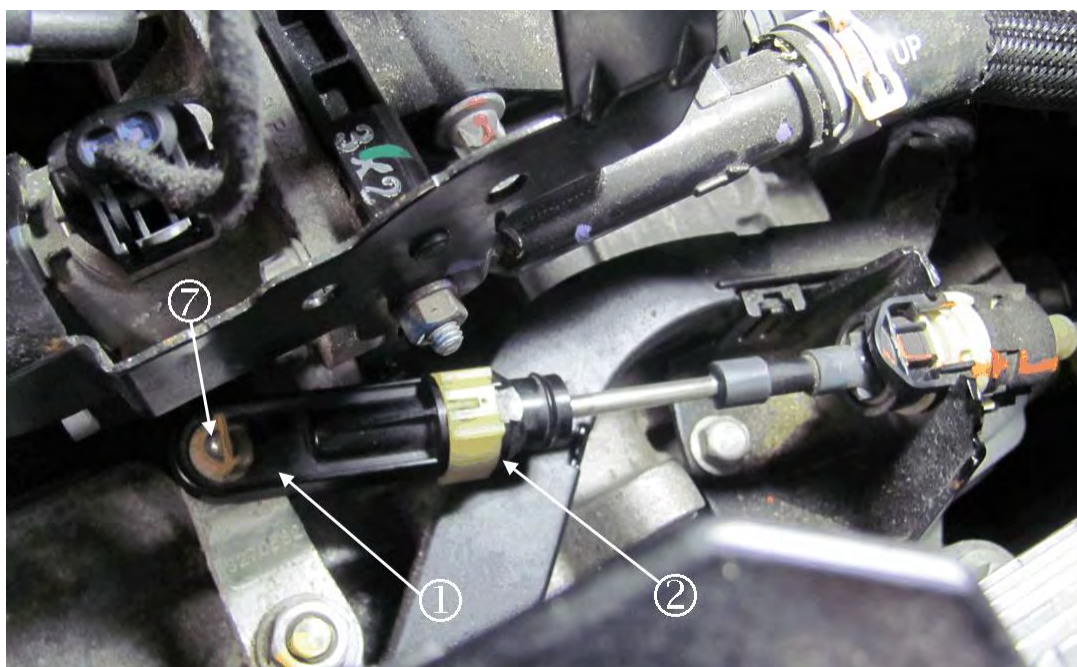
4211012

Photograph shown with the secondary lock and outside spring removed to show the white lock clip fully engaged. The top of the white lock clip should be flush with the black adjuster body.

9. Install the front end of the adjuster body (1) onto the transmission shift lever ball stud (7).
