Program Bulletin

SB-10058777-7074

SUBJECT: Left Front Knuckle to Hub Attachment Torque

MODELS: 2015-2016 Chevrolet Cruze

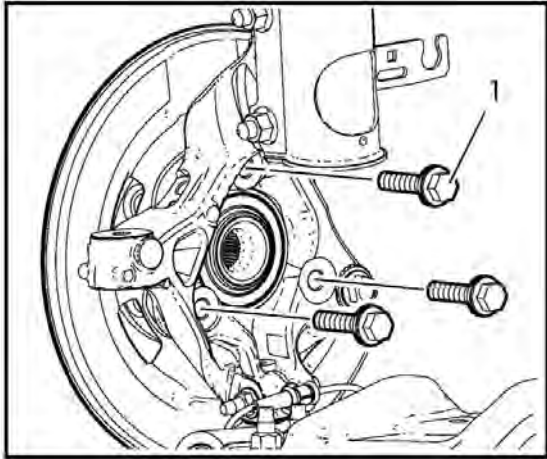
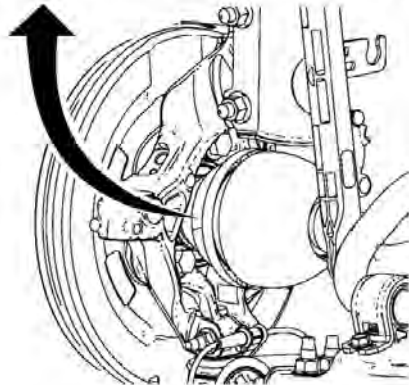
2027764

Certain 2015 and 2016 model year Chevrolet Cruze model vehicles may have been built with the left front knuckle to hub attachment below GM's torque specification. This condition could result in noise from the front suspension and separation of the steering knuckle to hub while driving, resulting in loss of steering control, potentially increasing the risk of a crash.

2. Locate the front driver side bearing/hub bolts.
3. Tighten the bearing/hub bolts (1) in 3 passes. Use the *EN-45059* angle meter. Refer to *Front Wheel Bearing and Hub Replacement* in SI. Ensure to tighten all front driver side wheel bearing/hub bolts.
 - a. First pass to **100 Nm (74 lb ft)**
 - b. Second pass to **20 – 35 degrees**
4. Lower the vehicle. Refer to *Lifting and Jacking the Vehicle* in SI.
