Bulletin No.: 15182
Date: June 2015

SB-10058786-3522

CUSTOMER SATISFACTION PROGRAM

SUBJECT: Backup Alarm Not Installed On Vehicle

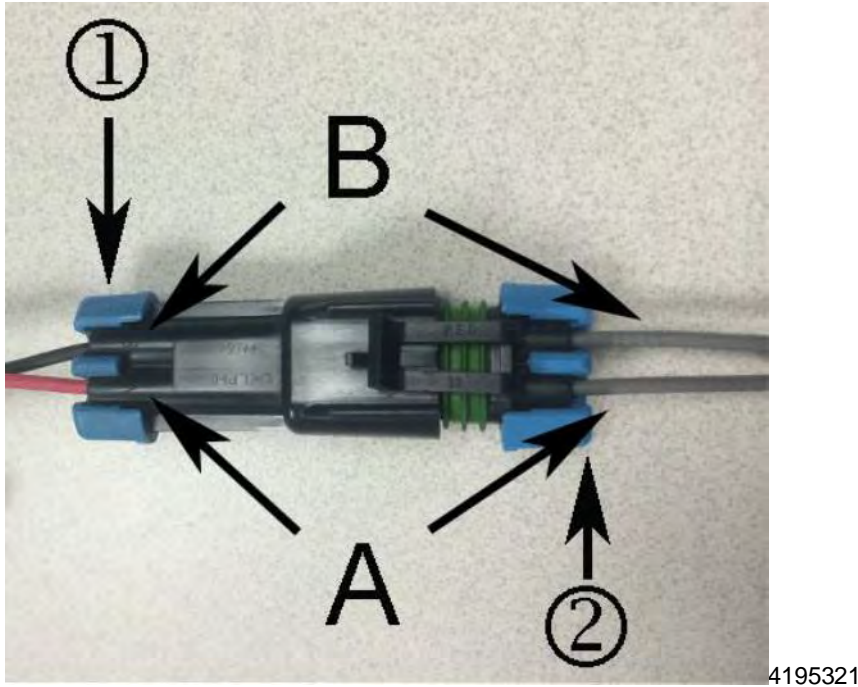
Backup alarm connector (1) terminals A/B shown with 12101855 connector (2).

8. Strip approximately 5.0 mm (0.20 in) of insulation from the end of each 12101855 connector wire.
9. Splice 12101855 connector wire going to terminal A of alarm to the thin gray wire (CKT 1624) of the vehicle harness with the salmon 19300089 Duraseal connector. Refer to *Splicing Copper Wire Using Splice Sleeves* in SI for splicing instructions.

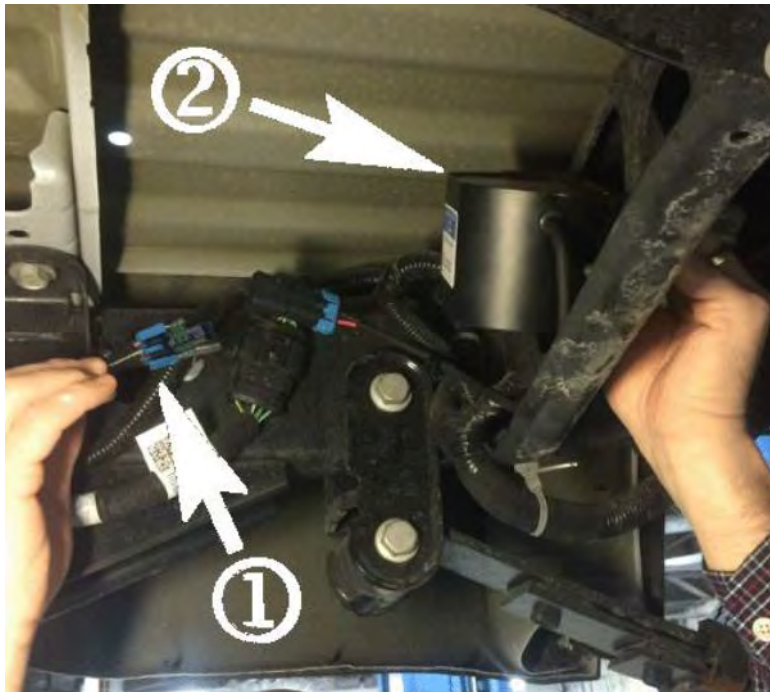
4195326

Backup alarm (2) and harness connector (1).

16. Install the backup alarm to the existing holes of the rear frame crossmember with the mounting nuts and bolts. The crossmember mounting location is near the leaf spring rear shackles. The alarm speaker must be pointing down.
17. Connect the rear harness connector (1) to the alarm (2) harness.
18. Tie strap the complete alarm harness to the existing wiring harness, securing it every 3 inches.
19. Lower the vehicle.
20. Connect the negative battery cable. Refer to *Battery Negative Cable Disconnection and Connection* in SI.
21. Turn the ignition to ON/RUN, and place gear selector into REVERSE to engage the backup alarm.
22. Raise the vehicle and install the spare tire. Refer to *Spare Wheel Carrier Hanger Replacement (Pickup)* in SI.
