Bulletin No.: 15285
Date: July 2015

SB-10058791-5041

SUBJECT: Special Coverage Adjustment - Excessive Engine Oil Consumption

**MODELS: 2011 Chevrolet Equinox
2011 GMC Terrain
Equipped with 2.4L Engine (LAF)**

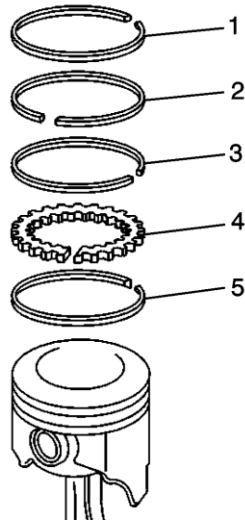
2146346

Some 2011 model year Chevrolet Equinox and GMC Terrain vehicles, equipped with a 2.4L engine, may exhibit excessive engine oil consumption (less than 2,000 miles per quart of engine oil), due to piston ring wear. If this condition is present, the oil can light may illuminate on the instrument panel or the following message may appear in the Driver Information Center: "Oil Pressure Low – Stop Engine".

- Engine Replacement
 - Technical Service Bulletin 13-06-01-003F
 - Piston and Connecting Rod Disassemble
 - Piston and Connecting Rod Assemble
 - Piston, Connecting Rod, and Bearing Installation (LAF, LAT, LE5, LE9, LEA, or LUK)
1. Remove the engine from the vehicle.
 2. Remove the pistons from the engine.
 3. Remove the pistons from the connecting rods.
 4. Discard the pistons and piston rings.
 5. Install the new piston rings onto the new pistons.
 6. Install the new pistons onto the connecting rods.
 7. Assemble the engine.
 8. Install the engine into the vehicle.
