## **Service Bulletin**

Bulletin No.: 15536  
Date: August 2015

**SUBJECT: Special Coverage Adjustment – Side Impact Air Bag Connector Faulty Recall Repairs**

**MODELS: 2008-2013 Buick Enclave  
2008-2013 GMC Acadia  
2008-2010 Saturn Outlook  
2009-2013 Chevrolet Traverse**

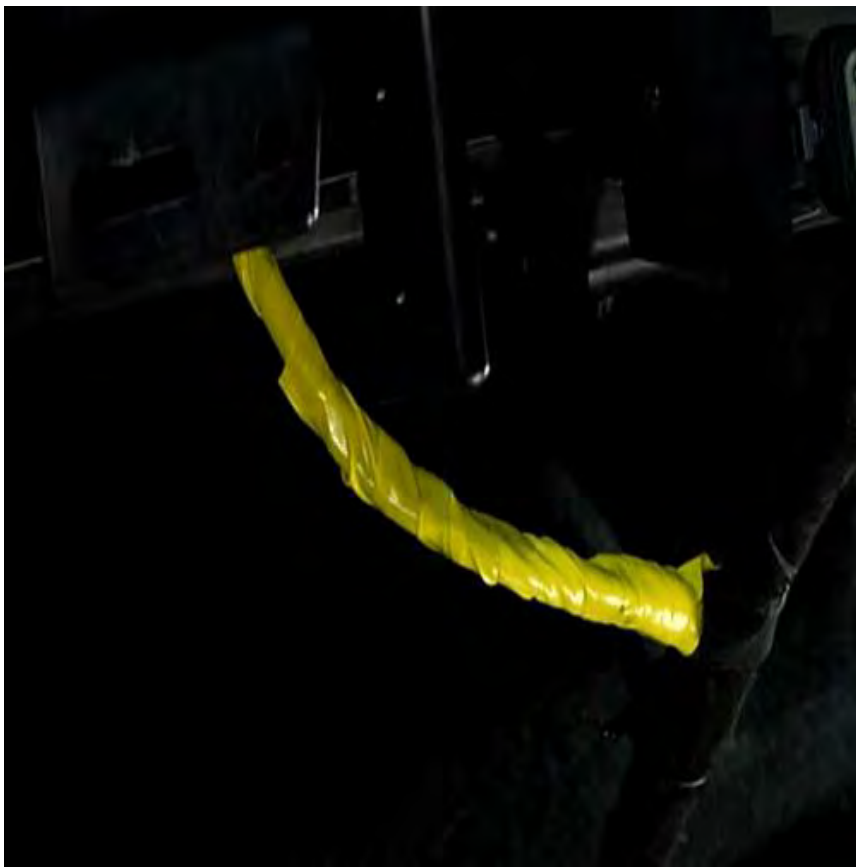
4245693

4. If DTC B0015 or B0022 is set, verify that the appropriate pretensioner connector and CPA are engaged. Proceed with the following wiring repair procedure even if the pretensioner connector or CPA are not fully engaged.
