**NUMBER:** 18-021-15 REV. E**GROUP:** Vehicle Performance**DATE:** October 07, 2015

Flash: 3.0L Powertrain Diagnostic And System Enhancements

RAM 1500 Pickup

NOTE: This bulletin applies to vehicles equipped with a 3.0L Diesel Engine (Sales Code EXF).

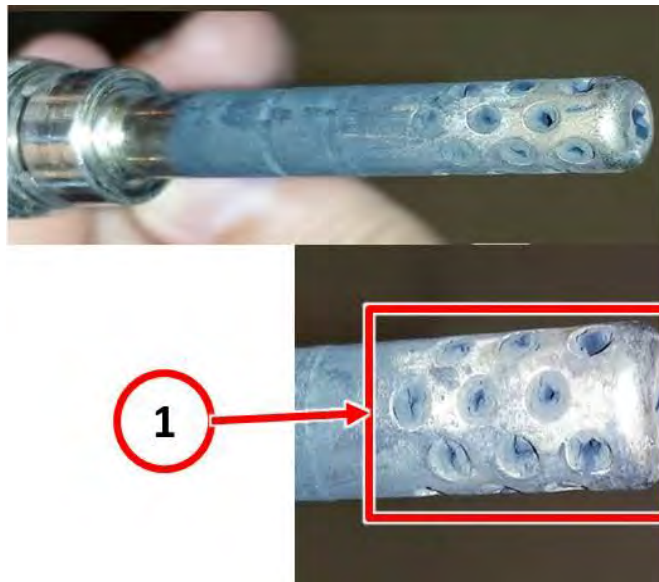
Fig. 1 EGT Sensor Bank 1 Sensor 1

11. Replace the O2 sensor. Refer to detailed repair procedures available in DealerCONNECT> TechCONNECT> Service Info Section 14 - Fuel System> Fuel Injection, Diesel> Sensor, Oxygen> Removal/Installation. Proceed to [Step #12](#).
12. Remove the EGT Sensor 1/2 located in the inlet of the Diesel Particulate Filter (DPF)/Diesel Oxidation Catalyst (DOC) assembly. Refer to detailed removal procedures available in DealerCONNECT> TechCONNECT> Service Info Section 11 - Exhaust System> Sensor, Exhaust Temperature> Removal> Exhaust Gas Temperature Sensor 1/2.
13. Inspect the sensor body and probe for any signs of damage or excessive soot. See ([Fig. 1](#)).

1 - Excessive soot blocking sensor ports

-
14. Was excessive soot found on the sensor?
 - a. Yes>>> Proceed to [Step #15](#).
 - b. No>>> Proceed to [Step #16](#).
 15. Using shop air set to a maximum of 80 psi, clean all excessive soot from the sensor probe.
 16. Using a suitable multi-meter with appropriate test probes, test the resistance between the sensor connector terminals 1 and 2. With the sensor at room temperature, 65-75 °F (18-25 °C), the resistance should measure between 200 and 240 ohms.

17. Is the temperature sensor resistance within specifications?
- Yes>>> Install the original EGT sensor 1/2. Refer to detailed installation procedures available in DealerCONNECT> TechCONNECT> Service Info Section 11 - Exhaust System> Sensor, Exhaust Temperature> Installation> Exhaust Gas Temperature Sensor 1/2.
 - No>>> Install a new EGT sensor 1/2. Refer to detailed installation procedures available in DealerCONNECT> TechCONNECT> Service Info Section 11 - Exhaust System> Sensor, Exhaust Temperature> Installation> Exhaust Gas Temperature Sensor 1/2.
18. Verify all engine systems are operating as designed. The bulletin is now complete.
