# TECH TALK

Volume 218 - August, 2015

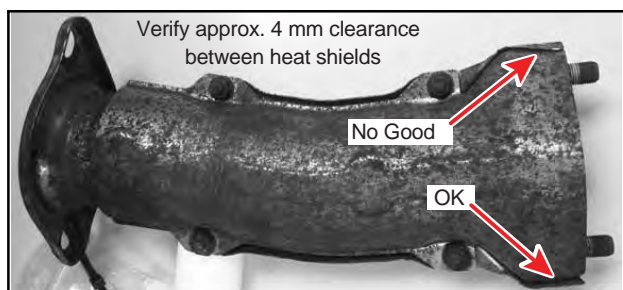
**FRONT EXHAUST PIPE AND SEAL RING BUZZ, SQUEAK, OR RATTLE (BSR)** — 2011–15 Outlander Sport/RVR. If a vehicle comes in for front exhaust BSR, verify that the heat shields shown in the photo below are not touching. If the heat shields are touching, use a screwdriver or appropriate device to pry them apart so there is approximately 4 mm clearance. If the BSR noise is still present, then replace the seal ring, springs, and bolts. Please do NOT replace the center exhaust pipe with catalytic converter until all other potential causes of BSR have been eliminated.

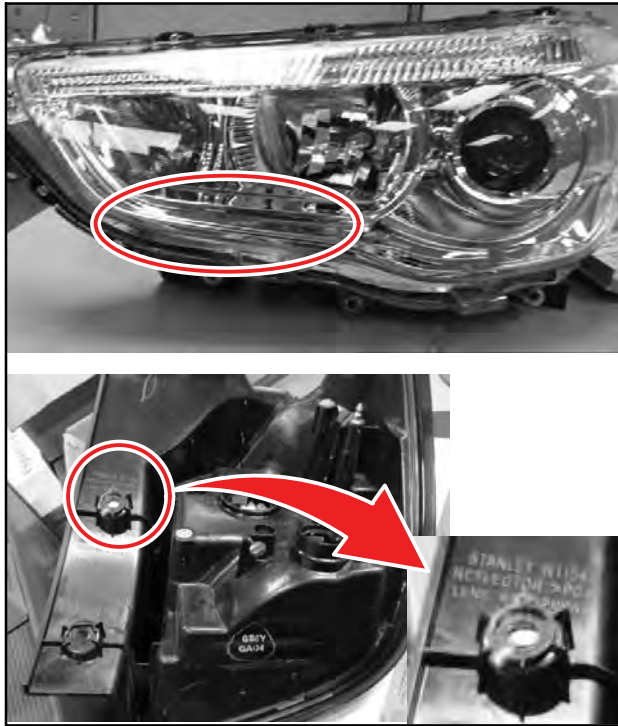
**AFTER-MARKET HEAD LAMPS/TAIL LAMPS** — 2013–15 Outlander Sport/RVR. MMNA Warranty is experiencing an unusually high return of after-market head lamps and tail lamps. “Stanley Corporation” is inscribed on original Mitsubishi (OEM) parts. The inscription is located on the lower front lens of the head lamp, and on the rear mounting surface of the tail lamp. Any other manufacturer markings indicate an after-market part that cannot be

repaired under warranty. Returned after-market parts that were improperly claimed will be debited to the dealer.

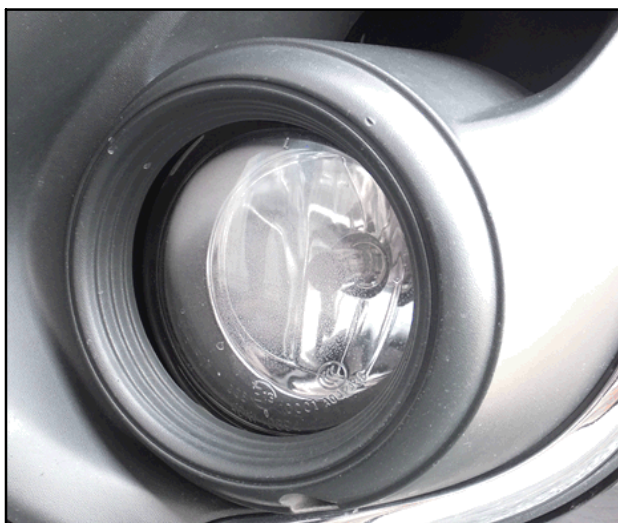
**CONDENSATION OF FOG LAMPS** — 2013-15 Outlander Sport/RVR. MMNA Warranty is experiencing high returns of fog lamp assemblies with only condensation inside the lens. A breather tube at the rear of the assembly is designed to let water vapor evacuate when the lamps are hot. If the condensation evaporates within 30 minutes with the fog lamps on, the fog lamp should NOT be replaced. Dealers will be debited for fog lamps that are replaced for this condition.

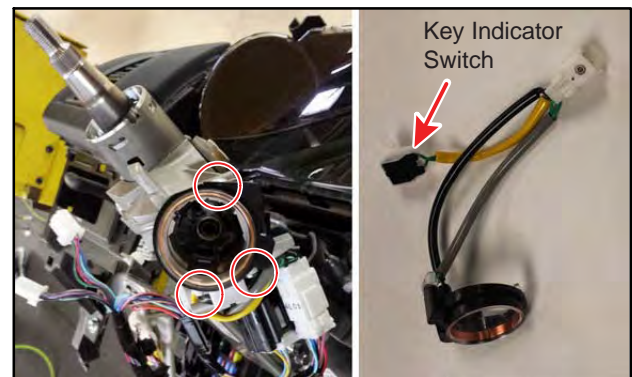
**INCORRECT INDICATION OF KEY IN IGNITION** — 2013-15 Outlander Sport/RVR. If the vehicle incorrectly indicates that the key is in the ignition, replace the Engine Starting Switch Attaching Switch (P/N: 4408A155). The key indicator switch detecting the key in the ignition may be operating intermittently.

In order to replace the Engine Starting Switch Attaching Switch, remove the steering wheel, separate the upper and lower column covers, and remove the steering column switches. There is no need to remove the ignition switch assembly. Remove 3 screws that attached the Eng Starting Switch. Refer to the screw locations marked with circles below: one screw for the antenna and two screws for the switch.
