SB-10058897-6444

Turbocharger Outlet Pipe
VN

FSB 252-031, Turbocharger Outlet Pipe

(September 2015)

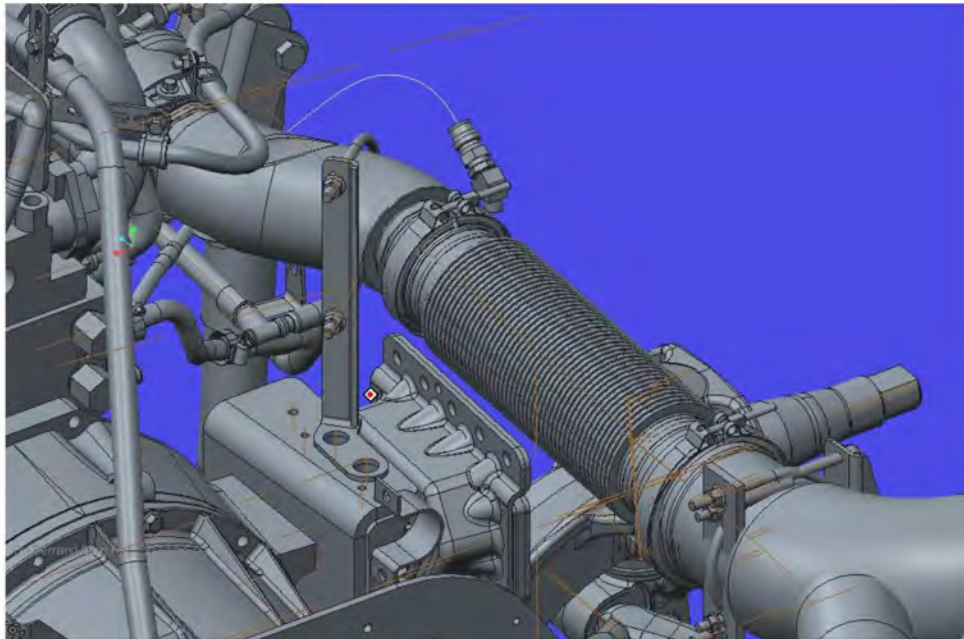
W2106127

Some Volvo vehicles equipped with Cummins ISL engine may have a cracked turbocharger outlet pipe. The crack develops at the flange to pipe weld area. There is a new support bracket to take load and vibration out of the joint area and eliminate future failures.
