## MP7 345R Throttle Delay at Cold Start LEU, MRU

### FSB 284-062, MP7 345R Throttle Delay at Cold Start

(July 2015)

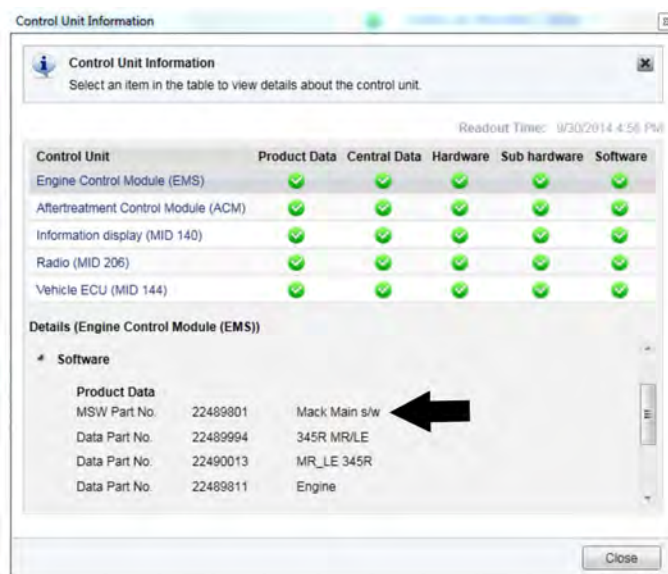
W2102733

If a chassis is experiencing the throttle delay as described in this bulletin, check the software level in the engine control module (ECM). Check for engine main software part number as shown below and compare to the table information.

Refer to service information in Function Group 284 to reprogram the engine control module (ECM).
