HYUNDAI NEW THINKING. NEW POSSIBILITIES.	GROUP CAMPAIGN	NUMBER 15-01-031
	DATE JULY 2015	MODEL(S) 3.3L SANTA FE (CM)
Technical Service Bulletin		
SUBJECT: CYLINDER HEAD COVER OIL LEAK REPAIR (SERVICE CAMPAIGN 936)

TO: Hyundai Dealership General Managers, Sales Managers,
Service Managers, Parts Managers, and Warranty
Administrators
FROM: Hyundai Motor America
DATE: August 27, 2015
SUBJECT: **Service Campaign 936: 2007-09 Santa Fe Cylinder Head
Cover Oil Leak Repair(TSB# 15-01-031)**

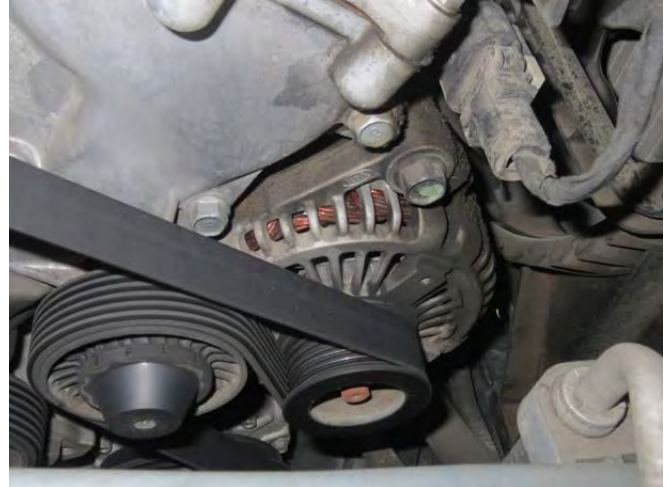
Example: Oil Contamination → Replace Alternator

Visually inspect the alternator for presence of any level of oil contamination due to oil leakage that may have occurred from the rocker cover.

*The example shown has a high level of oil contamination on the alternator, but **ANY** level of oil contamination found outside or inside the alternator requires replacement of the alternator.*

- If **ANY** level of oil contamination is found inside or on the exterior of the alternator, then the alternator must be replaced using the service procedure outlined in the following pages.

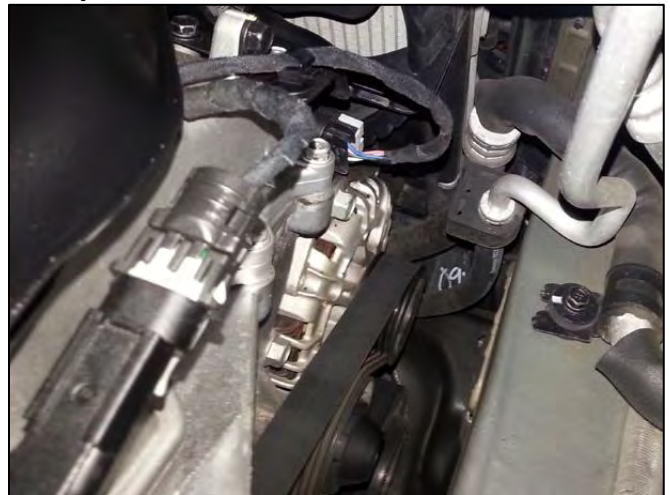
Example: No Oil Contamination → Good Alternator

- If **NO** oil contamination is found anywhere on the exterior or inside the alternator, then the service procedure is complete.
