HYUNDAI NEW THINKING. NEW POSSIBILITIES. Technical Service Bulletin	GROUP AUTOMATIC TRANSMISSION	NUMBER 15-AT-006
	DATE JULY 2015	MODEL 2015~ Genesis (DH) 3.8L
SUBJECT:	CRANKSHAFT POSITION SENSOR DTC P0315, P0300, P0303 & P0306

Description: Some Genesis (DH) 3.8L vehicles may experience the DTC and symptoms shown below.

This bulletin provides the procedure to inspect and/or if necessary replace the crank position sensor (C.P.S.) and/or the drive plate (C.P.S. wheel and plate).

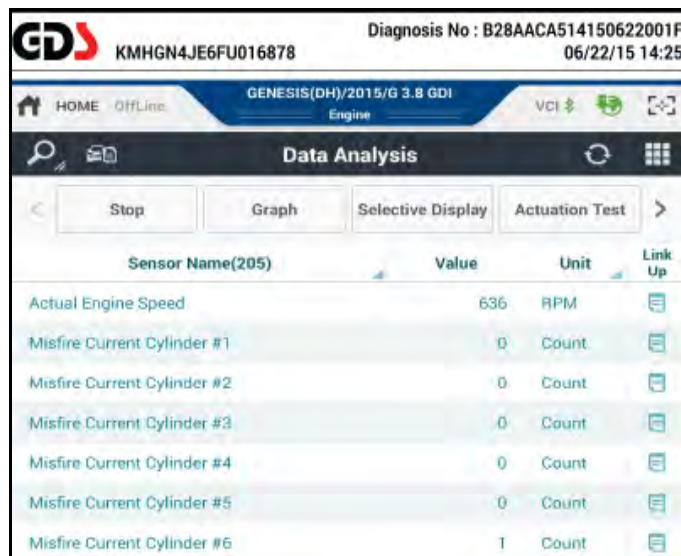
If the Actual Engine Speed shows the engine rpm about 600±50 rpm and continuously fluctuating, the wiring harness to the crankshaft position sensor currently has no open or short circuit. Go to Step 2. If not, repair or replace the control harness.

If cylinders #1, 3 and 6 have higher misfire counts than the other cylinders or all four DTC are found, the C.P.S. wheel may be out of specification. Go to Step 2.

1. Attach a GDS and select VIN, **Engine** menu, **Data Analysis** and the parameters shown to the right.
