NUMBER: 23-029-15

Water In Right Front Floor Footwell

This bulletin involves correcting a sealant void between the cowl plenum lower panel and dash crossmember.

2015 (KL) Jeep Cherokee

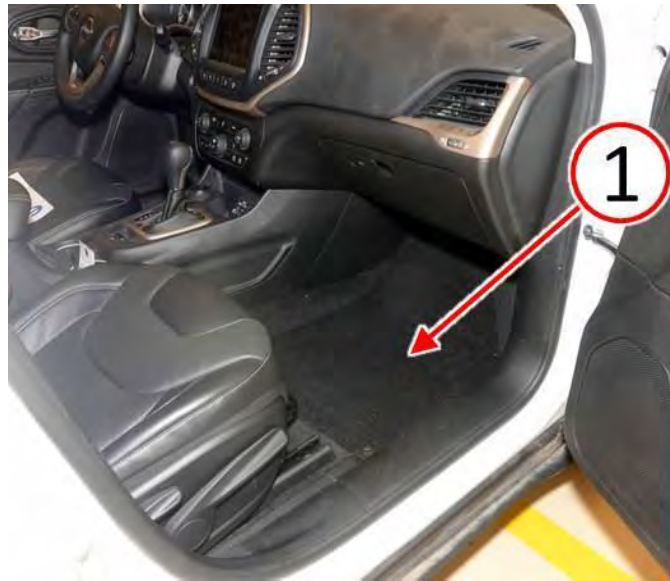
Fig. 1 Water In Right Side Front Footwell

The customer may describe damp or wet carpet in the right front footwell ([Fig. 1](#)). This condition may be due to a sealant void between the cowl plenum lower panel and dash crossmember allowing water to enter the vehicle interior.

1 - Right Front Footwell Carpet

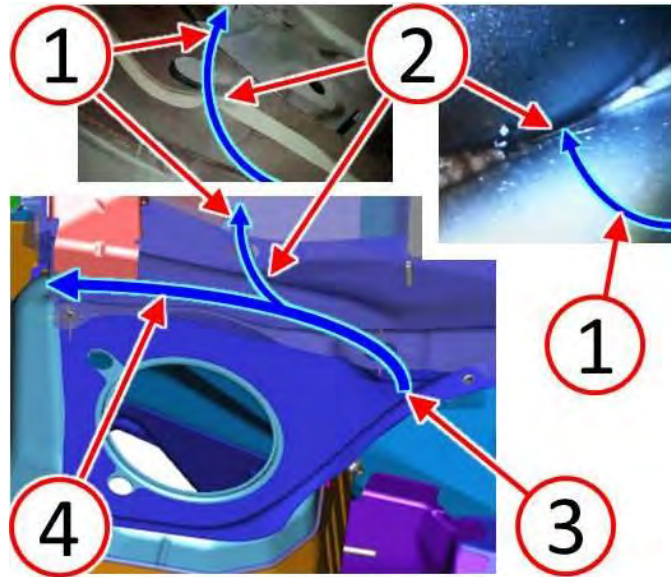
Fig. 9 Sealant Void And Water Path

NOTE: Images in (Fig. 9) show the proper water path (4) across the dash crossmember water management trough and also shows the location of the sealant void area (2) between the cowl plenum lower panel and dash crossmember which allows water (1) to enter the vehicle interior right front footwell.

- 1 - Water Leak Path To Vehicle Interior
 - 2 - Seam Sealant Void Location
 - 3 - Opening Into Water Management Trough
 - 4 - Proper Water Path Along Water Management Trough
-

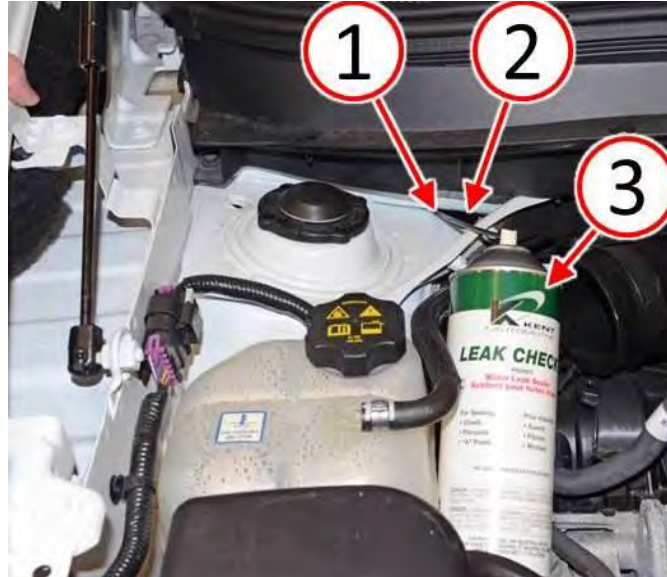
Fig. 10 Apply Seam Sealant

- 1 - Extension Tube
- 2 - Water Entrance Opening Into Cowl Plenum
- 3 - Kent® Spray Leak Check Sealer

10. Direct the Kent® spray leak check sealer extension tube (1) into the water entrance opening (2), between the cowl plenum lower panel and dash crossmember. Fully insert the extension tube (1) until it reaches the rearward seam in the approximate location of the sealant void area (Fig. 10).
11. Spray the Kent® leak check sealer (3) continuously along the rearward seam for the full range allowed in the opening between the cowl plenum lower panel and dash crossmember (Fig. 10).
12. Allow the Kent® spray leak check sealer to dry per the manufacturer's directions; approximately 15 minutes. Then repeat the application process for the second coat of sealant.

NOTE: Allow the Kent® spray leak check sealer to dry for one hour before performing the water test [Step #13](#).

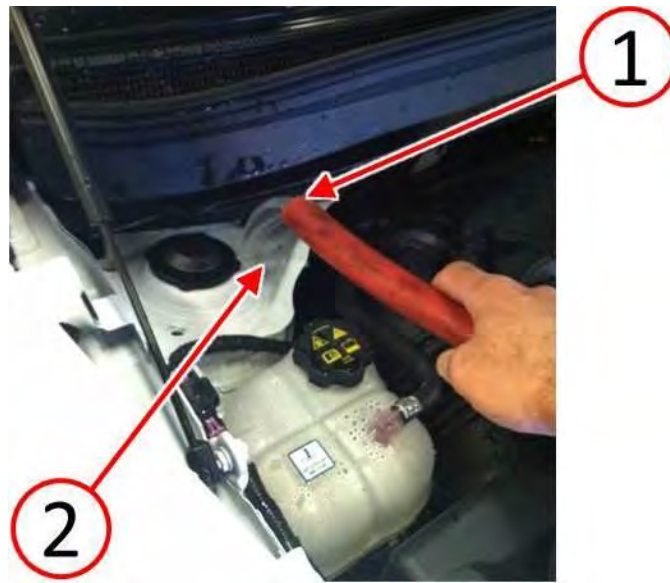
Fig. 11 Water Test

- 1 - Water Hose Flowing Water
 - 2 - Opening Into Water Management Trough
-

13. After the sealant has been allowed to fully dry, flow water (1) into the opening (2) between the cowl plenum lower panel and dash crossmember for one full minute (Fig. 11). While water is flowing, inspect for any water leaks as described in [Step #14](#).

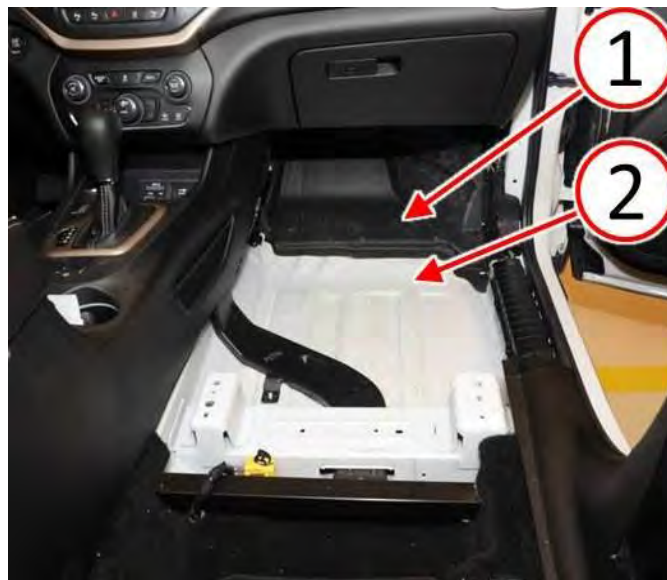
Fig. 12 Inspect For Water Leak

- 1 - Insulating Material
 - 2 - Right Front Footwell
-

14. Inspect for any trace of water coming from under the insulating material (1) and appearing in the right front footwell (2) (Fig. 12). If no water is found entering the vehicle interior during the water test then the sealant process is complete.
