This Service Information bulletin and attachment supersedes SI B11 10 12 **dated January 2013**.

N20 Engine: Repeated Juddering or Surging While Accelerating

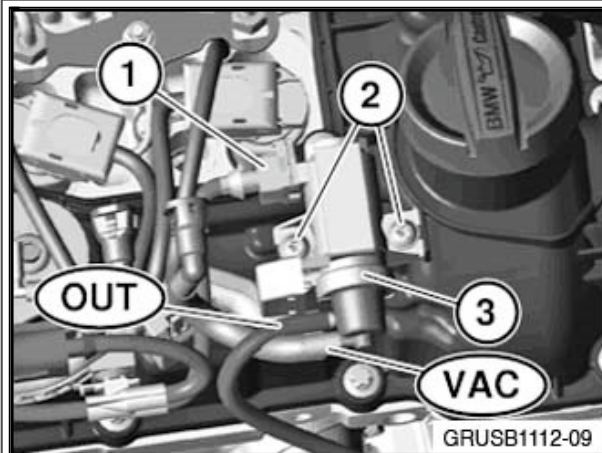
1. Remove the engine acoustic cover as per Repair Instruction 11 12 090, "Removing and installing/renewing acoustic cover (N20)."
2. Locate the EPDW located near the engine oil fill cap.

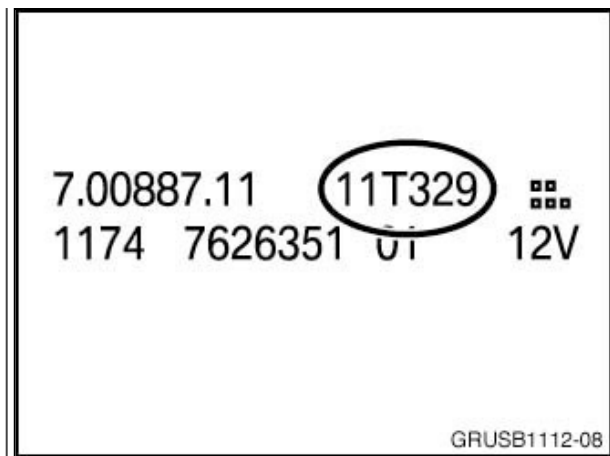
3. On the side the EPDW, there is a series of numbers printed.

The date code located on the side of the EPDW needs to be 12T158 or greater.

If the date code is 12T157 or lower, the EPDW will need to be replaced.

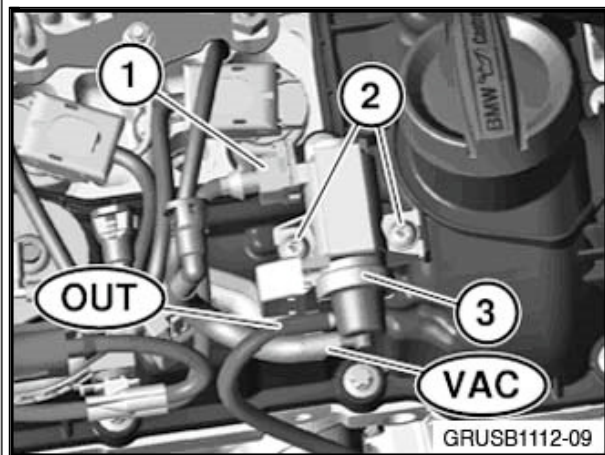
The EPDW (electropneumatic pressure convertor) for the turbocharger wastegate valve is binding internally.

4. Remove the electrical connector (1).
5. Remove the screws (2).
6. Remove vacuum lines marked "OUT" and "VAC."
7. Remove EPDW.
8. Install the new EPDW, connectors and vacuum lines. Install and torque the attaching screws to 3 Nm (2).
