TT7484EN, Rev. A  
February, 2015  
Page 1 of 3

SUBJECT: Inability to Check Oil Level via Pushbutton Shift Selector on Kenworth and Peterbilt Trucks

MODELS AFFECTED: 3000 Series and 4000 Series Product Family Transmissions

VOCATIONS AFFECTED: Kenworth Models T680 and T880 and Peterbilt Models 579 and 567

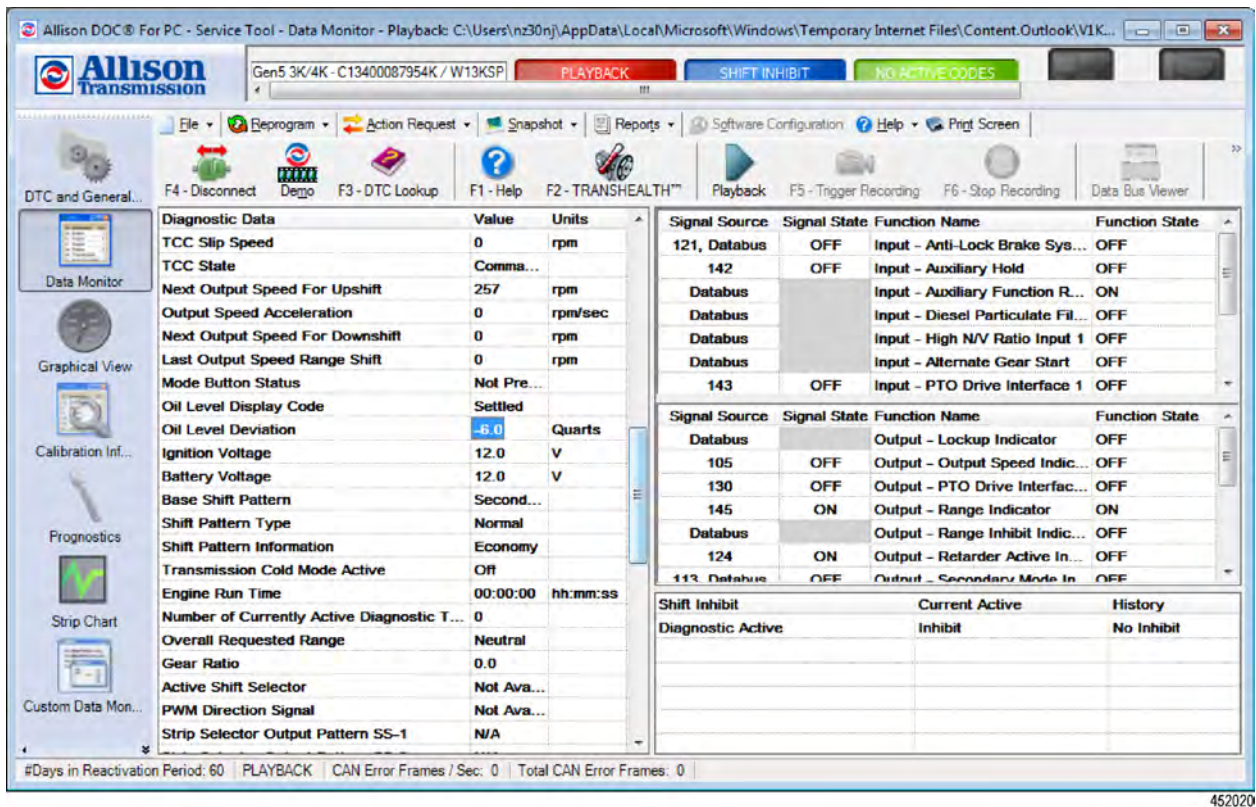
Figure 1. Oil Level Deviation Reading

- Inability to check oil level using the Pushbutton Shift Selector (skips to Prognostics).
- Very low (e.g. -6.0 Quarts) or no oil reading for "Oil Level Deviation" in the Data Monitor tab of the Universal Allison DOC® service tool. Refer to [Figure 1](#).

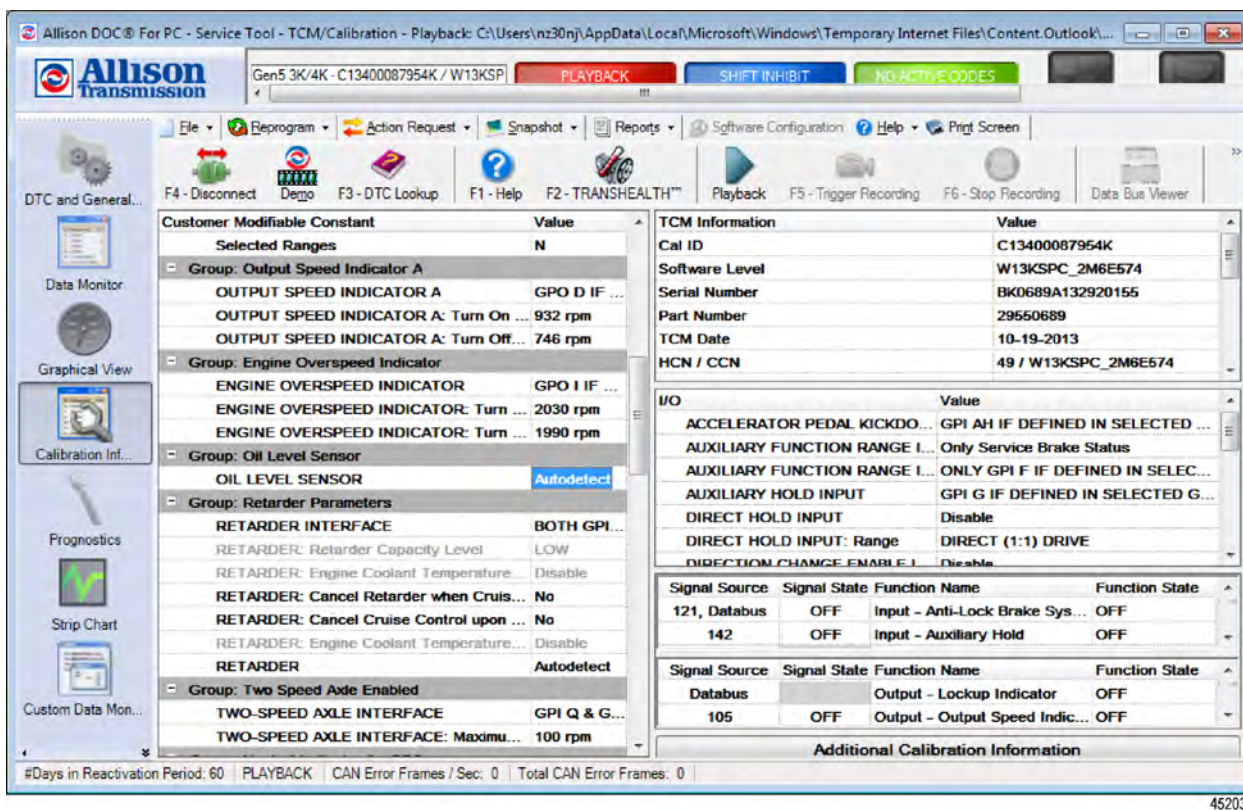
Figure 2. Oil Level Sensor Parameter

**NOTE:** When viewing the Calibration Information screen in the Universal Allison DOC® service tool software, the OIL LEVEL SENSOR parameter will still show “AUTODETECT”. Refer to [Figure 2](#).

**NOTE:** After Wire 116 is added to correct the oil level display issue, the oil level sensor auto-detect must be reset using the "Reset Auto-Detect Oil Level Sensor" feature in Universal Allison DOC® "Action Requests" menu for 5th Gen Controls, or "Reset Auto-Detect" for 4th Gen Controls.
