## SB-10058996-9619

TT7484EN  
April, 2014  
Page 1 of 3

SUBJECT: Inability to Check Oil Level via Pushbutton Shift Selector on Kenworth and Peterbilt Trucks

MODELS AFFECTED: 3000 Series and 4000 Series Product Family Transmissions

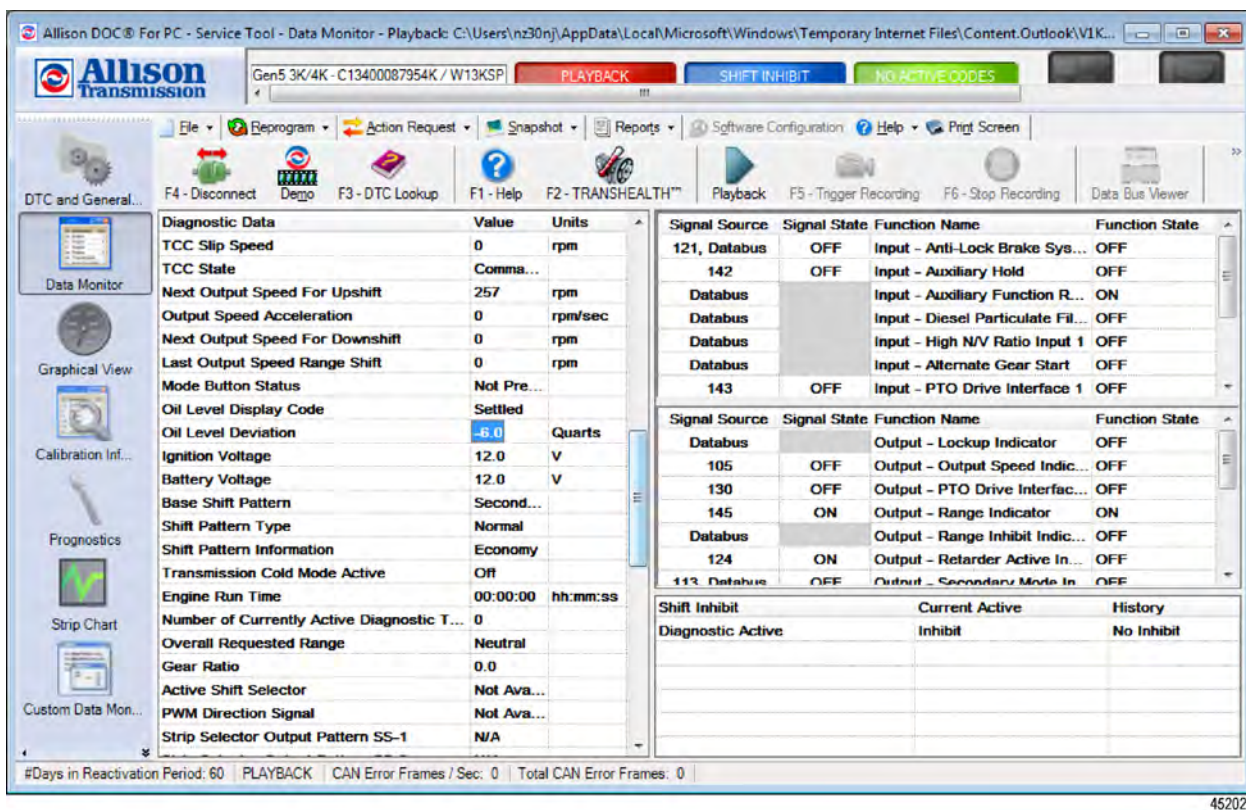
The Kenworth and Peterbilt models listed above have been built without a wire for the oil level sensor (OLS) in a portion of the OEM harness. Wire 116 may be present from the transmission to a bulkhead connector, but it may be missing on the other side of the bulkhead.

- Inability to check oil level using the Pushbutton Shift Selector (skips to Prognostics).
- Very low (e.g. -6.0 Quarts) or no oil reading for "Oil Level Deviation" in the Data Monitor tab of the Universal Allison DOC® service tool. Refer to [Figure 1](#).

Figure 1. Oil Level Deviation Reading

If an Allison customer brings their vehicle to your shop with complaint of this issue, or if this issue is discovered while performing customer maintenance or repair, please inform the customer that he or she should schedule an appointment with a Kenworth or Peterbilt dealer to address the issue.
