## SERVICE BULLETIN

SB1295

| <b>VEHICLE MODEL</b> | : TD925 US |
| <b>SUBJECT</b> | : <b>Proper attachment and securement of 110Vac cables above LH front wheel housing</b> |

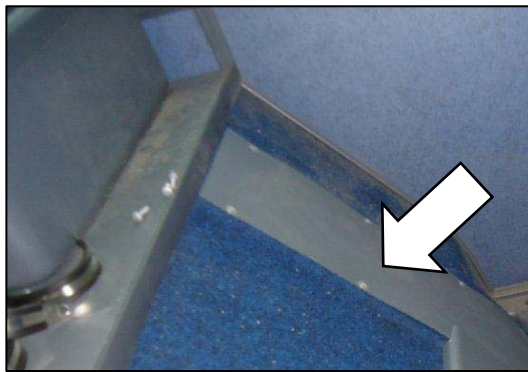
Figure 2

Field reports have shown that the routing and the clamping of the 110Vac cables above the LH front wheel housing on the coach interior can be compromised and needs to be checked. Additional spacers under the cover will be added as well as re-securing and routing the cables. The following information outlines how to perform this job.

1. Remove the seats in front of the left front wheel housing.
2. Remove the cable loom cover (refer to figure 2).
