Technical Bulletin SB-10059027-9752

SERVICE BULLETIN

EL15-026

2014-2015 TAXI; WIPER LINKAGE REPLACEMENT

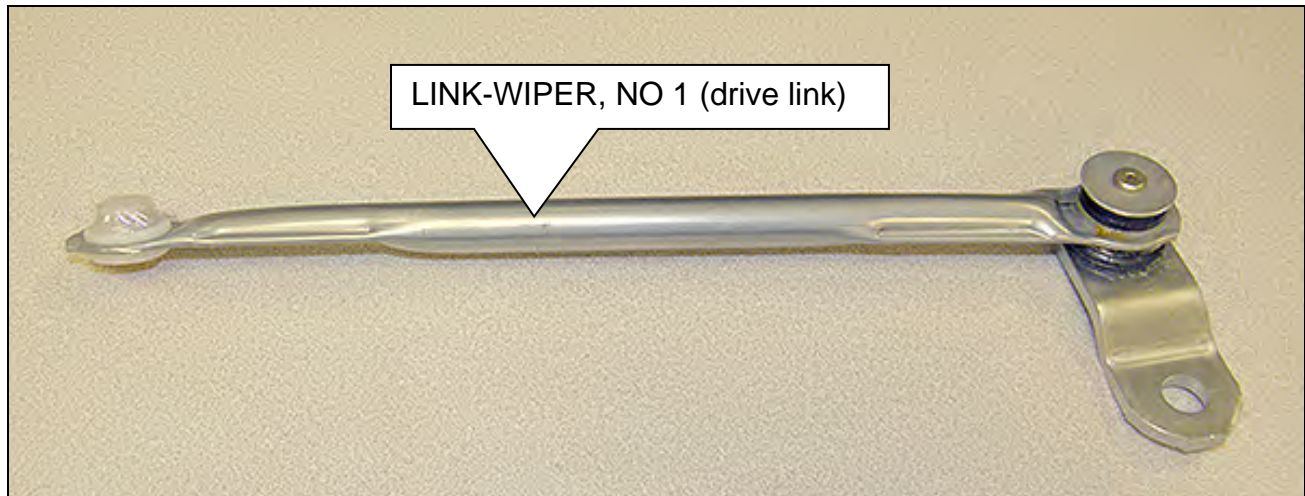
Figure A

If the LINK-WIPER, NO 1 (drive link) on the wiper assembly needs to be replaced for any reason, a new part is available.

If replacing the drive link, use the SERVICE PROCEDURE starting on page 2 to install the new part listed in PARTS INFORMATION.
