**Technical Service Bulletin Notification TSB #15-010**

# ROCK GUARD WINDOW GLASS AND FRAME SEPARATION

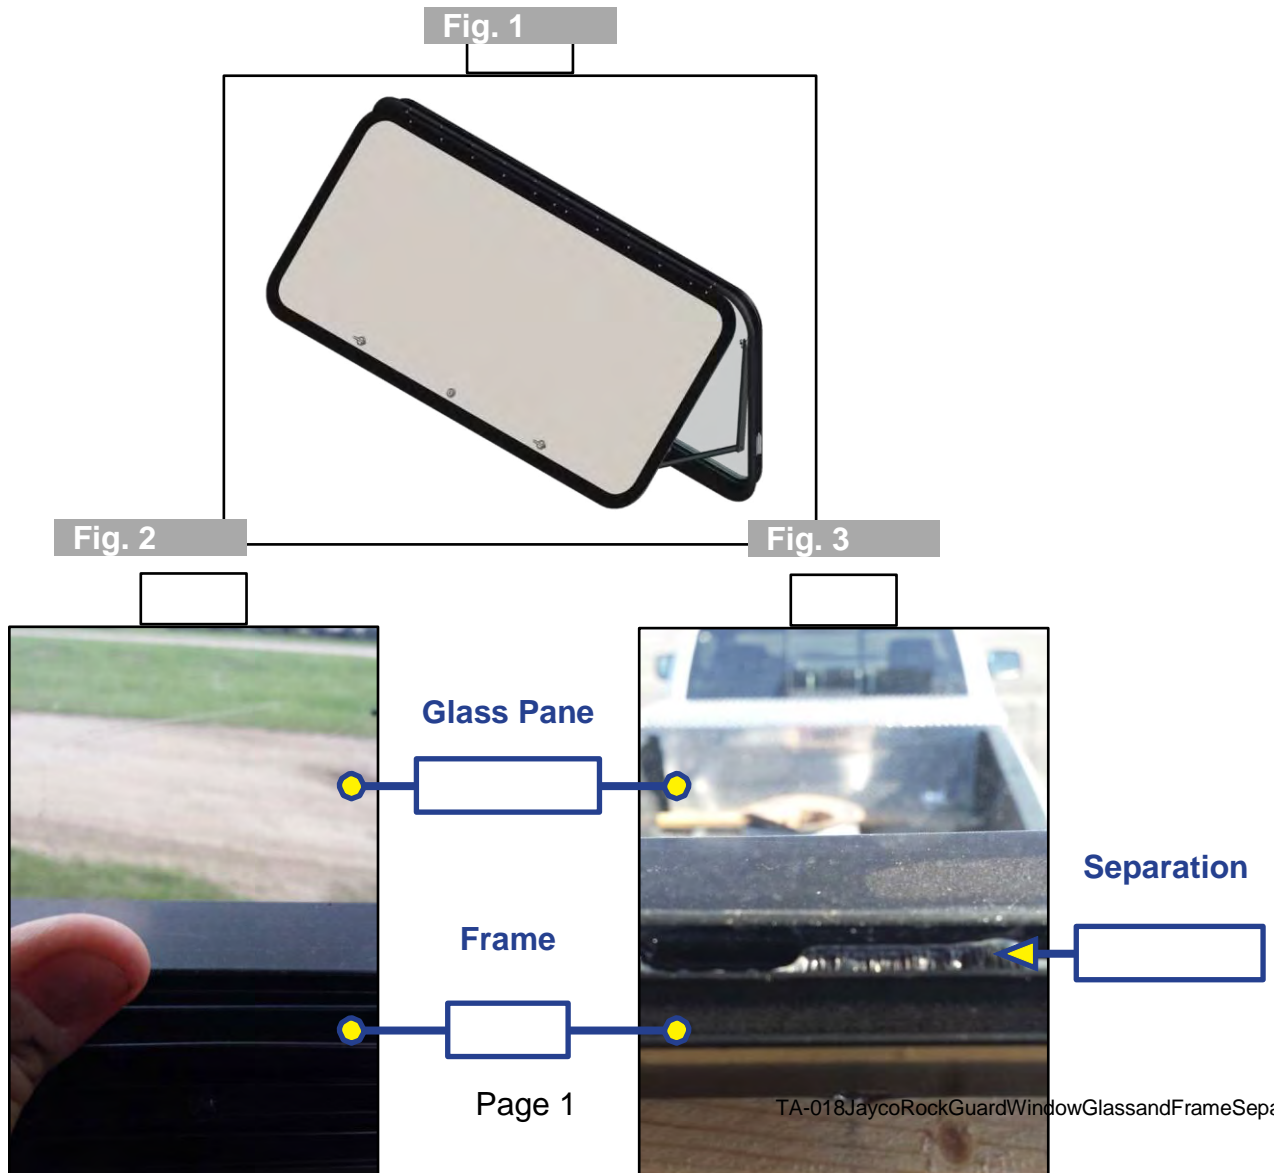
Starcraft has determined that certain Model Year 2015 and 2016 Autumn Ridge, AR-ONE, Launch Ultra Lite and Launch travel trailers require inspection of the rock guard window for possible glue failure that holds the glass to the frame. If the glue has failed, the window may allow moisture to enter the travel trailer.

The intent of this document is to provide direction on how to check Rock Guard windows provided by Lippert Components and installed in some Starcraft Travel Trailers to determine if there is a need to replace the component completely (Fig. 1). Due to a small number of Rock Guard windows having a possible glue failure issue where the glass is affixed to the frame of the window, the below instructions for inspection should be followed.

1. Open the rock guard portion of the window assembly.
2. From the inside of the coach, press on the glass at the bottom of the window (Fig. 2).
3. If the glass pane separates from the window frame at all (Fig. 3), the entire assembly **MUST** be replaced.
4. If the glass pane does not separate from the frame, no replacement of the assembly is required.
