Service Bulletin

Bulletin No.: PIP5248A

Subject: Shudder And/or Hard shifting Into 1st Gear Or Reverse Vibration On launch (With Excessive Crankshaft End Play)

Models: 2014-2015 Chevrolet Corvette
Built with an 6.2L, LT1, LT4 engine and auto or manual transmission

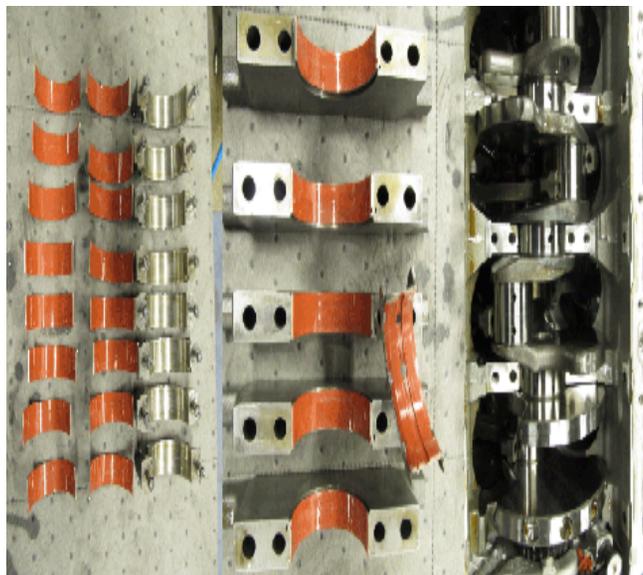
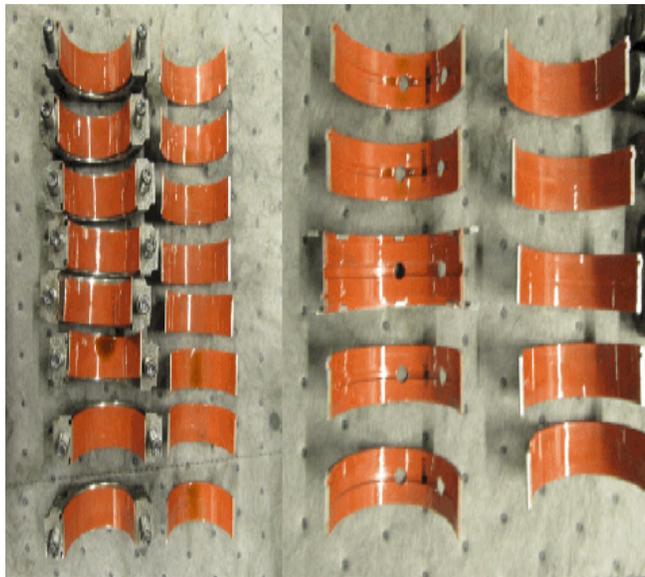
4051190

If both the main bearings and connecting rod bearings show no signs of significant wear (surface finish is not dull) Main Bearings show no signs of scratching or smearing that would indicate a possible spun bearing (rotated in the Main Cap).

Replace crankshaft, thrust bearing and main bearings

For this repair the oil tank with lines and oil cooler are both required to be replaced if equipped.
