**SUBJECT****Crackling Noises from Area Around Steering Column****MODEL**

I12 (i8)

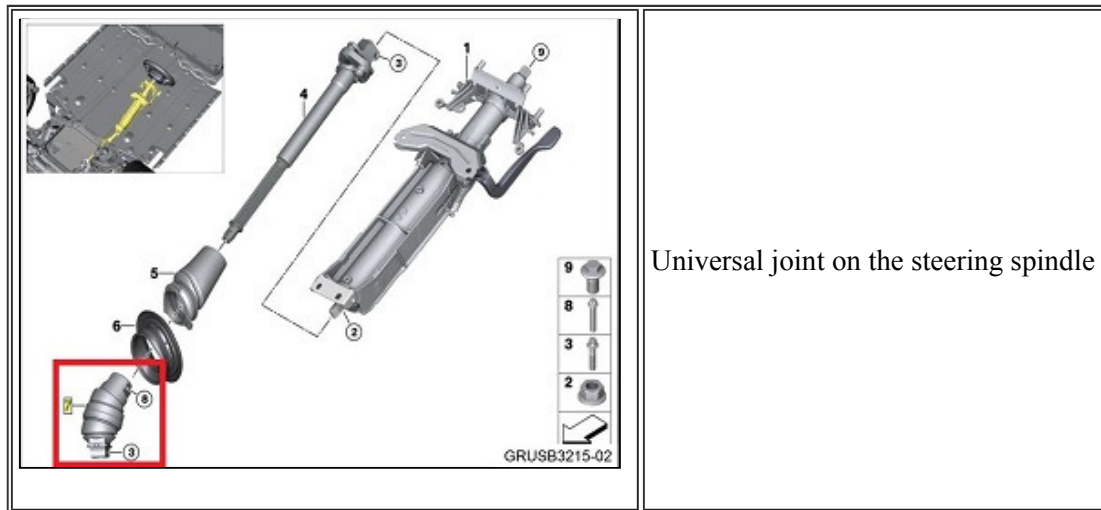
There are crackling noises from the area around the steering column when steering into bends or maneuvering the vehicle.

Replace the universal joint per Repair Manual RA 32 31 215, "Removing and installing/replacing double pivot (universal joint) for steering shaft, bottom."
