SI B51 26 15
Body Equipment

September 2015
Technical Service

Driver or Passenger's Front Doors Handles Inoperable

F30 (3 Series Sedan)

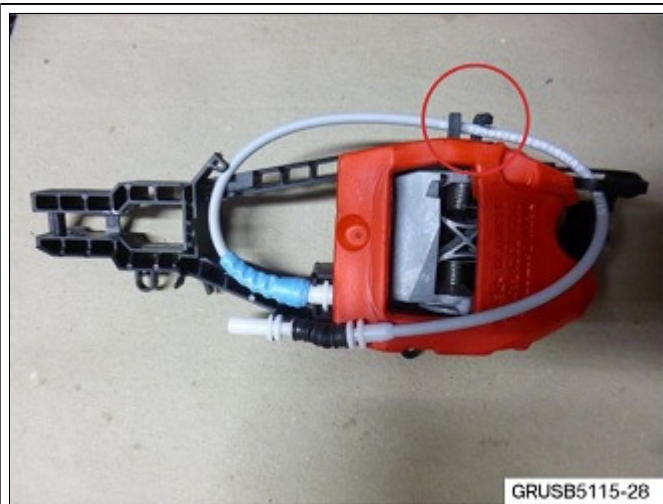
Incorrect routing of the Bowden cable.

This picture shows that the Bowden cable is clipped in place on the support, which is putting unnecessary stress on the cable.

Unclip the cable from the support and retest, to make sure that the door opens freely each time.
