# Service Bulletin

Bulletin No.: 15-08-45-001

**Subject:** Various Electrical Concerns

**Models:** 2004-2012 Chevrolet Malibu, Malibu Maxx  
2005-2010 Pontiac G6  
2007-2009 Saturn AURA

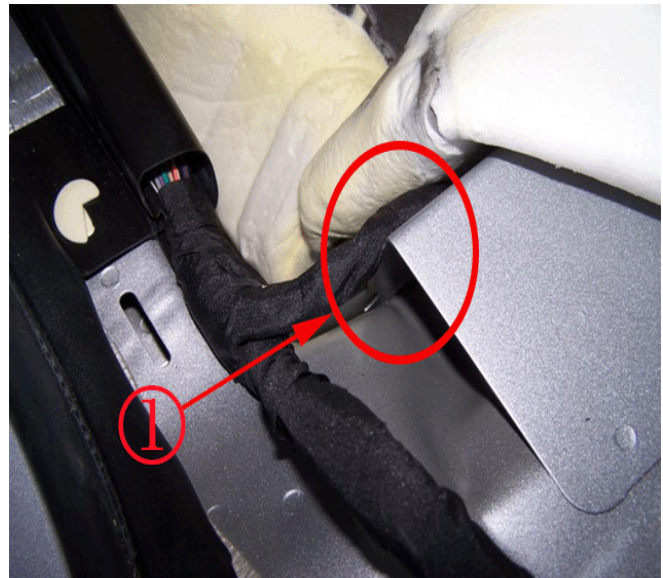
4217811

These symptoms may be caused by the body harness making hard contact against the floor panel's edge under the left rear seat cushion.

4. If harness penetration is present as illustrated above, repair the wire or wires as necessary. Refer to the Wiring Repairs in SI.
5. If no evidence of harness damage, continue diagnosis. Refer to the appropriate Service Information.
6. Rewrap that section of the body harness that has been repaired with woven polyester electrical tape (PET) or equivalent anti-abrasion tape or electrical tape.

7. Reposition the body harness so the harness does not make hard contact to the floor panel's edge.
8. Return carpet to original position.
9. Reinstall the left rear side door opening floor carpet retainer. Refer to the Rear Side Door Opening Floor Carpet Retainer Replacement in SI.
10. Clear any related DTCs and verify the concern(s) has been eliminated.
