Service Bulletin

SB-10059103-5473

SUBJECT: Service Update for Inventory and Customer Vehicles
Body Wire Harness Chafe
Expires with Base Warranty

MODELS: 2015 Chevrolet Colorado
2015 GMC Canyon

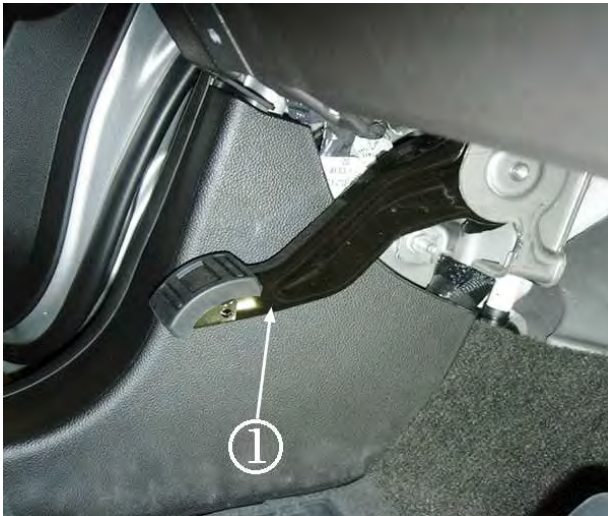
4147615

1. Locate the park brake pedal assembly (1). The park brake pedal assembly is located under the instrument panel on the driver side of the vehicle.

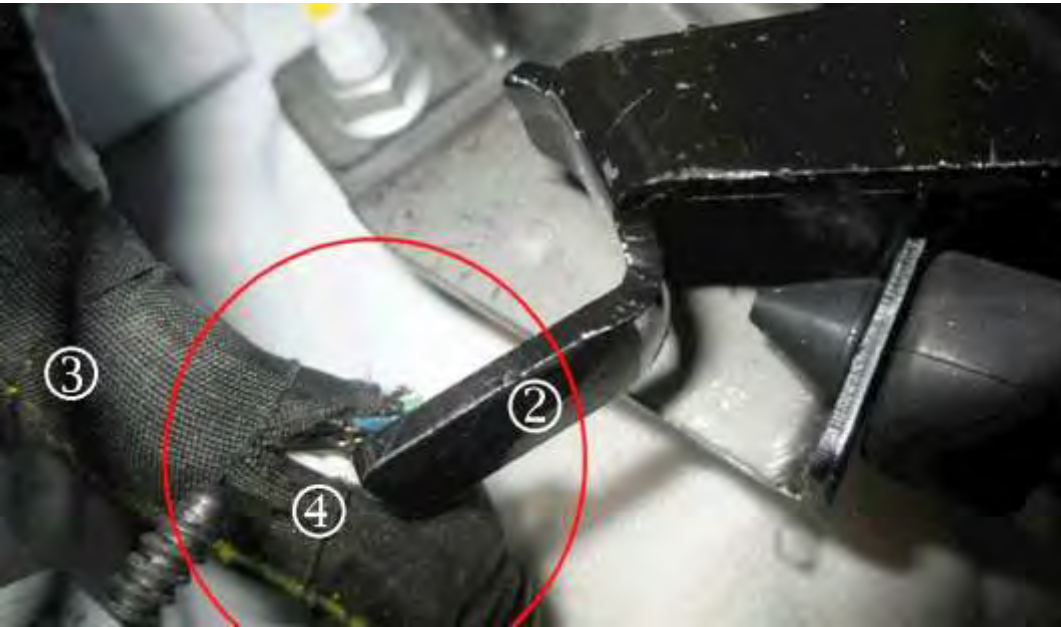
4147560

Photograph shows a damaged (4) body wire harness. Note the contact between the park brake pedal assembly switch activating tab (2) and the body wire harness (3).

2. Locate the park brake pedal assembly switch activating tab (2) and body wire harness (3).
3. Using a flash light determine if the body wire harness has been damaged (4) by park brake pedal switch activating tab.

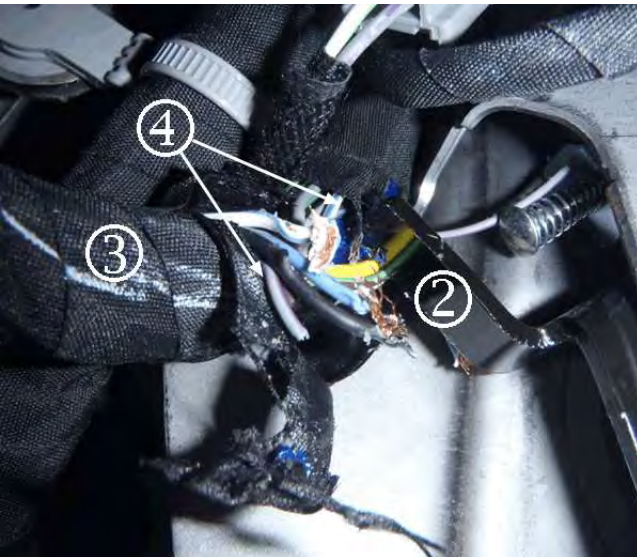
4147567

- If the body wire harness (3) is chafed and damaged (4) by the park brake pedal assembly switch activating tab (2), proceed to step 4.
 - If the body wire harness is NOT chafed and damaged by the park brake pedal assembly switch activating tab, proceed to step 8.
4. Remove tape from body wire harness to gain access to the damaged portion of the body wire harness.

5. Repair damaged wires using wire repair information in SI. Refer to *Splicing Copper Wire Using Splice Sleeves* in SI for splicing instructions.
6. Wrap electrical tape around the repaired portion of the body wire harness.
7. Wrap woven polyester electrical tape (PET) or equivalent anti-abrasion tape around the repaired portion of the body wire harness.

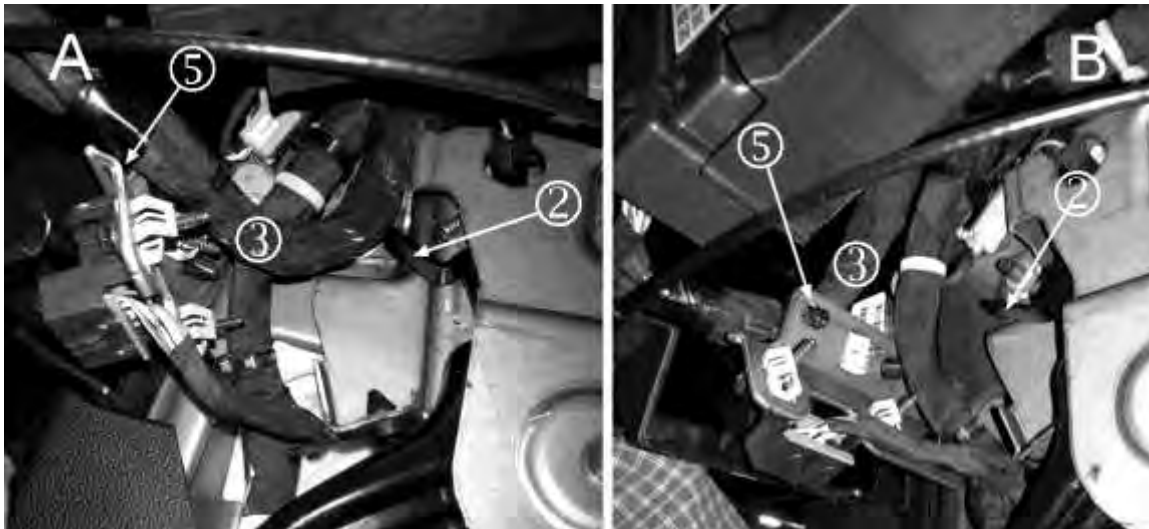
4165682

- (A) An incorrectly routed body wire harness. The body wire harness contacts the park brake pedal switch activating tab (2). The body wire harness is mounted on the front side of the bracket.
- (B) A correctly routed body wire harness. The body wire harness does NOT contact the park brake pedal switch activating tab (2). The body wire harness is mounted on the backside of the bracket.
8. Determine if the body wire harness is routed correctly. A correctly routed body wire harness will NOT contact the park brake pedal switch activating tab. In addition, the body wire harness clip on a correctly routed body wire harness is installed on the backside of the mounting bracket.

- If the body wire harness is routed correctly and it does NOT contact the park brake pedal assembly switch activating tab, no further action is required.
 - If the body wire harness is NOT routed correctly and it contacts the park brake pedal assembly switch activating tab, proceed to step 9.
9. Detach the body wire harness from the front side of the bracket and install the body wire harness clip to the backside of the bracket.

10. Ensure the body wire harness is routed correctly and does NOT contact the park brake pedal assembly switch activating tab.
