Service Bulletin

SB-10059104-2987

SUBJECT: Service Update for Inventory and Customer Vehicles
Transfer Case Adapter Missing Lower Bolts
Expires with Base Warranty

MODELS: 2015 Chevrolet Colorado 4WD
2015 GMC Canyon 4WD
Equipped with 2.5L Engine (RPO LCV) and 6-Speed Automatic
Transmission (RPO MYB)

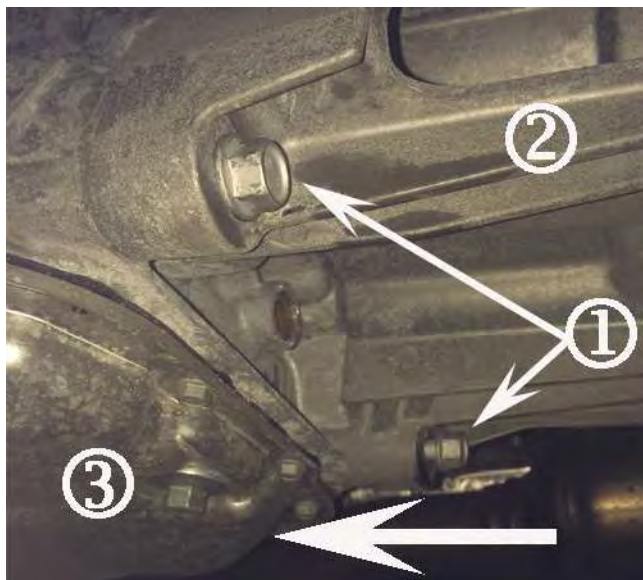
4135343

This bulletin provides a service procedure to install two bolts onto the transfer case adapter housing on **certain** 2015 model year Chevrolet Colorado 4WD and GMC Canyon 4WD vehicles equipped with a 2.5L engine (RPO LCV) and a 6-speed automatic transmission (RPO MYB). These vehicles may be missing two lower transfer case adapter bolts. This could cause increased vibration at vehicle speeds above 80 mph (128 km/h). CAE analysis shows that there will be increased stress levels to the transmission housing, bell housing, and adapter housing. If a vehicle with this condition also has a severely imbalanced driveline and is operated at high vehicle speeds for a long period of time, these increased stress levels could lead to cracks in the transmission housing, bell housing, and adapter housing. If cracks occur, the vehicle could leak transmission fluid. With enough fluid loss, the "Check Engine" light will illuminate. Additionally, if the adapter housing develops a circumferential crack, the vehicle could suddenly lose propulsion.

Note: Confined area calls for a short socket.

Note: The adapter is bolted to the transmission with six fasteners inside the adapter housing. Threading in the two lower external bolts may meet with some resistance. If needed, gradually thread bolts in/out before final torquing to ensure complete seating of fasteners.

2. Install the two transfer case adapter lower bolts (1) through the adapter (2) and into the transmission (3).
3. Torque the bolts to **58 Nm (43 lb-ft)**.
