GM Bulletin No.: 15057  
Date: April 2015

SB-10059105-6811

**SUBJECT:** Service Update for Inventory and Customer Vehicles  
Double Cab Right-Rear Door Missing Laser Welds  
Expires with Base Warranty

**MODELS:** 2015 Chevrolet Silverado Double Cab  
2015 GMC Sierra Double Cab

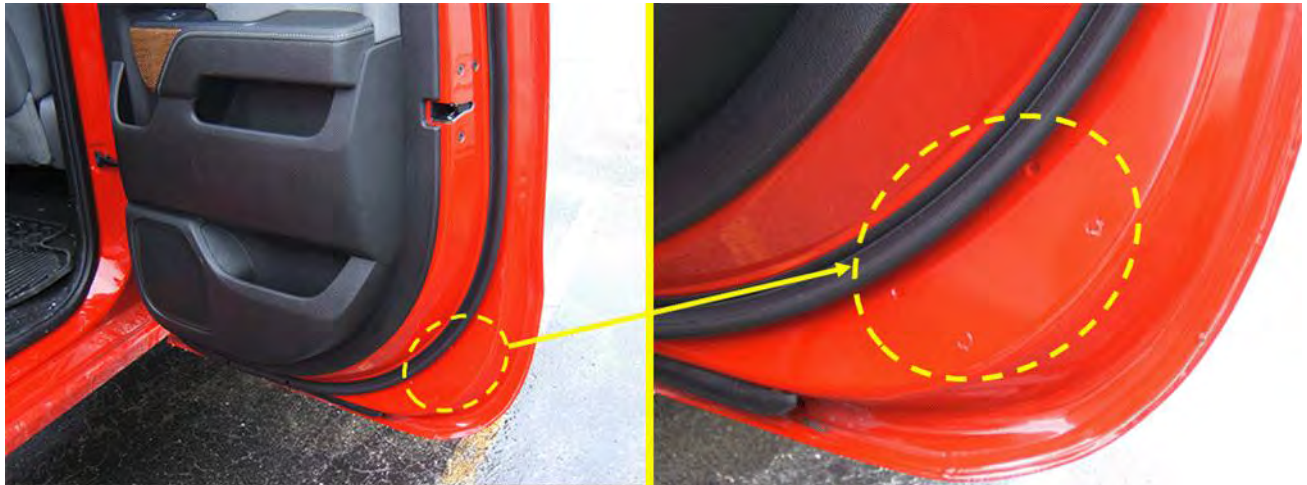
4162141

1. Open the right rear door and visually inspect the area shown circled in the graphic above.

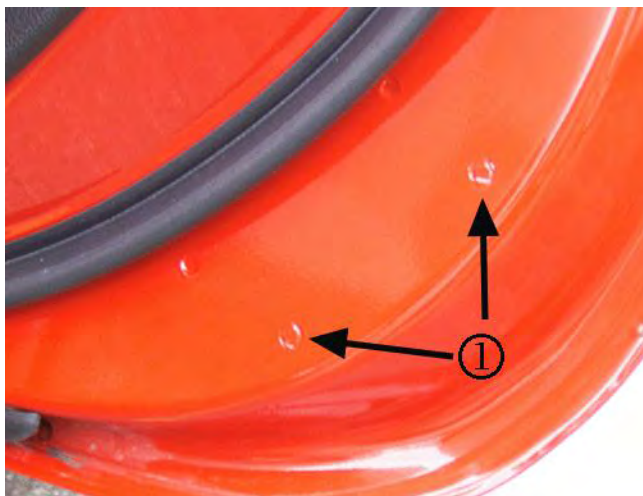
4162142

2. Inspect for the evidence of the two lower, outboard welds which look like “C”- shaped impressions (1).
  - If these two weld locations ARE visible, no further action is required.
  - If these two weld locations ARE NOT visible, continue ahead to the *Rivet Installation Procedure*.
