GM Bulletin No.: 15190
Date: May 2015

SB-10059108-3217

SUBJECT: Service Update for Inventory and Customer Vehicles
Body Harness Pinch by Seat Belt Bracket at C-Pillar
Expires with Base Warranty

MODELS: 2015 Chevrolet Colorado
2015 GMC Canyon

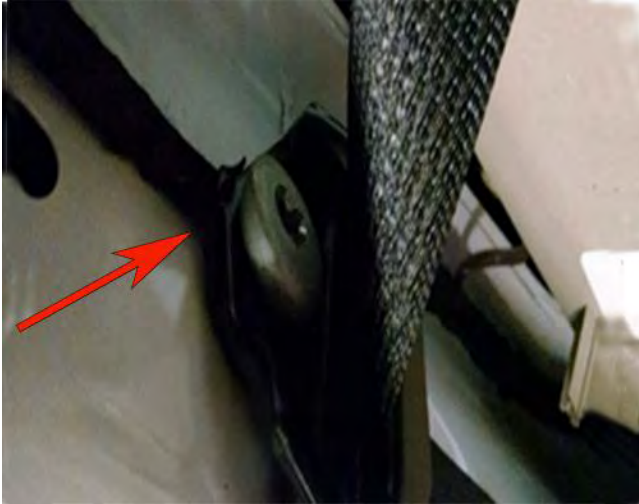
4192982

A branch of the body wiring harness may be trapped under the upper rear seat belt pivot bracket. Use the following steps to inspect the left and right rear seat belt bracket mounting area located in the upper "C" pillar area of the vehicle. If the seat wiring harness is not trapped, no further action is necessary. If the wiring harness is trapped, proceed to the repair steps.

Example of Trapped Harness (Pillar Trim Removed For Photo)

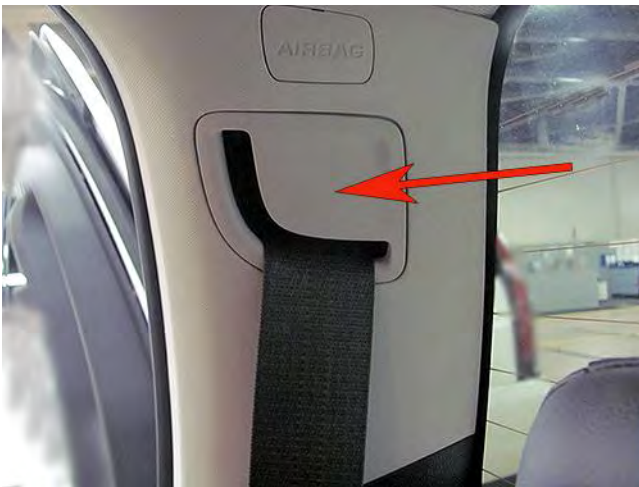
4192984

1. Locate the left and right rear seat belt pivot bracket inserts, located in the upper area of the "C" pillar.
2. Remove the left and right inserts by placing two fingers in the slot and pull the insert out of the pillar trim.

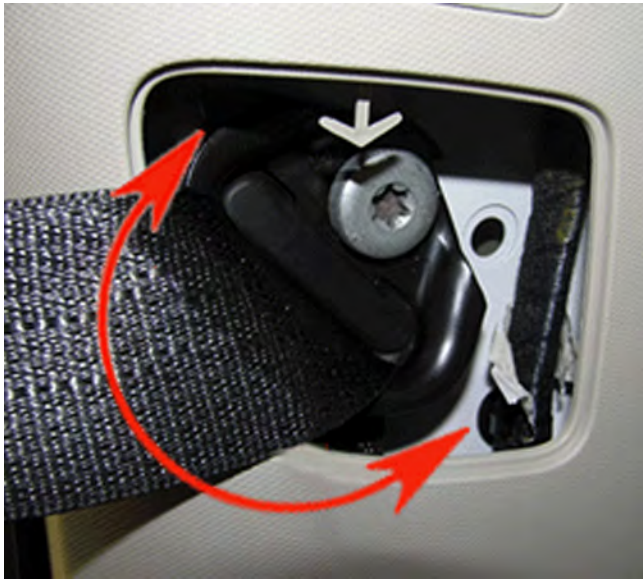
3. Verify the left and right seat belt pivot brackets are free to rotate around the mounting bolts.

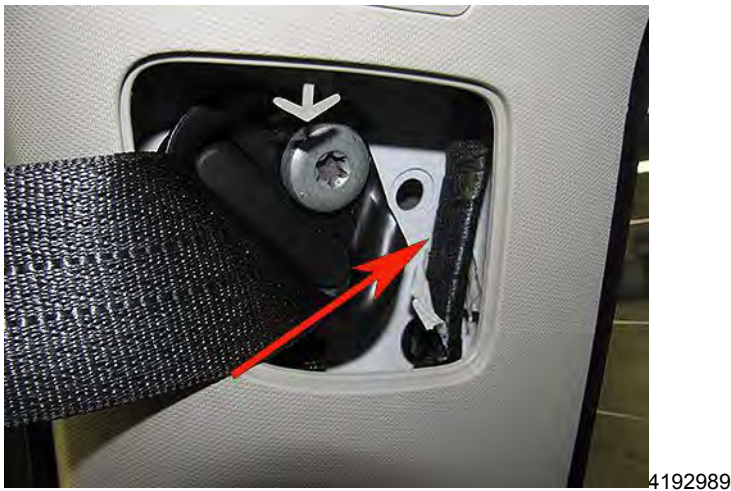
4. Verify the left and right wiring harnesses are not pinched, trapped or bound up under the pivot brackets.
 - If the vehicle passes the above two steps, reinstall the inserts, no further action is required.
 - If a wiring harness is trapped under the pivot bracket, proceed to the Repair Procedure below.
