GM Bulletin No.: 15435B
Date: July 2015

Service Bulletin

SUBJECT: Service Update for Inventory and Customer Vehicles
Torque Converter Machining Spill
Expires with Base Warranty

MODELS: 2015 Chevrolet Silverado HD
2015 GMC Sierra HD, Sierra Denali HD
Equipped with Allison 6-speed Automatic Transmission (RPO MW7)

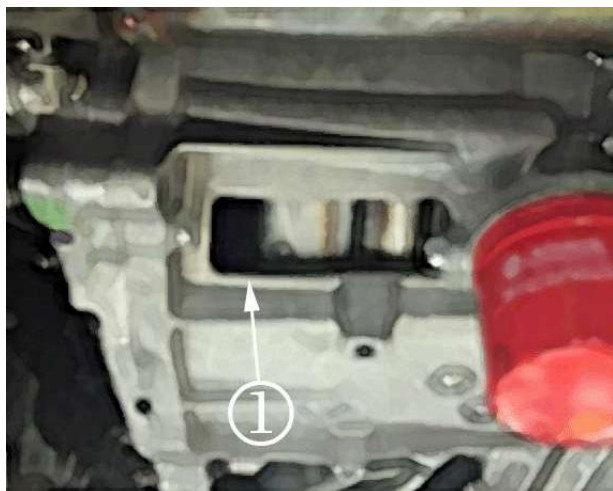
4212661

2. Locate the transmission access cover. The access cover is located on the bottom side of the transmission on the driver side of the vehicle.
3. Remove the access cover from the bottom of the transmission to expose the 25 mm (1 in) x 51 mm (2 in) inspection window (1).
4. Rotate the torque converter clockwise using the engine crankshaft damper bolt until a white label appears in the inspection window.

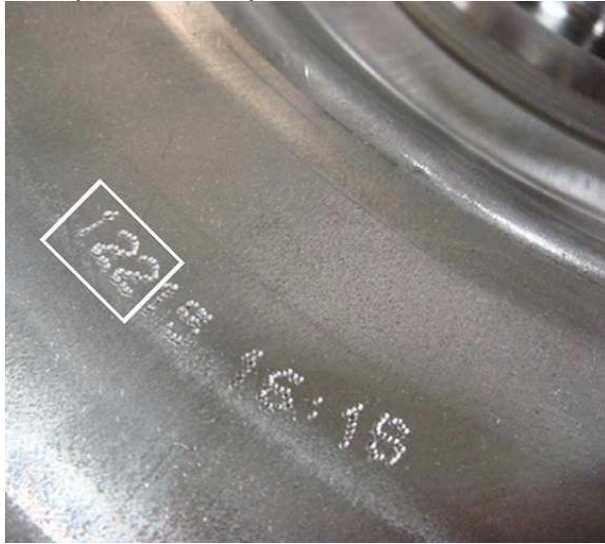
4212662

5. Rotate the torque converter clockwise an additional 180 degrees to reveal the Julian date stamp on the torque converter.

For torque converters built during the 2015 calendar year, inspect the first 3 digits of the Julian date, which are identified in the box, to determine if the torque converter must be replaced.

6. Use a light with a mirror or a borescope to read the Julian date.
- If the last two digits are 15 and the first three digits of the Julian date are 123, 124, 125, 126 or 127, the torque converter will need to be replaced. Proceed to step 7.
 - If the last two digits are 15 and the first three digits **are anything but 123, 124, 125, 126 or 127**, the torque converter does NOT require replacement. No further action is required. Install the transmission access cover and lower the vehicle. Refer to *Lifting and Jacking the Vehicle* in SI.
 - If the last two digits are 14 the torque converter does NOT require replacement. No further action is required. Install the transmission access cover and lower the vehicle. Refer to *Lifting and Jacking the Vehicle* in SI.
