GM Bulletin No.: 15472 Date: August 2015

Service Bulletin SB-10059122-5630

SUBJECT: Service Update for Inventory and Customer Vehicles

MODELS: 2015 Cadillac Escalade, Escalade ESV

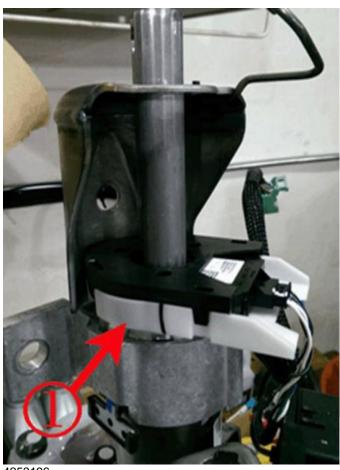
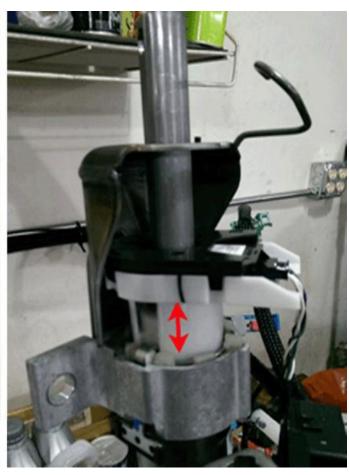
4253196

The lower column bearing housing assembly (1) may be out of position. The 1st picture shows the lower column bearing assembly (1) in its correct position, while the 2nd picture shows the lower column bearing out of position. Steering column is removed for illustration purposes.

Note: To correct either above condition, repair the steering column assembly by replacing the column lower bearing adapter assembly and retainer as instructed in the following. Below are the

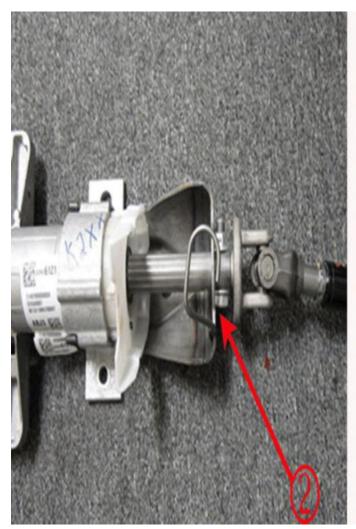
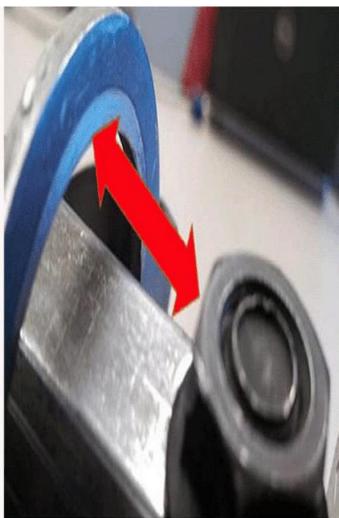
4256119

The upper intermediate steering shaft to lower column shaft bolt and nut (2) may be contacting the inhibitor/shifter cable bracket. Verify there is a minimum 7 mm (0.28 in) gap between the lower column shaft bolt and nut and the inhibitor/shifter cable bracket.
