GM Bulletin No.: 15684  
Date: August 2015

**SUBJECT:** Service Update for Inventory and Customer Vehicles  
Main Engine Harness Wire Chafe  
Expires with Base Warranty

**MODELS:** 2016 Cadillac ATS-V

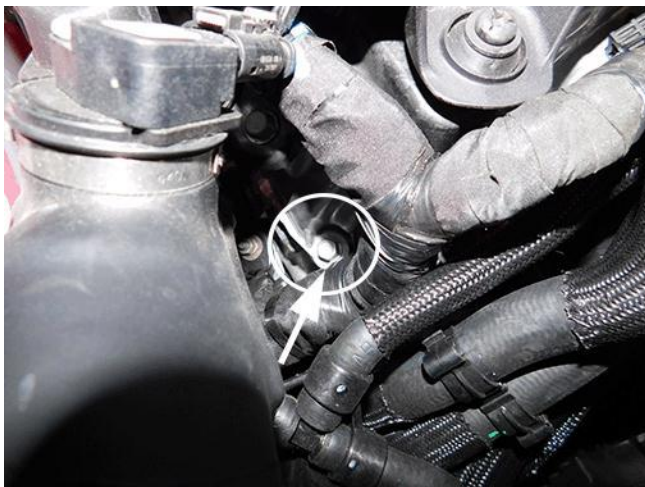
4258399

2. Inspect the engine harness for any rub through and/or chafing from the cam cover bolt by loosening the right intake snorkel clamp and moving the snorkel out of the way. If any damage to the engine harness is found, refer to SI for wire repair.

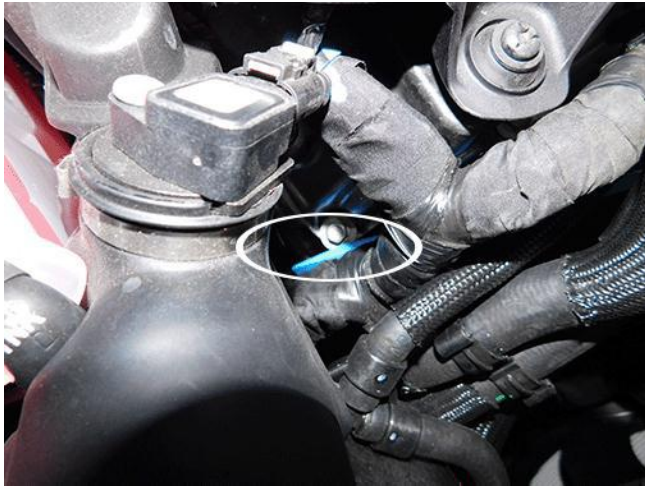
4258401

**Note:** There should be no contact between the cam cover bolt and the harness.

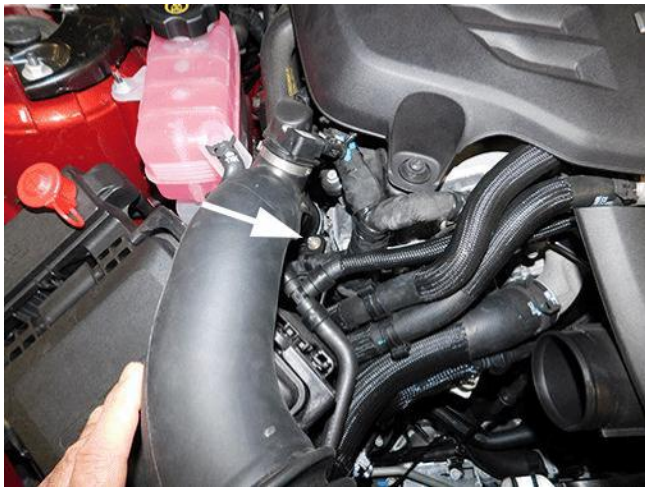
4258403

3. Using a nylon trim tool or equivalent, insert the tool between the engine wiring harness and cam cover bolt and make sure there is a 5 mm (3/16 inch) space in between.
  - If there is enough space, inspection is complete and no further action required.
  - If there is not 5 mm (3/16 inch) of space between the harness and the cam cover bolt, continue to step 4.
