**SB-10059130-4469**

Bulletin No.: PI1090A

**Subject:** Wet Carpet/Floor at Driver and/or Passenger Footwell Areas

**Models:** 2010-2016 Chevrolet Equinox  
2010-2016 GMC Terrain

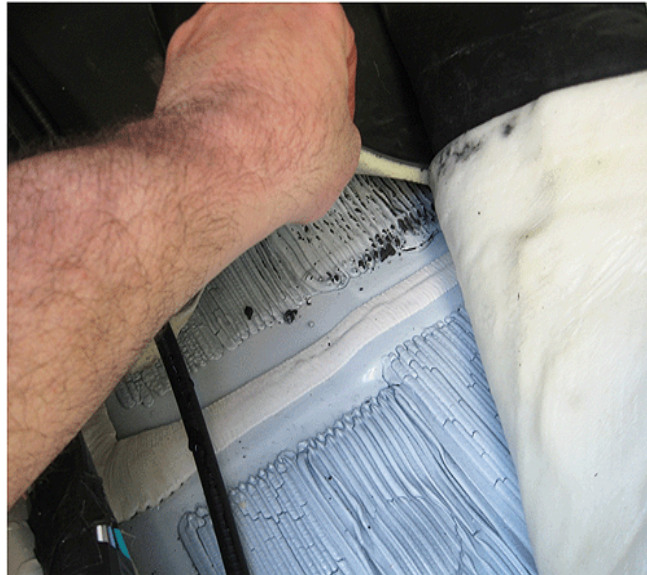
2450865

This condition may occur due to incomplete or insufficient sealing within the front roof to body side outer panel seams. The condition is most commonly found in the roof ditch within the first 30.5 cm (12 in) rearward from the windshield glass.

If evidence of water is found in these locations, inspect the affected side roof ditch for possible voids in the sealer. Inspect for, and correct this leak, following the repair steps below:

1. On the side(s) affected, carefully remove the forward portion of the roof ditch molding; enough to access the first 30.5 cm (12 in) of the roof ditch. Refer to Roof Panel Molding Replacement in SI.

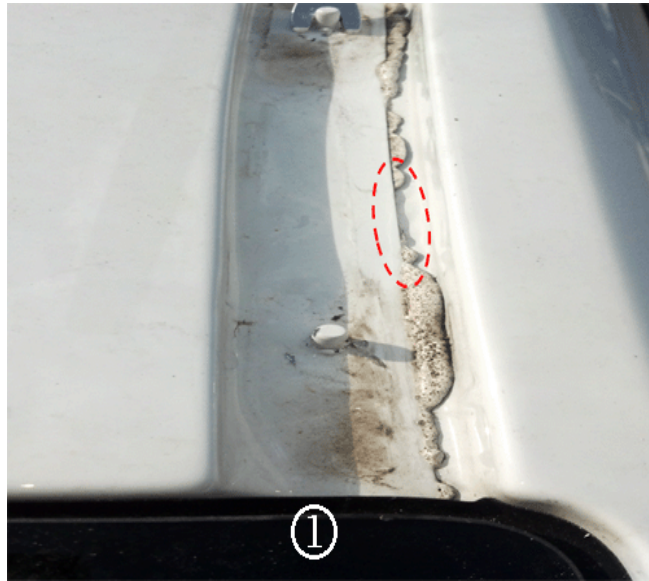
3636325

2. Inspect for voids/gaps in the seam sealer along the outboard edge of the roof ditch. Examples of this condition are shown in the driver side (1) and passenger side (2) graphics above.
3. Clean the affected area and seal all gaps with \*Kent Automotive High-Tech™ Clear Seam Sealer, P/N 10200 (5 oz tube), or equivalent. Avoid excess sealer build up within the ditch while assuring any voids in the factory seal are filled.
4. Allow the seam sealer to adequately set-up, then water test by placing a water hose mid-roof near the ditch, allowing water to run forward to the A-pillar. Visually inspect for any water leaks along the inner roof, A-pillar and floor areas.
5. Once the repair is verified, reinstall the roof ditch molding. Refer to Roof Panel Molding Replacement in SI.
6. Dry the interior of the vehicle as needed. Refer to Floor Carpet Drying in SI.
