Service Bulletin

Bulletin No.: PI1456A

Subject: Diagnostic Tip for DTC P0336: Crankshaft Position Sensor Performance

Models: 2015 Chevrolet Spark
Equipped with 1.2L Engine (RPO LL0)
Built Prior to VIN Breakpoint FC747743

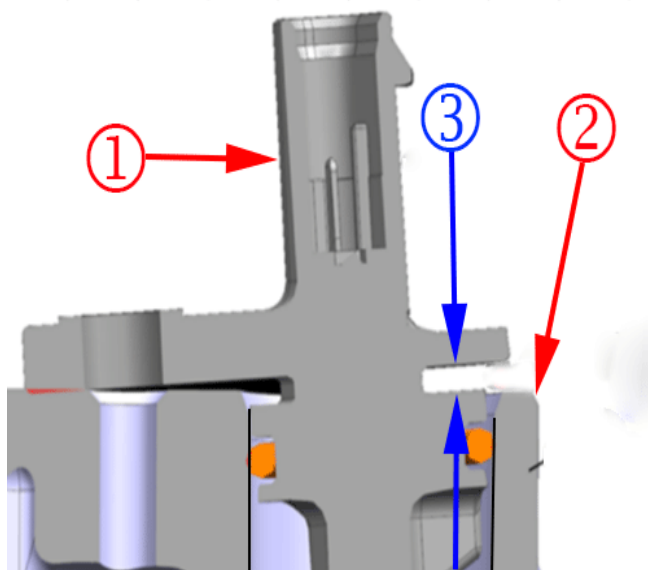
This may be caused by the crankshaft position sensor not being fully seated in the bore of the transmission case, creating an excessive space between the crankshaft position sensor and the automatic transmission flex plate.

2. Inspect the gap as illustrated above.
 - Correct gap is less than 0.35 mm (0.01378 in).
 - Incorrect gap is 0.35 mm (0.01378 in) or more.
3. If the gap is correct, wiggle the connector to verify if the connector is secured. If the connector is secured, continue diagnosis. Refer to the diagnostic code P0336 in SI. If the connector is not secure, secure connector and then skip to step 5.
4. If the gap is incorrect, remove and reinstall the crankshaft position sensor.

Tighten the bolt to 10 N•m (89 lb in).
