Service Bulletin

Bulletin No.: PI1469

Date: May, 2015

Subject: Service Air Bag Message Displayed in Driver Information Center (DIC), DTC B0014, B0021 or B001E Set with Symptom Code :04 or 0D

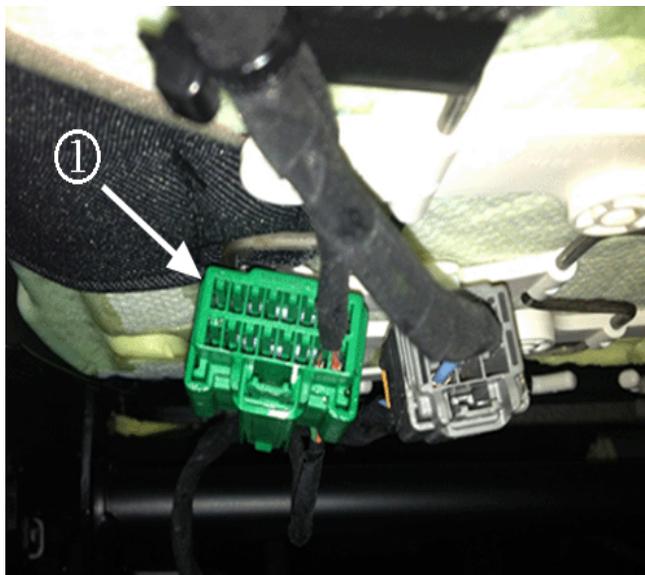
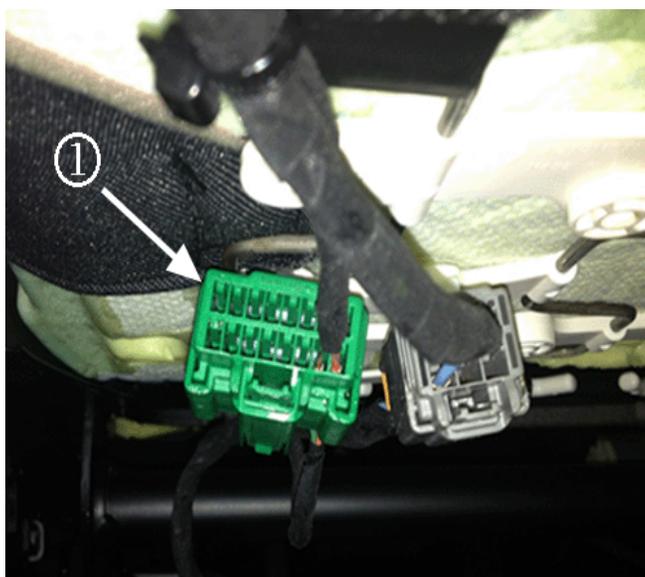
3957382

Some customers may comment on a "Service Air Bag" message displayed in the driver information center (DIC). This may be caused by high resistance in the wiring harness connectors. The SDM interprets the high resistance as a fault. DTCs set are B0014 or B0021 or B001E with symptom bytes :04 or :0D.

1. On the driver seat, locate the outboard green SIAB harness connector (1) on the underside of the seat cushion.
2. Gently pry the connectors from the seat mat.
3. Carefully remove approximately 76 mm (3 in) of conduit and tape from each side of the connector to gain access to the wires.
