Service Bulletin

Bulletin No.: PI1474

Subject: Air Bag Indicator Illuminated with DTC B0012 or B0013

Models: 2015 Cadillac ATS, CTS Sedan (VIN A)
Built Between August 1 through October 1, 2014

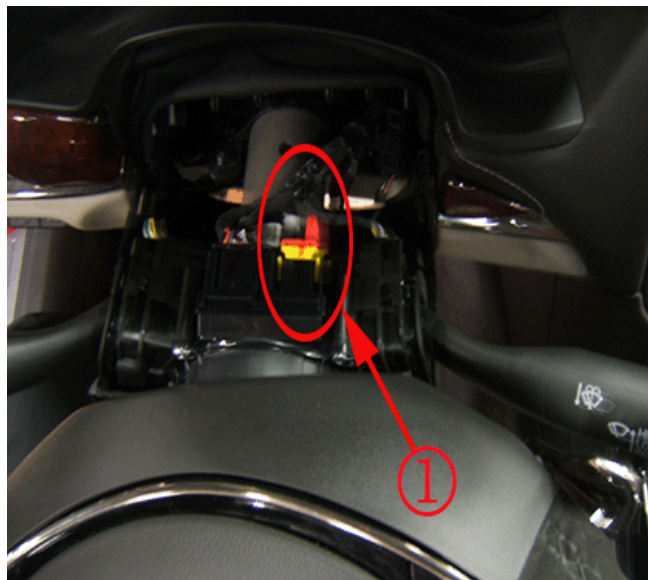
Some customers may comment that the AIR BAG indicator is illuminated.
Technicians may find code B0012 or B0013 with symptom bytes 04 or 0D set as current or in history.
This condition may be caused by poor terminal tension in X85 Steering Wheel Air Bag Coil X3 connector.

3. Disconnect the X85 Steering Wheel Air Bag Coil X3 connector (1), illustrated above.
 - Disengage the connector position assurance (CPA).
 - Disconnect the X3 connector.
4. Test probe each terminal for poor tension with J-35616-65B (LT BU).
5. If the terminal tension is within specification, continue diagnoses. Refer to the diagnostic trouble code (DTC) B0012 or B0013 in SI.
6. If one or more terminal tension is found to be poor, replace the connector with service connector P/N 13580115 with the next steps of this procedure.
7. Remove the steering column lower trim panel. Refer to the Steering Column Lower Trim Cover Replacement in SI.
8. Remove the instrument panel knee bolster deflector. Refer to the Driver Knee Bolster Reinforcement Replacement in SI.
