Service Bulletin

Bulletin No.: PI1487

Subject: IPC Gauges Sweep, Loss of Power Steering Assist, Intermittent No Crank, Reduced Engine Power and Multiple U-Codes

Models: 2014-2015 Chevrolet Impala (VIN 1)
Built Prior to March 26, 2015

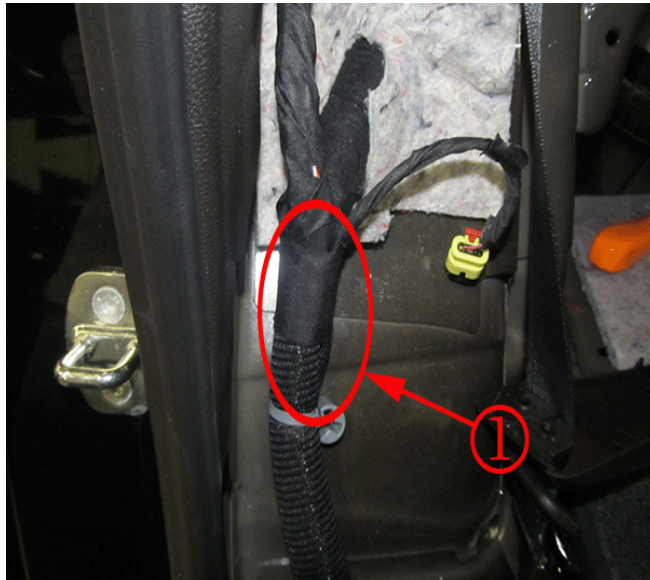
4206604

These symptoms may be caused by the right rear seat back bolster bracket contacting the body harness. The bracket may have rubbed passed the anti-abrasion tape and wiring insulation causing a short to ground.

3. Inspect the body harness (1) at this section above for any evidence of affected wiring.
4. If no evidence of bracket interference, continue diagnosis. Refer to the appropriate Service Information.
5. Repair the wire or wires as necessary. Refer to the Wiring Repairs in SI.
6. Rewrap that section of the body harness with woven polyester electrical tape (PET) or equivalent anti-abrasion tape or electrical tape.

If these symptoms exists, removal of the right rear seat back bolster should be performed to inspect the body harness. If there is evidence that the bolster bracket has rubbed through, contacting electrical wiring, repair of the wire or wires is necessary. Also, rewiring of the body harness, re-angling the bolster's bracket and installation of protective conduit will be necessary.
