Bulletin No.: PI1522

## **Service Bulletin**

**Subject:** Malfunction Indicator Lamp (MIL) ON, Poor Transmission Shift Performance/Quality

**Models:** 2015-2016 Chevrolet Silverado  
2015-2016 GMC Sierra  
Equipped with Allison Model 1000 Automatic Transmission (RPO MW7)

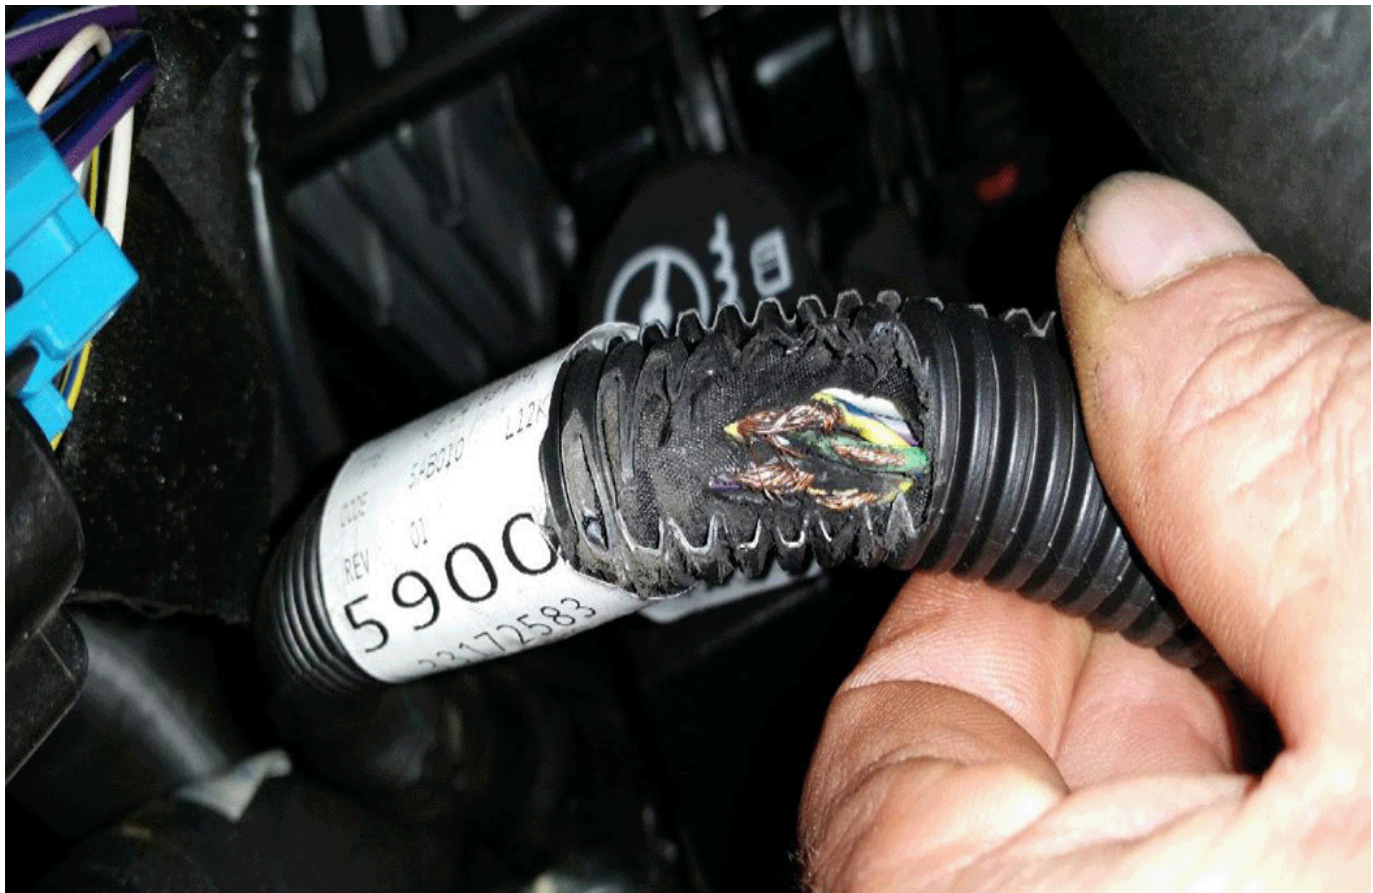
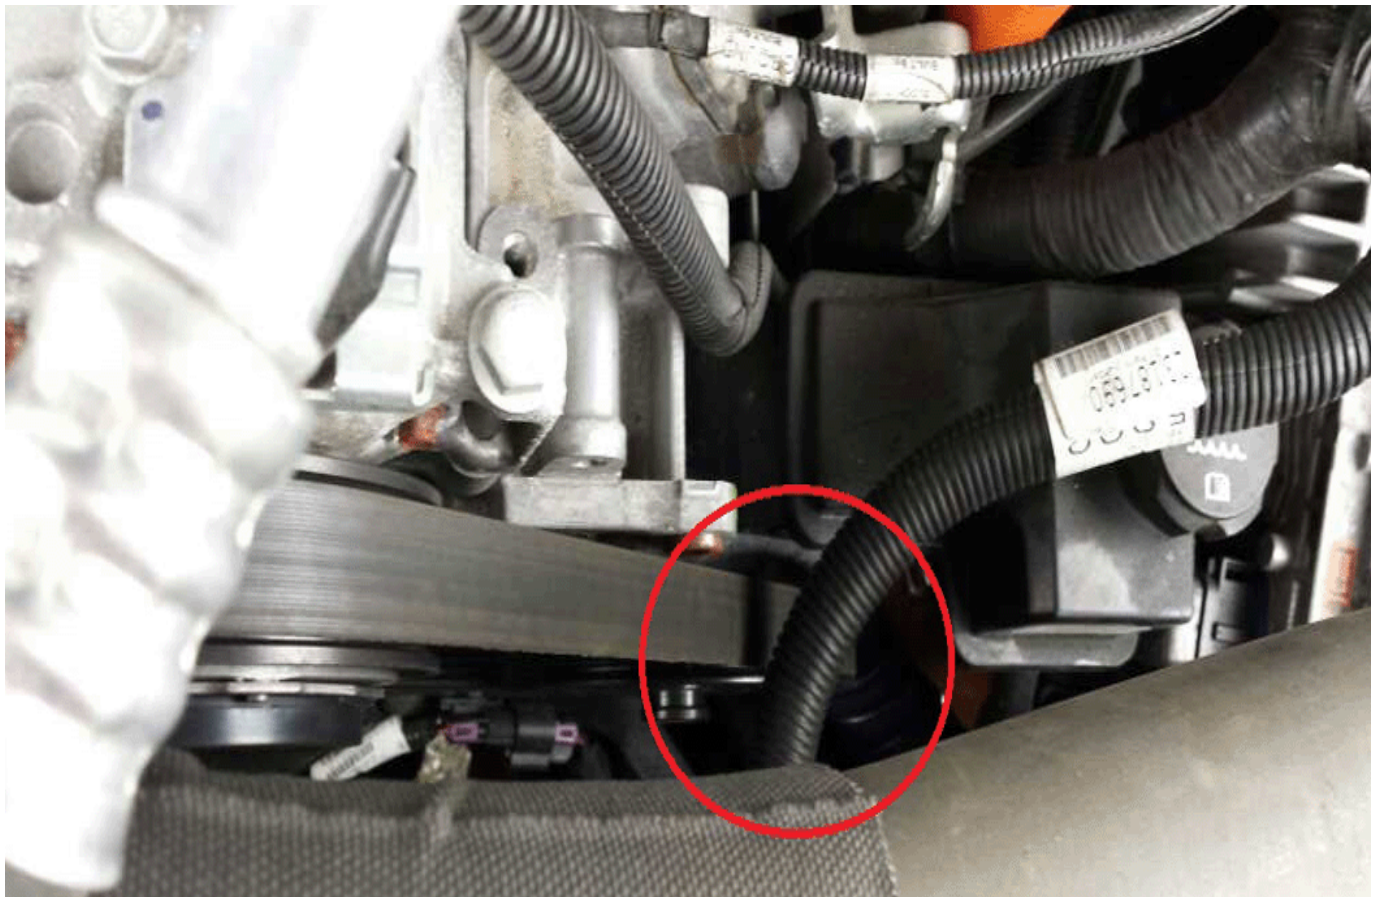
4251829

The TCM wire harness routing allows interference with the engine accessory drive belt, which can cause damage to the wire harness.

See the picture below of a damaged harness.

Repair the TCM harness as required.
