SERVICE BULLETIN

APPLICABILITY: 2010-14MY Legacy and Outback Models
SUBJECT: Design Change to Retaining Clip for Front ABS Wheel Speed Sensor

NUMBER: 06-49-15
DATE: 05/29/15

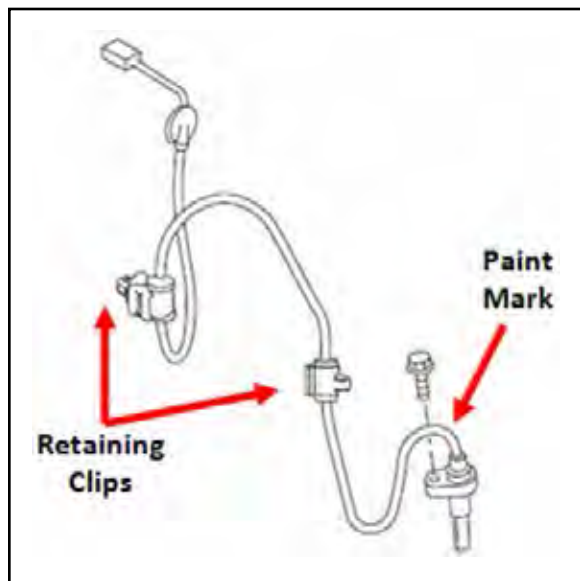
In response to isolated reports of cracked or broken ABS wheel speed sensor harness retaining clips caused by reaction with acids used in some wheel cleaners, the clip material has been changed to polypropylene (PPO).

NOTE: The paint markings are located on the harness near the sensor mounting flange end.

Old parts may be recognized on the car by their Pink (Legacy) or Blue (Outback) paint marks.

IMPORTANT: In the event a cracked or broken sensor harness retaining clip is identified on one side of the vehicle, the opposite side of the vehicle **MUST** be inspected for possible similar damage.

The retaining clips are not serviceable separately. If a cracked or broken clip is identified, the sensor sub-assembly will need to be replaced.

Follow the service procedure in the applicable Service Manual for replacing the ABS sensor sub-assembly. The retaining bolt torque specification is 7.5Nm (5.5 ft. lbs.).
