## Technical Service Bulletin

**Ramp Door Bolts On Momentum Toyhauler**

15-002

Momentum

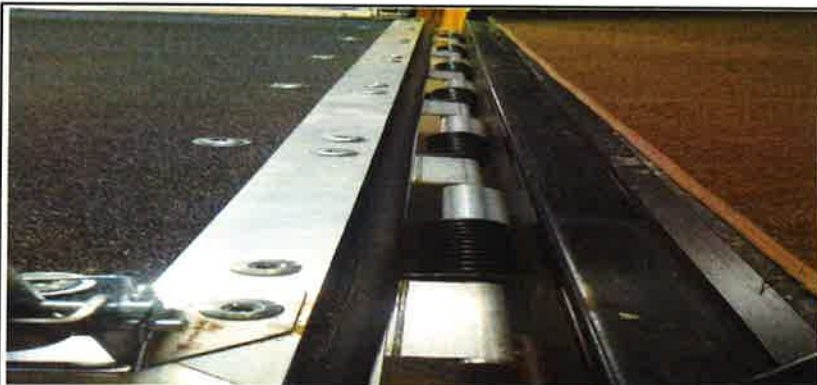
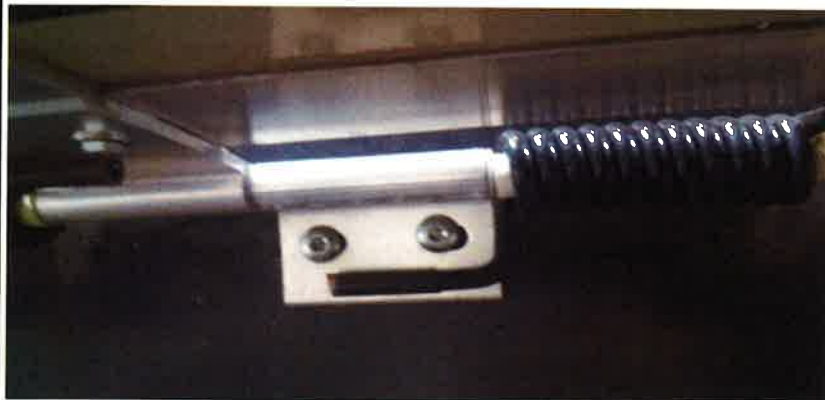
Bolts used to secure the ramp door to the rear bumper may become loose over time

Remove existing bolt, drill 27/64 hole, install 1/2" self threading bolt pn 960989. Complete on all bolts that secure the door to the bumper
