# Special Bulletin **SB-10060329-9191** **SP15-23**

## STEER LEVER BOLT INSPECTION

Prevost vehicles

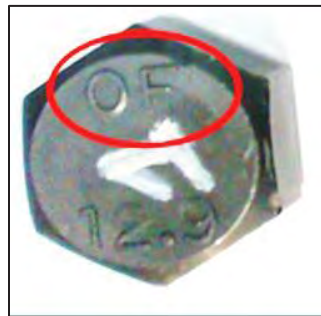
Figure 1

- 1) Verify the bolt head for the marking "OF". If present on one of the bolts, replace BOTH bolts

- 3) Replace one bolt at a time
  - Short Bolt M20 X 60 G12.9                      PN 611305 QTY 2/VEH
  - Long Bolt M20 X 80 G12.9                      PN 611307 QTY 2/VEH
- 4) Run a **M20 X 2.5 size tap** in the threaded section of the axle. You have to go from the back side and not the bracket side
- 5) Clean the bolt thread as well as the support thread using degreaser. Dry with compressed air.
- 6) Apply 271 Loctite or Permatex 27100 on bolt and threaded hole
- 7) Torque to **547 FT LBS**, Qty: 2 per side
- 8) Apply undercoating on Bolt heads
- 9) Reinstall sway bar links. Torque to **165 lbf-ft.**
- 10) Reinstall shocks. Torque to **110 lbf-ft.**
- 11) If no **“OF”** marking on the bolts, the vehicle is Conform.

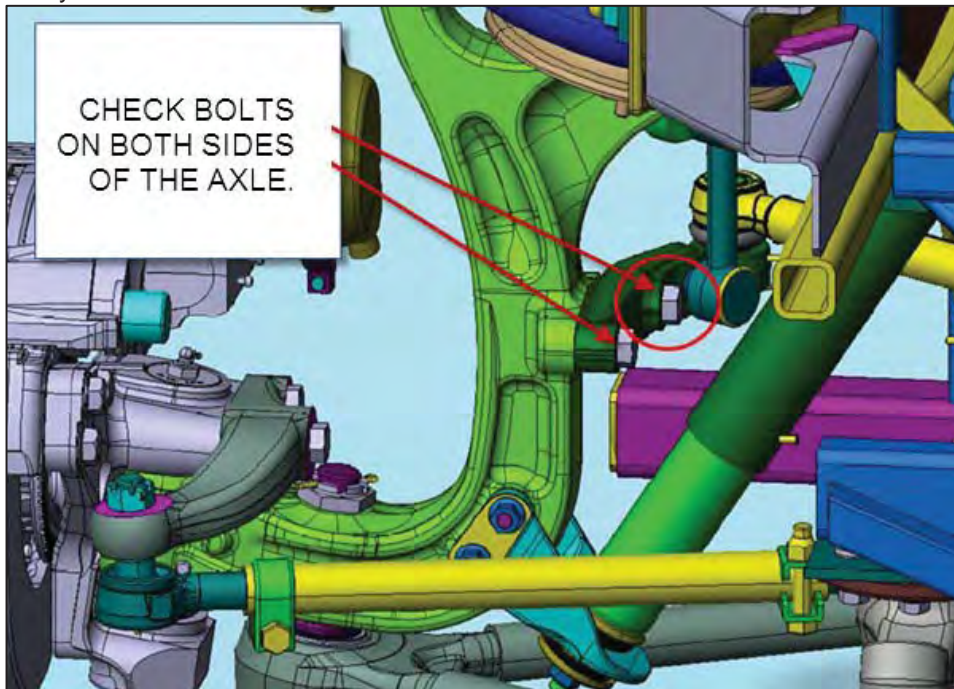
Figure 2

On the front independent suspension, inspect the bolts highlighted in fig. 2. Note that you may have to remove the shocks and the sway bar links to perform the replacement. Support the body on both sides before removing any components.

- 2) Verify **both sides** of vehicle
