# PREVOST

# WARRANTY BULLETIN

**WB15-13**

| SUBJECT : | IFS LEVEL VALVE CONTROL ROD POSSIBLE CONTACT | | |

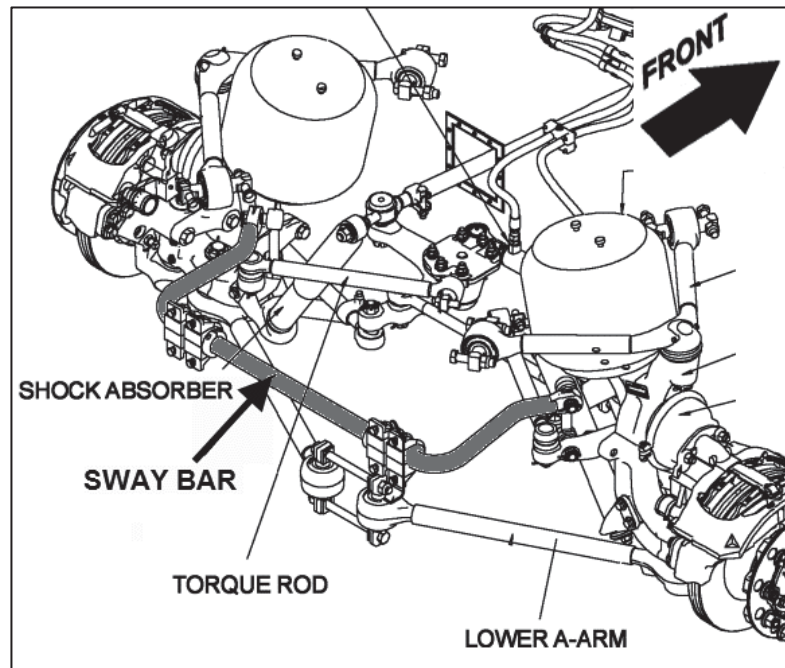
Figure 1

1. On the front axle, locate the front suspension sway bar. (Fig. 1)

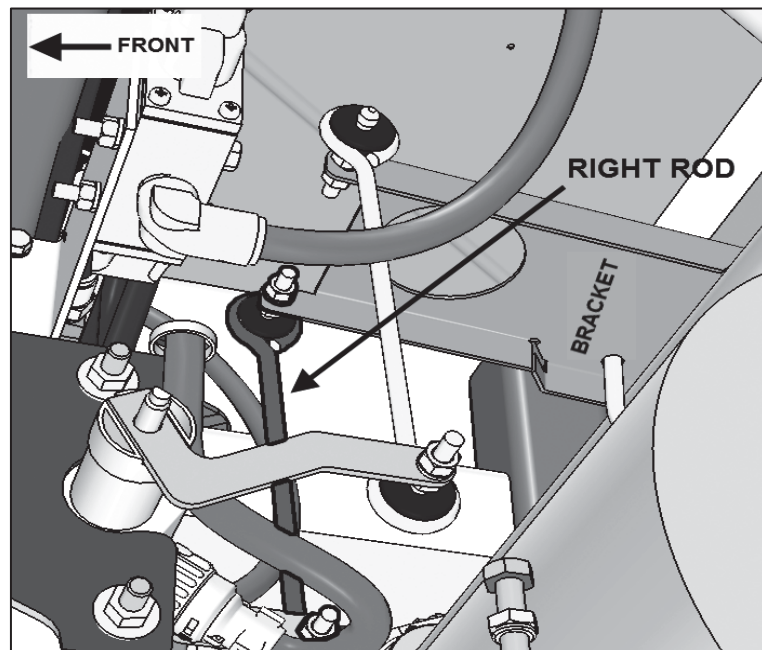
Figure 2

2. In the middle of the sway bar you will find a bracket clamped on the tube. The bracket supports two control rods (Fig. 2)

3. On the right hand side rod. (Fig.2) Unscrew the upper and lower mounting nuts.
4. Flip the rod over to the opposite side of the control lever and bracket tab above. (Arrow, Fig. 3)
5. Re-assemble hardware. (Fig.3)

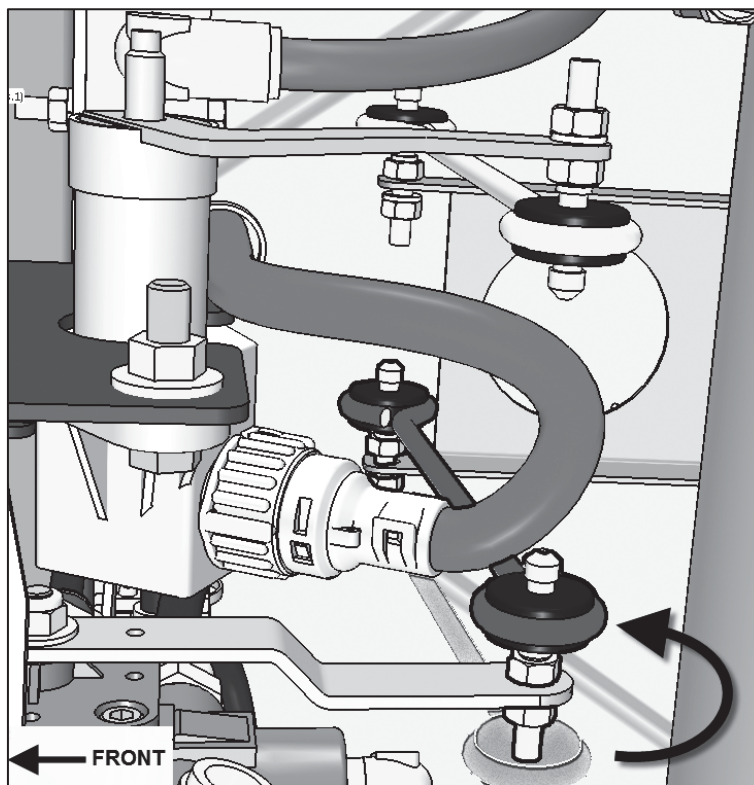
On the independent front suspension level valve linkage of the vehicles affected by this bulletin, a control rod may come in contact with an air reservoir outlet when vehicle rises from Low to High Buoy. As a result, the vehicle may be leveled higher in "Normal" position.

Figure 3 : Flip upper and lower connection of control rod.

The interference is corrected by changing the side on which the rod is attached to the linkage.
