SB-10060338-2610

BRAKE HOSE INSPECTION

Prevost vehicles

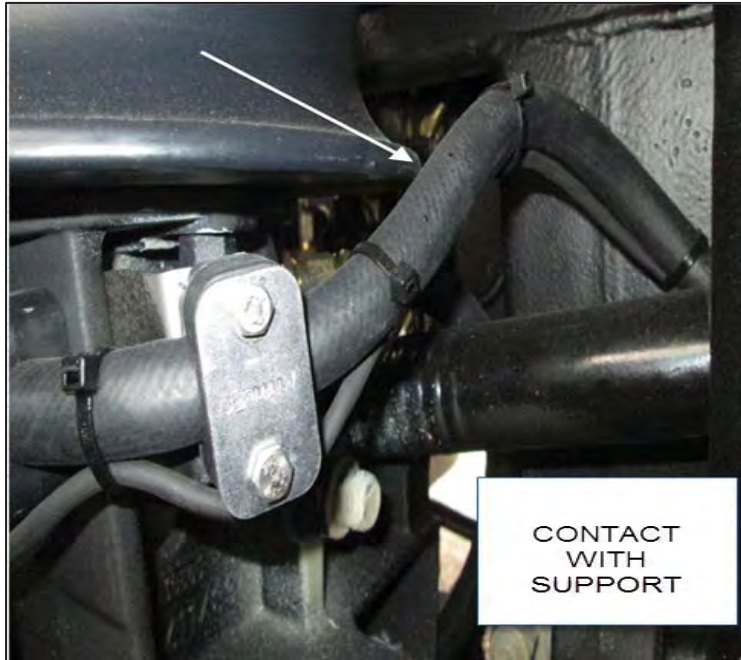
Figure 1

1. On each side of the vehicle, make sure that the brake hose to the brake booster does not come into contact when suspension is in low or high buoy.
2. If no contact is found, end the bulletin here.
