Special Bulletin

SP15-336C

FIVE FOOT SWITCHES REPLACEMENT

Prevost vehicles

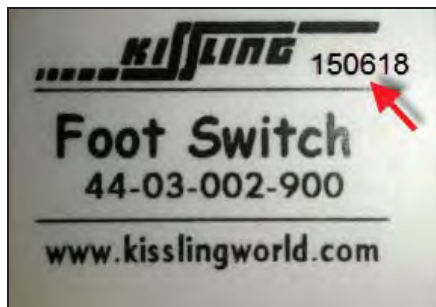
Validate that the new foot switch date code (yymmdd) on label is 150618 or more recent.
