# Service Bulletin

Bulletin No.: PIT5323

**Subject:** Normal Characteristic - Appearance Of Uneven Bed Or Accessory Rails After Installation Of Accessory Tonneau Cover

**Models:** 2015 Chevrolet Colorado  
2015 GMC Canyon

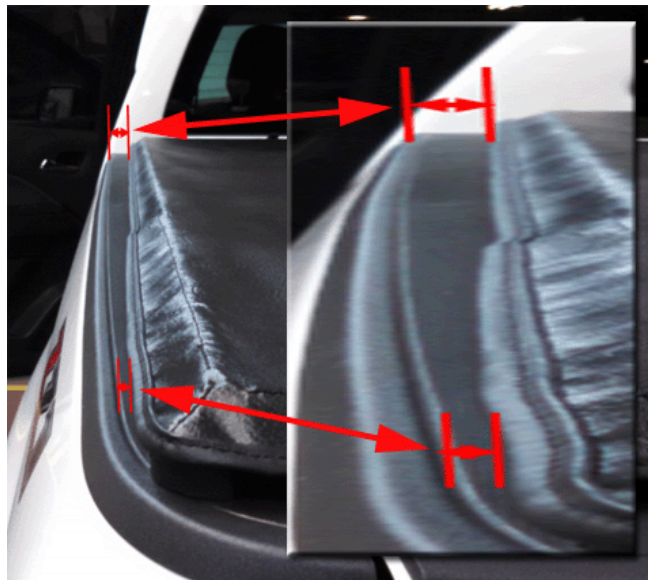
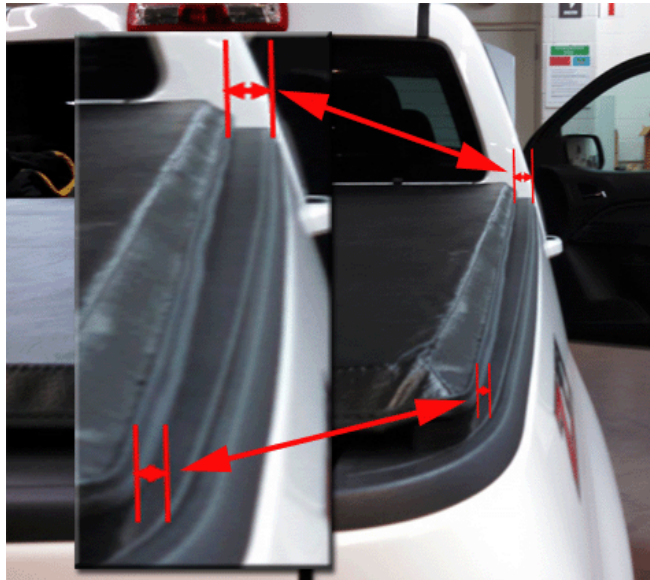
3982886

A customer or technician installing accessories on the bed rail caps may notice the rails are not as wide at the rear of the pickup bed as they are at the front of the bed. This is typically noticed after the installation of GM Accessory Soft Folding or Soft Roll-Up Tonneau Cover rails.

Some may think the accessory install was incorrect or that parts of the accessory kit are damaged

The changing width of the bed rail cap is by design and part of the sleek appearance of the truck; no repairs are necessary to correct it.

Because the bed rail caps narrow as they go toward the rear of the vehicle, and the tonneau cover rails maintain a rectangle shape, the narrowing of the bed rail caps is highlighted and more noticeable.

**Important:** Do not attempt to repair or replace parts for this condition.
