Technical Service Bulletin

48 Electric steering column adjustment is inoperative

48 15 67 2017266/9 September 15, 2015. Supersedes Technical Service Bulletin Group 48 number 14-62 dated September 23, 2014 for reasons listed below.

Model(s)	Year	VIN Range	Vehicle-Specific Equipment
A6	2005 – 2011	All	Not Applicable
A8	2003 – 2010	All	Not Applicable
Q7	2007 – 2015	All	Not Applicable

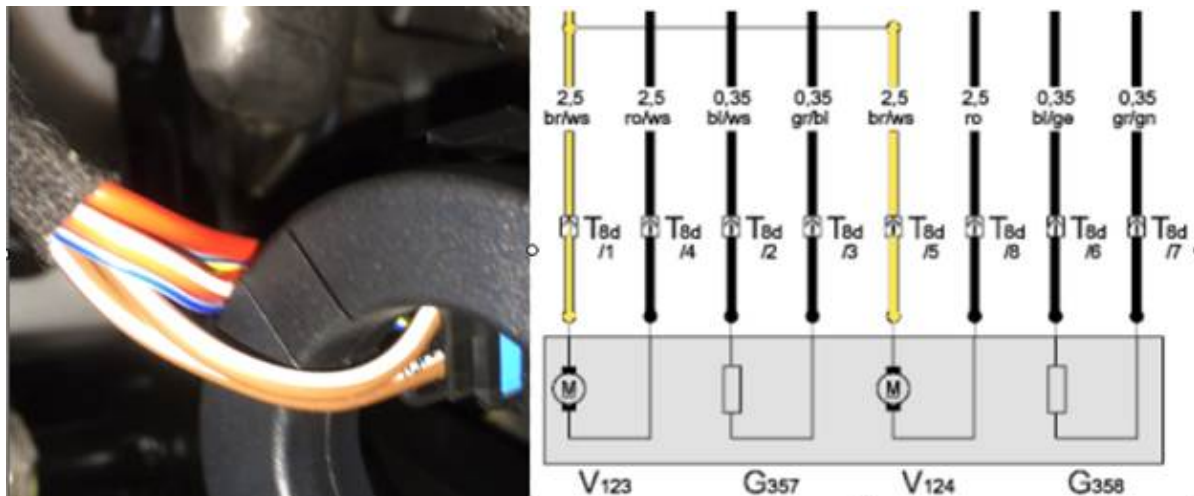
Figure 1. Current clamp installed (left), pins 1 and 5 (right).

1. Remove the steering column trim to gain access to the 8-pin (black) connector located under the dash.
2. Identify wires on T8d/1 and T8d/5. Install the current pick-up clamp around these wires (Figure 1).

3. Perform basic settings of the steering column in the J519 control module. Record the peak current values during the length and height adjustment.
 - The expected current draw in correct steering columns is about 1A for axial adjustments and about 2.8A - 3.4A for vertical adjustment (lower current draw typically found during testing, 2.0A-2.5A). Current draws above these values are an indication of binding or a tight steering column.

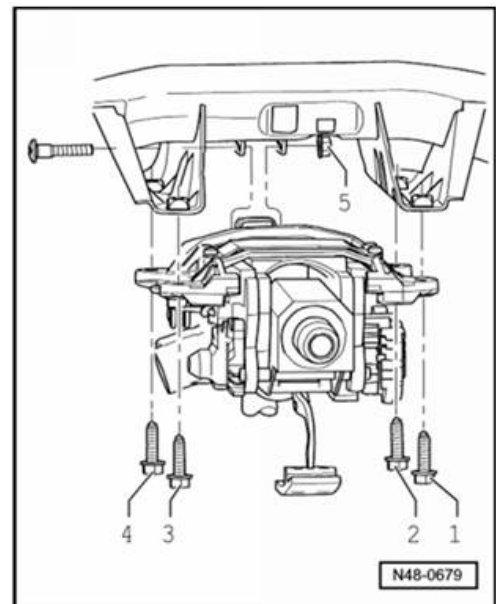
Figure 2. Tightening sequence (see ELSA for correct torque specifications)

4. Loosen the steering column from the cross carrier, then tighten the column according to ELSA instructions (Figure 2). This should relieve any tension between the steering column and cross carrier, if any existed.

5. Operate the steering column up and down and note the peak current draw:
 - If the current draw is lower and within the specifications after the mounting bolts have been loosened and retightened, the steering column had tension. If the current draw stays low after the reinstallation, the tension is only caused by the installation. An adjustment of the steering column is not necessary.
 - If the current draw rises to its original level after the reinstallation, the tension is caused by unfavorable tolerances of the components. The steering column must be adjusted as described in the instructions that follow.

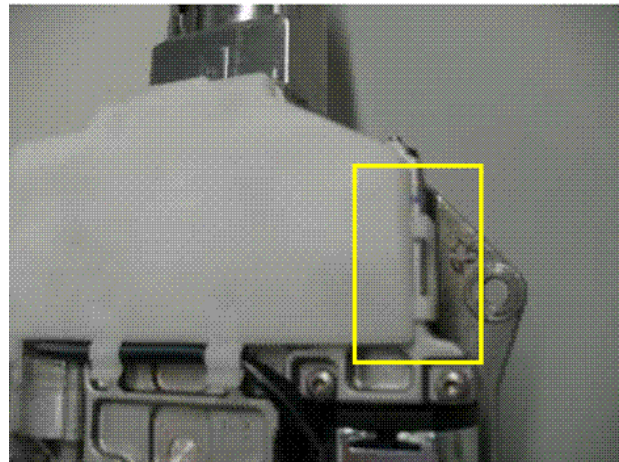
Figure 3. Side clips.

1. Loosen the belt cover of the steering column:
 - If necessary, remove the footwell and steering column covers.
 - Next, move the height adjustment of the steering column to a central position.
 - Then, carefully loosen the side clips without damaging the clasps (Figure 3).

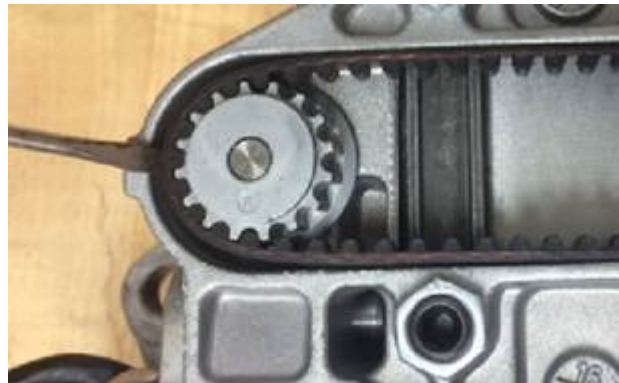
Figure 4. Remove the gear belt with a fine screwdriver.

2. Carefully remove the gear belt from one gear wheel, using a fine screwdriver (Figure 4). Leave the gear belt removed from one wheel for step 3.

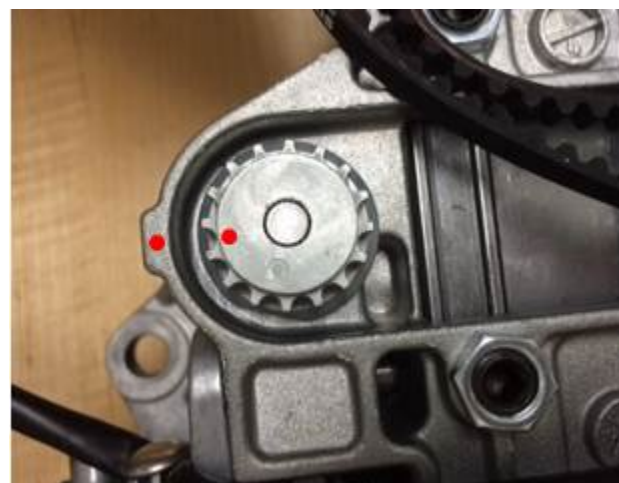
Figure 5. Marking original gear location.

3. Reduce the tension in the steering column:
 - Mark the gear's original location on the gear, on the housing, and on the belt (Figure 5).

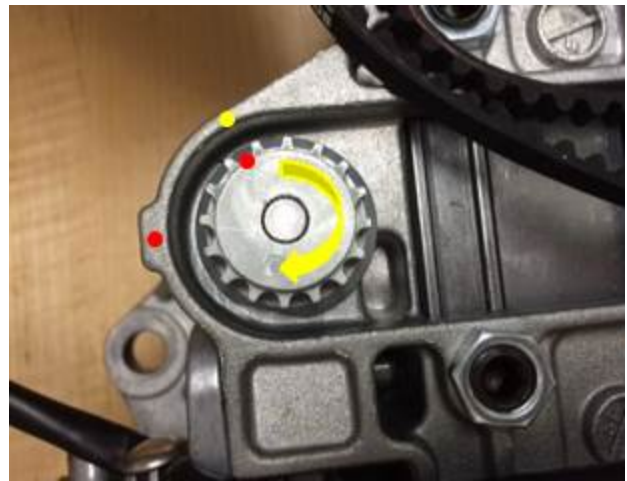
Figure 6. *Marking the location with the greatest resistance in the clockwise direction.*

- Turn the gear clockwise and mark the location with the greatest resistance (Figure 6).

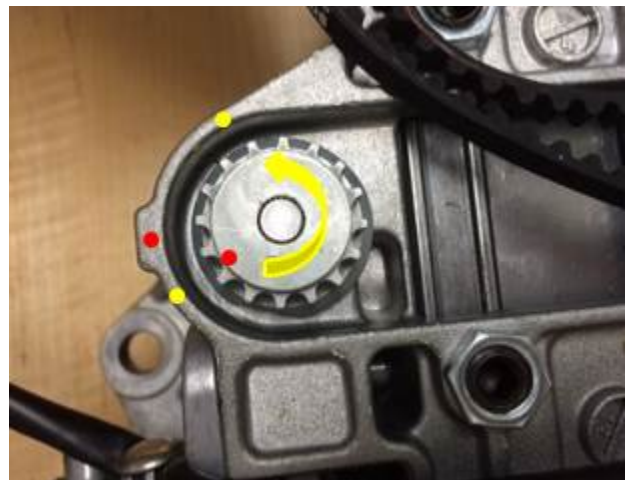
Figure 7. *Marking the location with the greatest resistance in the counter-clockwise direction.*

- Turn the gear counter-clockwise and mark the location with the greatest resistance (Figure 7).

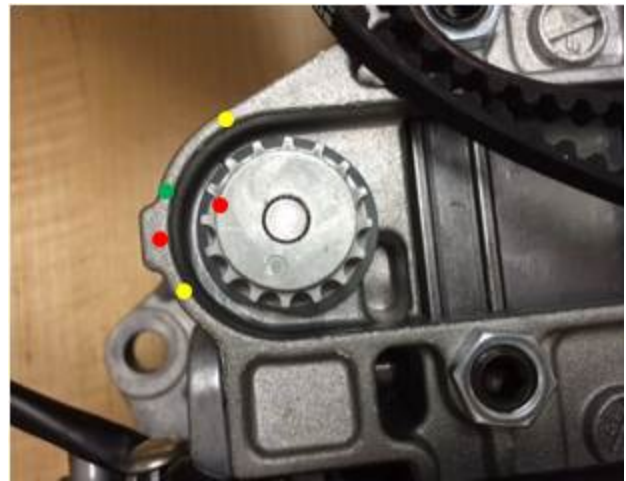
Figure 8. *Placing a green dot in between the two yellow dots and turning the gear (red dot) to match the green dot on the housing.*

- Place the original marking of the gear in the center of the two greatest resistance markings (Figure 8).

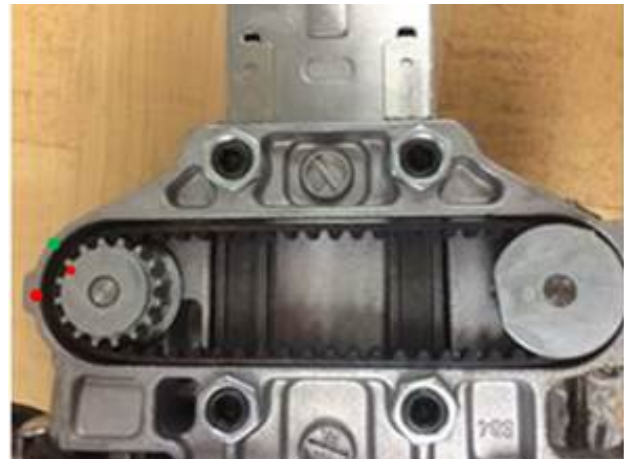
Figure 9. *Installation of gear belt.*

4. Place the gear belt, by hand, on the gear wheel (Figure 9).

The gear may have to move slightly to engage the belt during installation but other than that, the gear and green dot should line up (+/- ½ tooth). This will ensure that the gear is now centered between the two greatest resistance points.

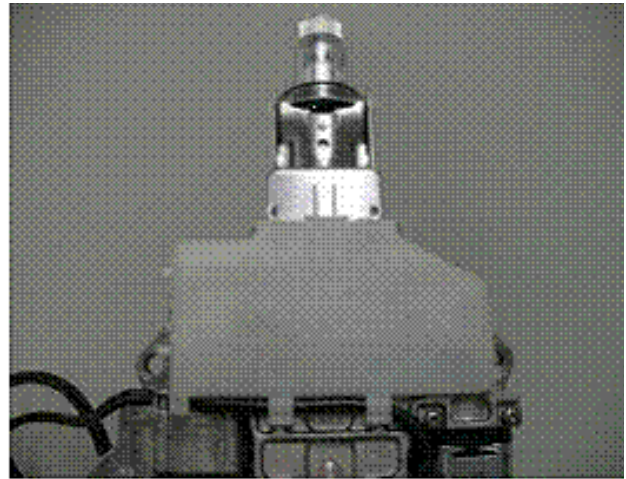
Figure 10. The cover, installed on the housing.

5. Carefully reinstall the cover on the housing (Figure 10).
