# CAPACITY TECHNICAL SERVICE BULLETIN

CAP-TSB-15-017

## BOOM CYLINDER TORQUE

November 16, 2015

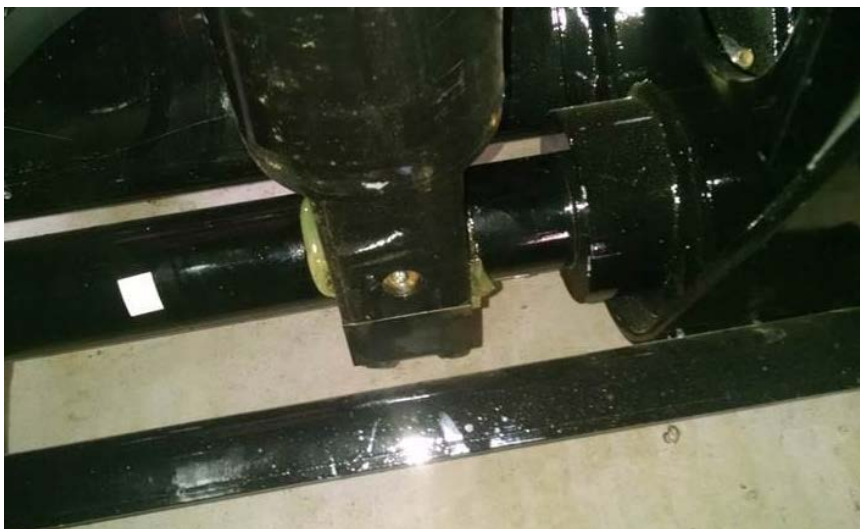
Identify the 2 boom cylinders located in the Rear axle. Identify the bolts shown in the pictures.

Torque bolts to 80 ft.lbs, a total of 8 bolts are installed on each boom cylinder (4 on the top and 4 at the bottom), there should be a total of 16 bolts that must be torqued properly.

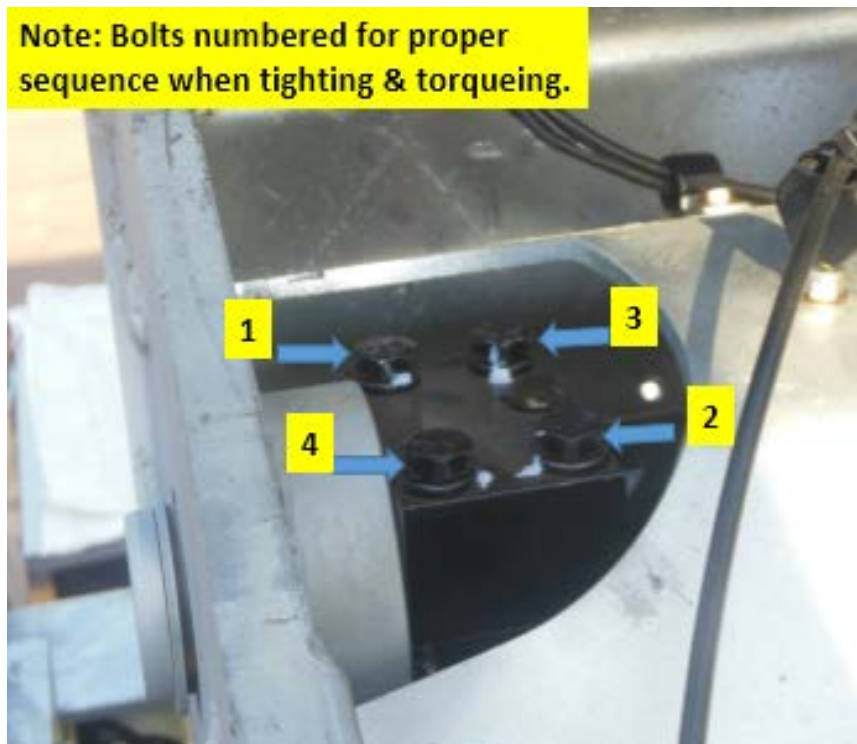
**Note: Bolts numbered for proper sequence when tightening & torquing.**

Make sure that Bolts were torqued in the correct sequence:
