NUMBER: 08-033-15 REV. B

DATE: November 13, 2015

Flash: RE2 RE3 RE4 RE6 RE7 RB4 RB5 RB6 RB4 Radio Enhancements

This bulletin involves updating the radio control head software and navigation if equipped.

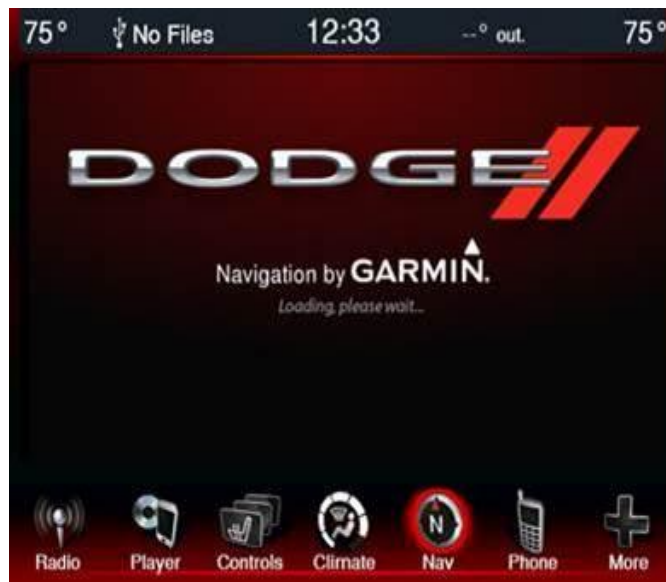
Fig. 1 System Loading Screen

3. Press the navigation screen button and attempt to access the navigation main menu system.
4. Is the radio stuck on the “Loading Please Wait” screen? See ([Fig. 1](#)).
 - a. Yes >>> The radio will have to be replaced. Replace the radio using current electronic exchange center stock following normal warranty repair procedures. Refer to published service information in Tech Connect Section 08 - Electrical/8E - Electronic Control Modules/MODULE, Telematics Gateway/Removal. No further action is required, the bulletin is now complete. The replacement radio will contain the latest software update.
 - b. No >>> Proceed to [Step #5](#) and perform the software update.
