GROUP ENG	MODEL 2014~2015MY Cadenza (VG)
	NUMBER 148	DATE September 2015
<p align="center">TECHNICAL SERVICE BULLETIN</p>		
<p>SUBJECT: CHATTER/RATTLE NOISE FROM ENGINE AFTER COLD SOAK</p>

This bulletin provides information about the timing chain tensioner and tensioner arm replacement of some 2014~15MY Cadenza (VG) vehicles, which may experience a brief chattering or rattling noise concern from the engine on start-up, after a cold soak. After confirming the noise concern, follow the procedures outlined in this TSB to resolve the concern.

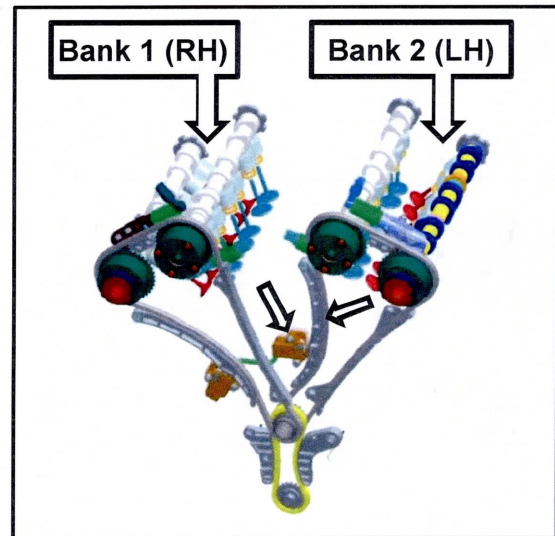
This Service procedure should ONLY be performed on engine bank 2 (LH), as shown.

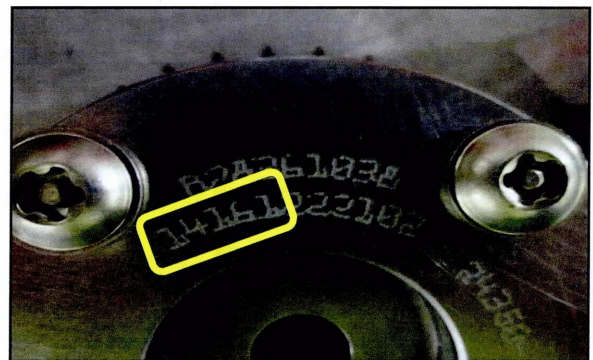
1. Refer to the "Engine Mechanical System → Timing System → Timing Chain" section in the applicable Workshop Manual on KGIS, to install the improved parts. **NOTE: prior to installation, refer to steps 2~4 for supplementary inspection/installation information.**
2. After removal of timing chain cover, inspect CVVT's on both engine banks to ensure the first five (5) digits of the eleven (11) digit serial number is equal or greater than "14111", on both Intake and Exhaust CVVTs. If the serial number is greater than 14111, proceed to step 4. If the serial number is less than "14111", replace the CVVT(s) prior to performing the remainder of this TSB procedure.

Additionally, inspect the replacement CVVTs to ensure the first five (5) digits of the serial number are greater than "14111".

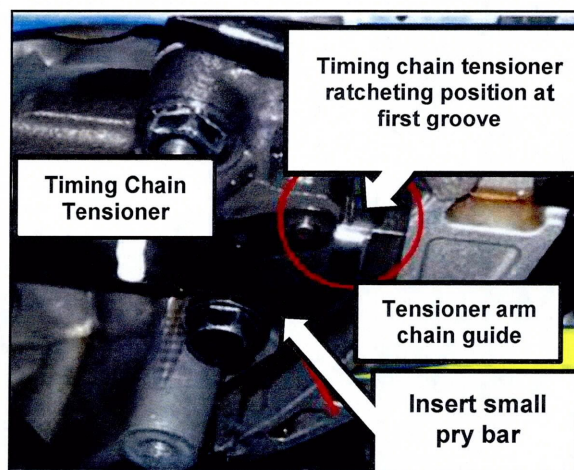
Prior to removing chain tensioners/adjusters, note position of the timing chain tensioner pawl to the rack grooves and count the number of teeth/grooves extending from the tensioner, as shown below. Make sure to record the count for later reference.

3. After installing the new tensioner, and timing chain guide, manually rotate the crankshaft three (3) full revolutions to securely seat the tensioner, then, check the number of grooves extending from the tensioner. When compared to the initial count, it should now be one (1) groove further out towards timing chain.
