Wayne E. Bahr, Global Director  
Automotive Safety Office  
Sustainability, Environment & Safety Engineering

Subject: 49 CFR Part 579.5 Monthly Communications – October 2015

**INDEX OF SERVICE BULLETINS,  
NOTICES, AND COMMUNICATIONS TO DEALERS**

**3.5L TI-VCT - ROLLING/SURGING OR LOW IDLE DURING A/C OPERATION****TSB 15-0149****FORD:**

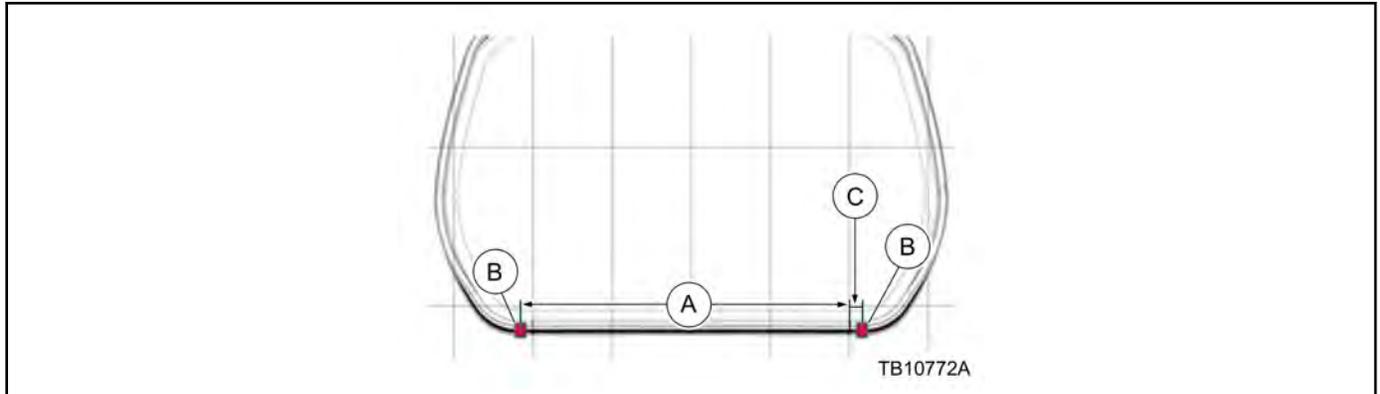
Figure 1 - Article 15-0150

(1) The square notches are located 83 cm (32 11/16" ) apart. (Figure 1A )

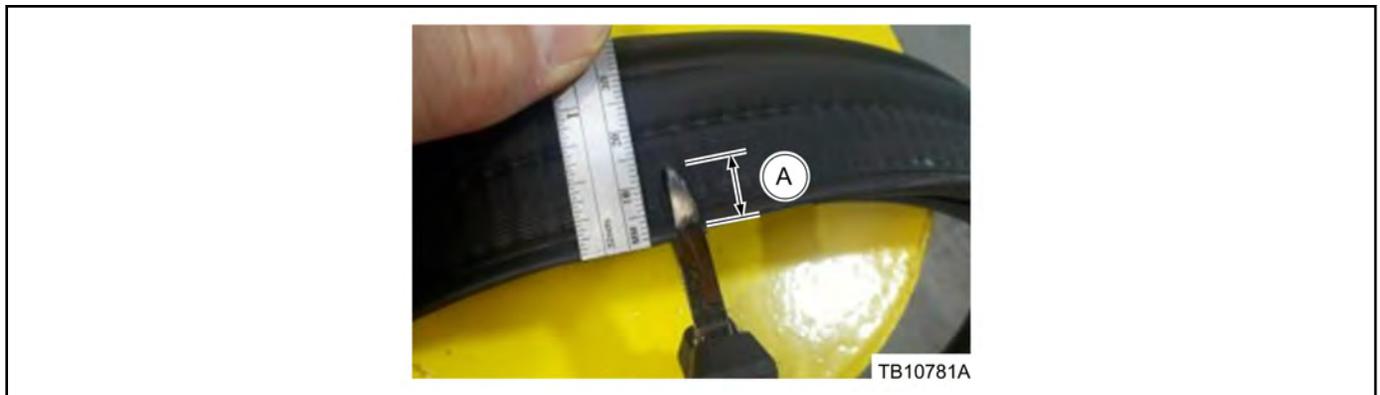
Figure 2 - Article 15-0150

(2) The square notches are 14 mm deep by 5 mm wide (9/16" by 3/16"). (Figure 2A)

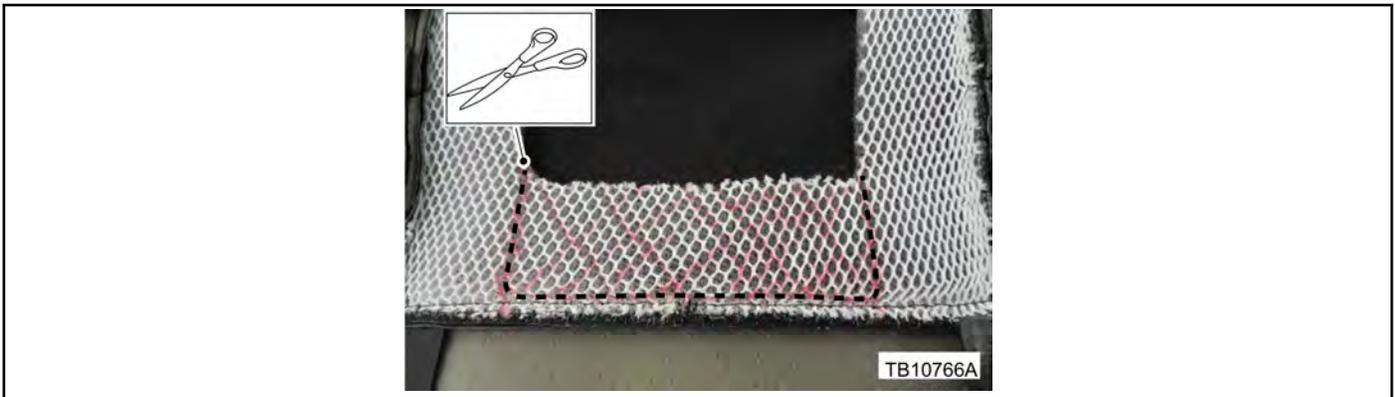
Figure 1 - Article 15-0154

1. Can the backrest blower motor be heard running when using the climate controlled seats?
  - a. Yes - proceed to Step 2.
  - b. No - this article does not apply. Refer to Workshop Manual (WSM), Section 501-10 for normal diagnostics.
2. Remove the front seat backrest blower motor. Refer to WSM, Section 501-10.
3. With the seat backrest cover positioned upward, use scissors or equivalent cutting device to remove the indicated portion of the seat backrest cover foam spacer pad (using the existing spacer pad opening as a guide). Do not cut the stitched seam at the lower edge of the seat backrest cover. (Figure 1)

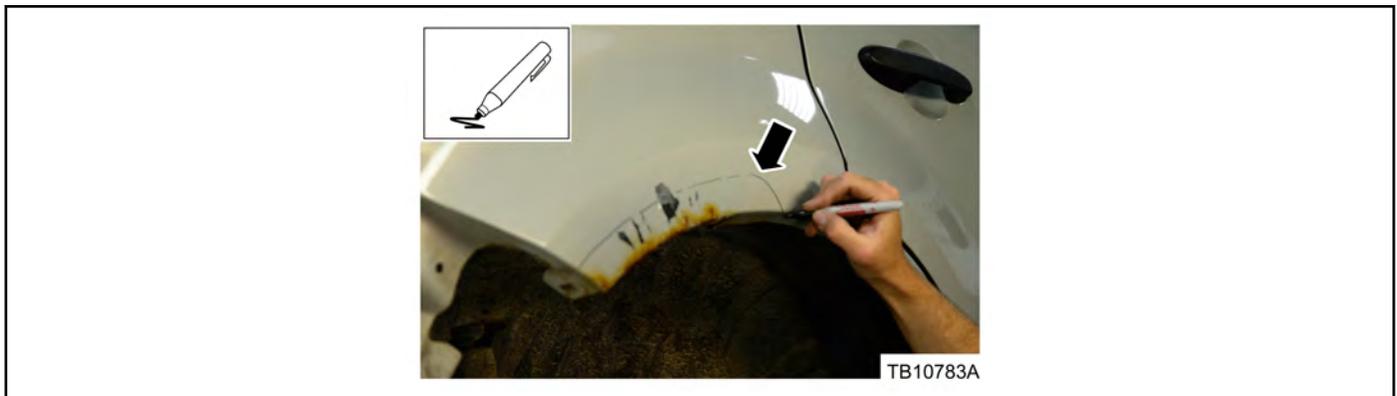
Figure 1 - Article 15-0157

Some 2009-2012 Escape and 2009-2011 Mariner vehicles may exhibit rear quarter panel(s) with corrosion and/or perforation around the wheel well lip area.

1. Disconnect the negative battery cable. Refer to Workshop Manual (WSM), Section 414-01.
2. Remove the rear bumper cover. Refer to WSM, Section 501-19.
3. Remove the rear lamp assembly.
4. Remove the wheel and tire. Refer to WSM, Section 204-04.
5. Use a marker and trace a line 13 mm (1/2") beyond the corrosion area of the outer quarter panel. (Figure 1)

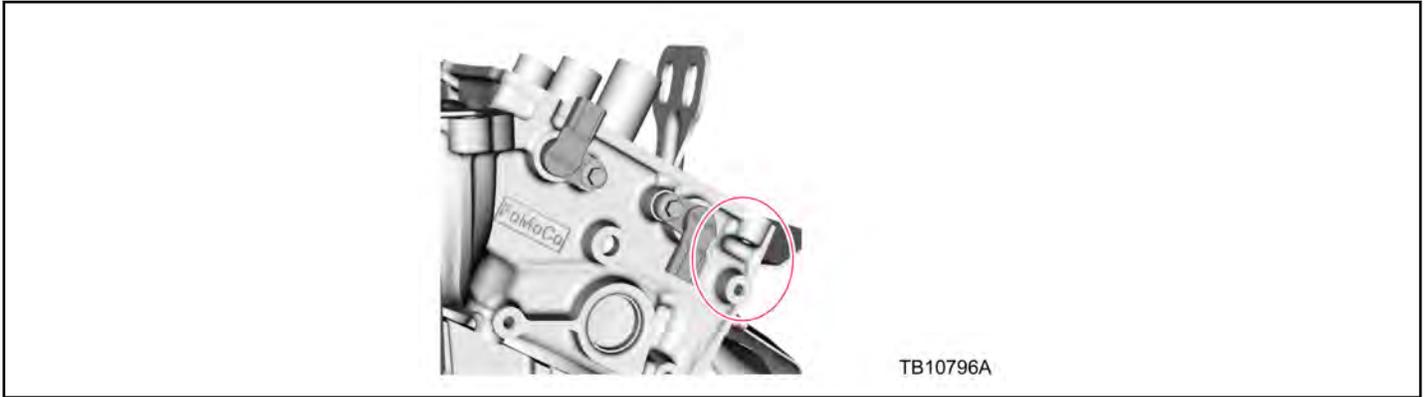
Figure 1 - Article 15-0160

14. Position the detached section of the harness on top of the engine to allow harness inspection and repair.
15. Inspect the harness takeout for HO2S11 electrical connector C1571 for chafing or wire worn through that may have been caused by contact on the back of the cylinder head. (Figure 1)

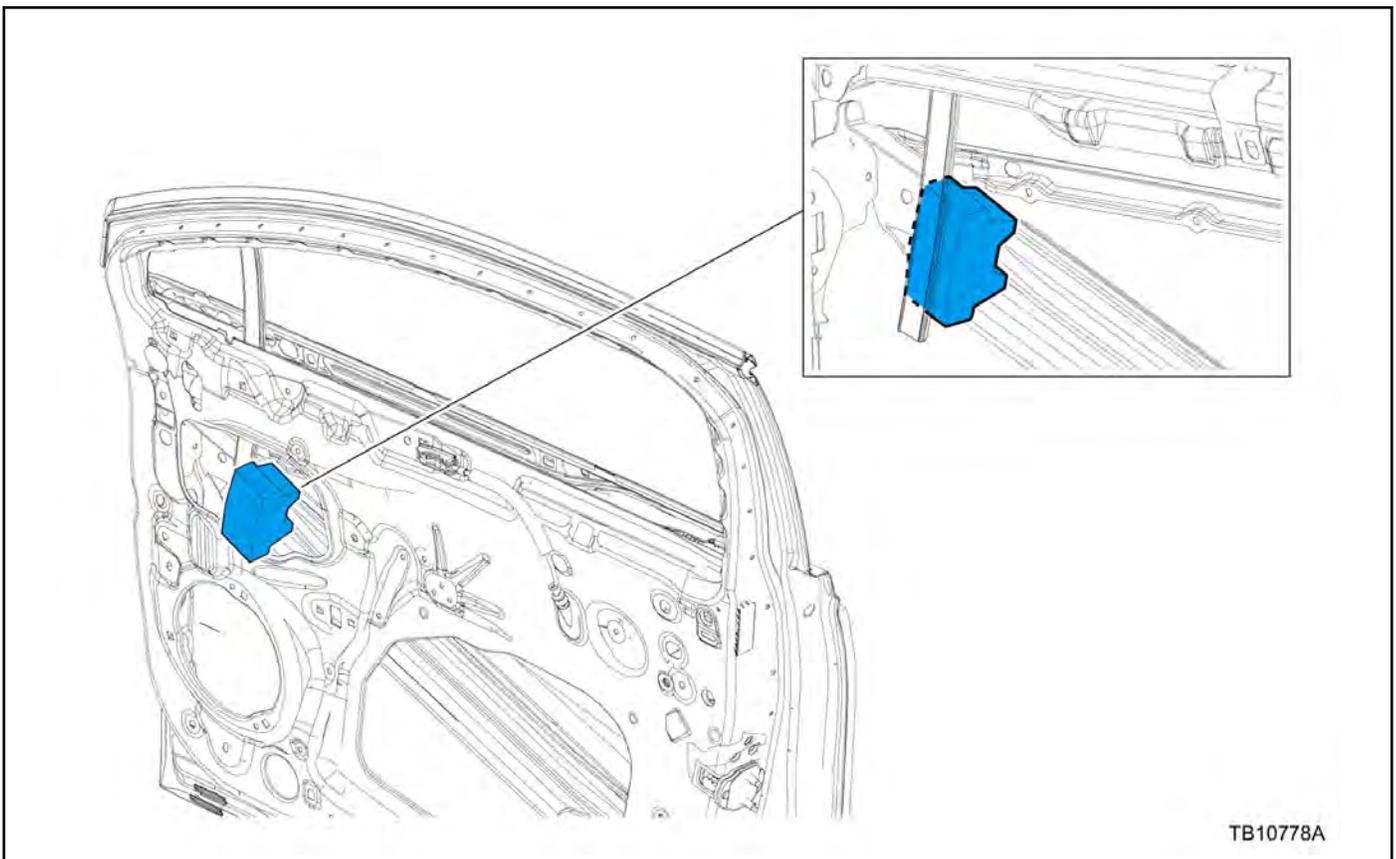
Figure 1 - Article 15-0167

1. Remove the front door trim panel on the affected door and remove the window regulator access cover. Refer to Workshop Manual (WSM), Section 501-05.
2. Is the front window fixed glass division bar window run channel foam block support present? (Figure 1)
