**Subject: 49 CFR Part 579.5 Monthly Communications – November 2015**

**INDEX OF SERVICE BULLETINS,  
NOTICES, AND COMMUNICATIONS TO DEALERS**

**HEADLAMP BULB FLICKERING OR IS INOPERATIVE - BUILT ON OR BEFORE 1/11/2015****TSB 15-0168****LINCOLN:**

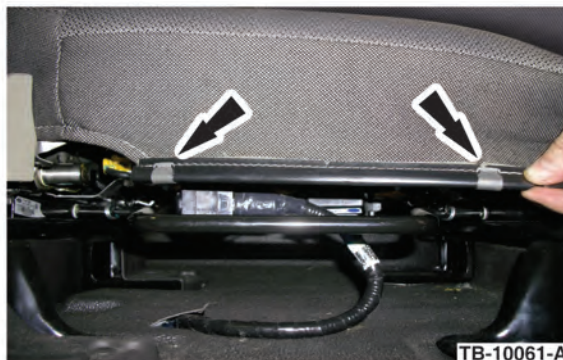
Figure 1 - Article 15-0169

Some 2016 Explorer vehicles may have a front seat cushion cover that appears loose near the front edge of the seat. This may be caused by the seat cushion cover J-retainer becoming disengaged from the seat cushion pan flange.

1. Position the affected seat rearward.
2. Completely disengage the J-retainer from the seat cushion pan flange.
3. Install one (1) clip on each side of the J-retainer, approximately 5-25 mm (1/4" - 1.0") from the outboard edge. Right hand seat shown. (Figure 1)

4. Secure the J-retainer to the seat cushion pan flange. To aid in assembly, begin at the inboard edge of the flange, working outboard.

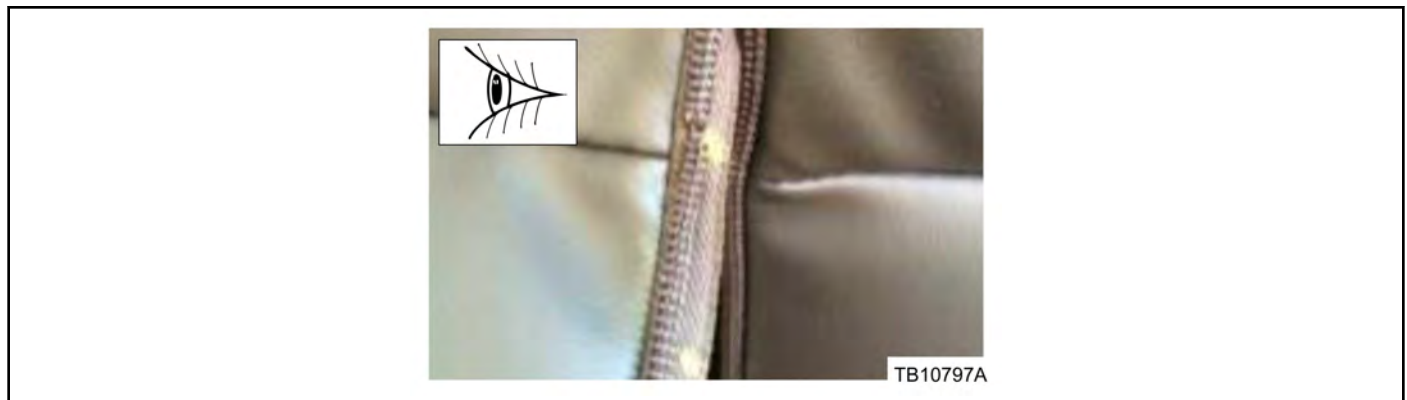
Figure 1 - Article 15-0173

Some 2015-2016 MKC vehicles built on or before 7/24/2015 may exhibit a front seat backrest cover zipper separated, split or broken due to excessive trim cover tension.

1. Inspect the front seat backrest cover zippers. Are any of the the zippers separated, split or broken? (Figure 1)

4. Inspect the zipper teeth for any damage. Are the teeth damaged?
  - a. Yes - replace the front seat backrest cover. Proceed to Step 5.
  - b. No - the front seat backrest cover can be reused. Proceed to Step 5.

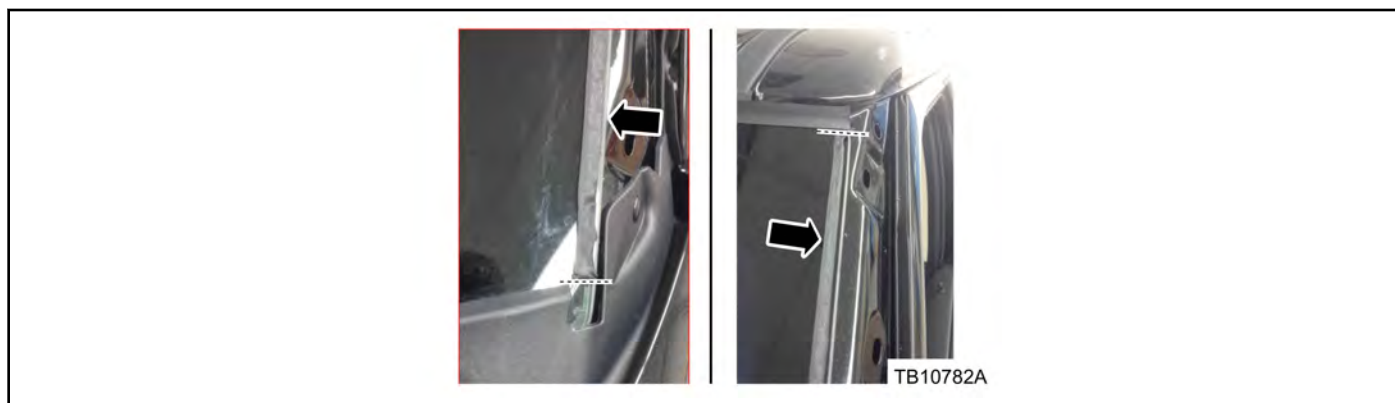
Figure 1 - Article 15-0175

Some 2013-2015 Flex vehicles may exhibit a wind or whistle-type noise from the left and/or right A-pillar area at highway speeds in crosswind conditions. This may be due to the exterior A-pillar window moulding rocking or not being fully seated.

1. Remove and discard the exterior A-pillar window moulding(s). Refer to the Workshop Manual (WSM), Section 501-08.
2. Apply strips of 3M Strip-Calk or equivalent along the outside edge of the windshield on the affected side(s). (Figure 1)

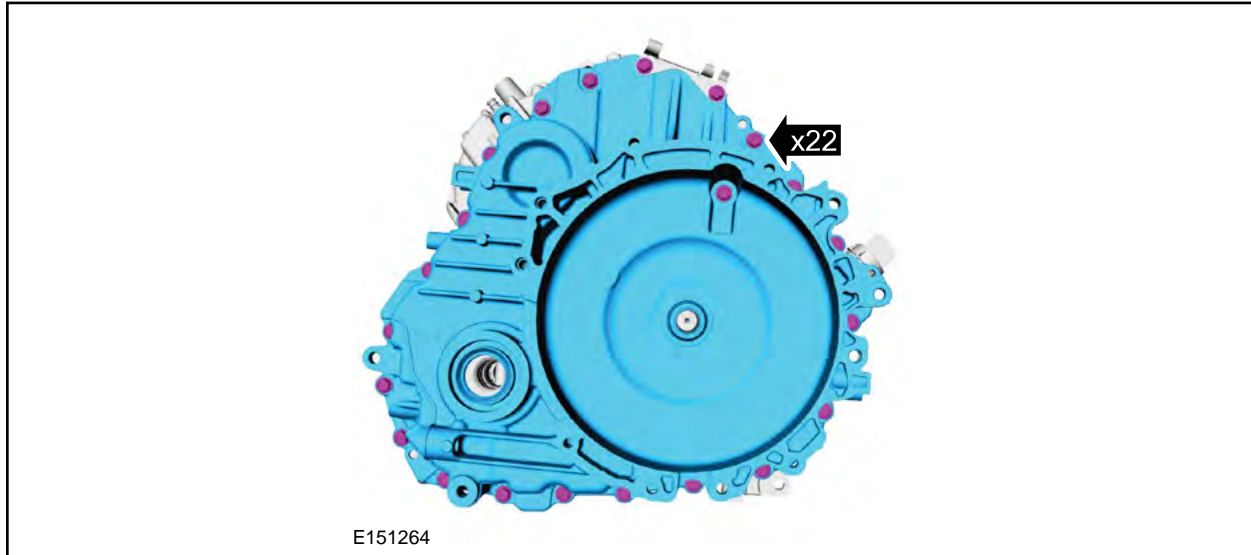
**FIGURE 1**

Some 2013 C-Max, 2013-2014 Fusion, MKZ Hybrid and Energi vehicles equipped with a HF-35 automatic transmission and built on or before 12/1/2013 may exhibit a transmission fluid leak at the damper housing to transmission case joint. This condition may be due to an adherence failure of the RTV.

1. Remove the bolts and the damper housing. See Figure 1.
